AIRCRAFT ACCIDENT REPORT AND EXECUTIVE SUMMARY

Reference:	CA18/2/3/9494	
Aircraft Registration	ZS-OAA	Date of Accident	26 October 2015		Time of Accident	9:54Z
Type of Aircraft	Boeing 737-400		Type of Operation		Commercial Part 121	
Pilot-in-command Licence Type	ATPL	Age	49	Licence Valid	Yes	
First Officer Licence Type	ATPL	Age	40	License Valid	Yes	
Pilot-in-command Flying Experience	Total Flying Hours	9186.1		Hours on Type	2899	
First Officer Flying Experience	Total Flying Hours	5817.1		Hours on Type	480.5	
Last point of departure	Port Elizabeth International Airport (FAPE)					
Next point of intended landing	O.R. Tambo International Airport (FAOR)					
Location of the accident site with reference to easily defined geographical points (GPS readings if possible)						
On runway 03R during landing at O.R. Tambo International Aerodrome						
Meteorological Information	Wind direction: 034°, Wind speed: 10kt; Wind Temp: 26°C; Visibility: 9999; Cloud cover: Few; Cloud base: 4500ft; Dew Point: 04°C

Name of Owner : Comair Limited
Name of Operator : Comair Limited
Manufacturer : Boeing Aircraft Company
Model : 737-400
Nationality : South African
Registration Marks : ZS-OAA
Place : O.R. Ta

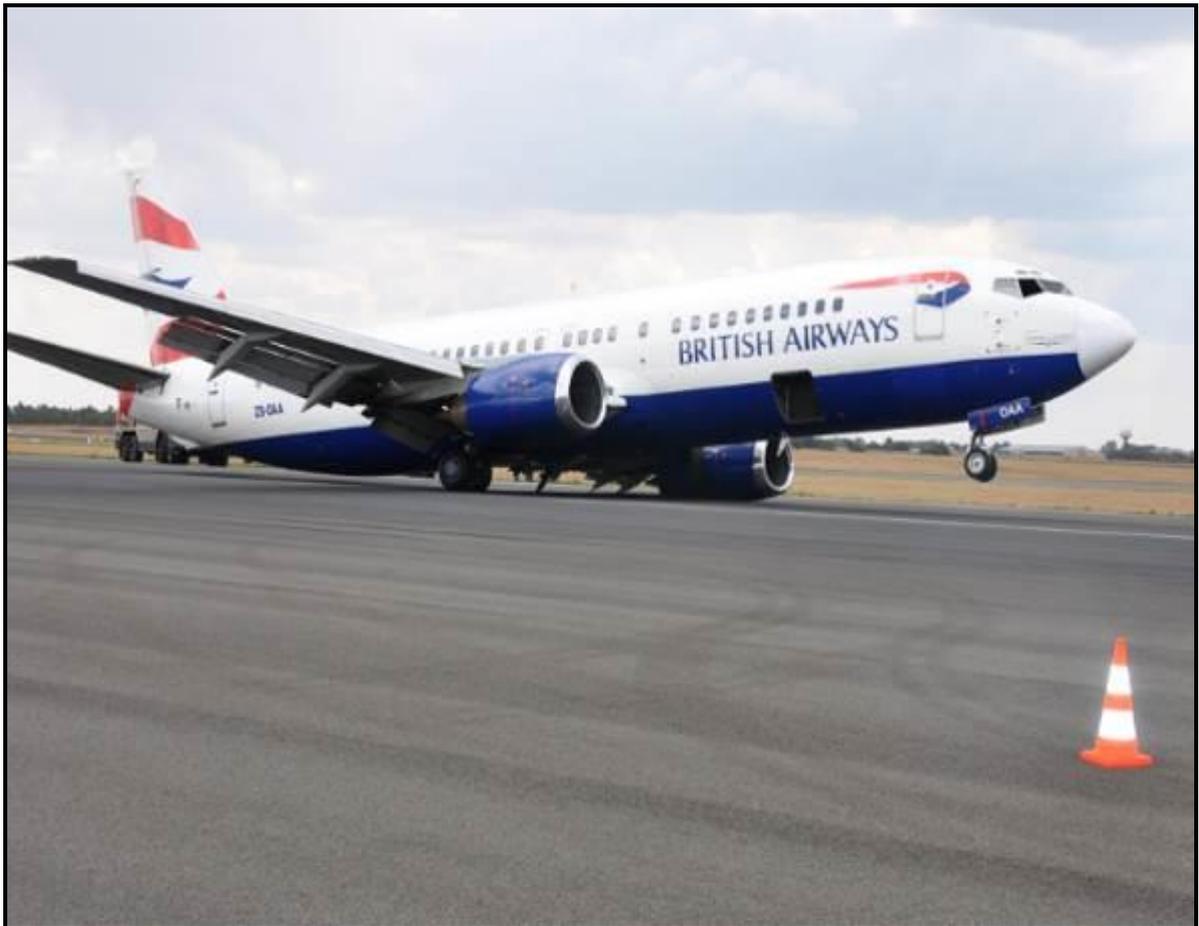
Figure 1: Aircraft as it came to rest

1.3.1 The aircraft sustained substantial damage to the No. 1 engine as the engine scraped along the runway surface after the landing gear detached from the aircraft structure.

1.3.2 At the time the landing gear was detaching from the aircraft mountings, more damage was caused to the landing gear mounting points and mechanisms, including flaps fairings, wing root attachment fairings and the landing gear extension / retraction link (lower torsion links and shimmy damper assembly).

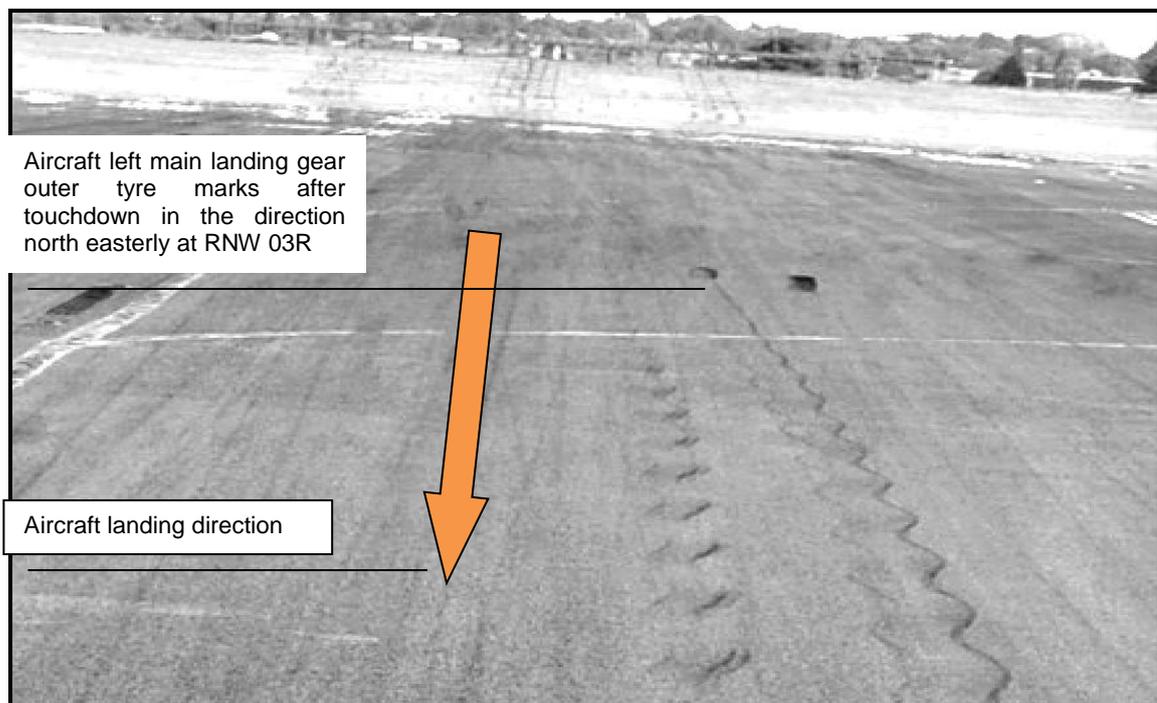
Figure 4: Shows initial contact marks

1.12.1 The accident occurred during landing on a cleared runway 03R. The on-site observation was that, during landing, the aircraft was subjected to a slight left roll attitude which might have enabled the aircraft to make contact with the runway with the left main landing gear first. It is not clear where the aircraft initially touched down, but at approximately 1 km past the threshold, the left main landing gear tyre marks indicated a form of shuddering manoeuvring beginning slightly and increasing gradually. This was inconsistent with the pilot's statement that during touchdown the aircraft started vibrating.

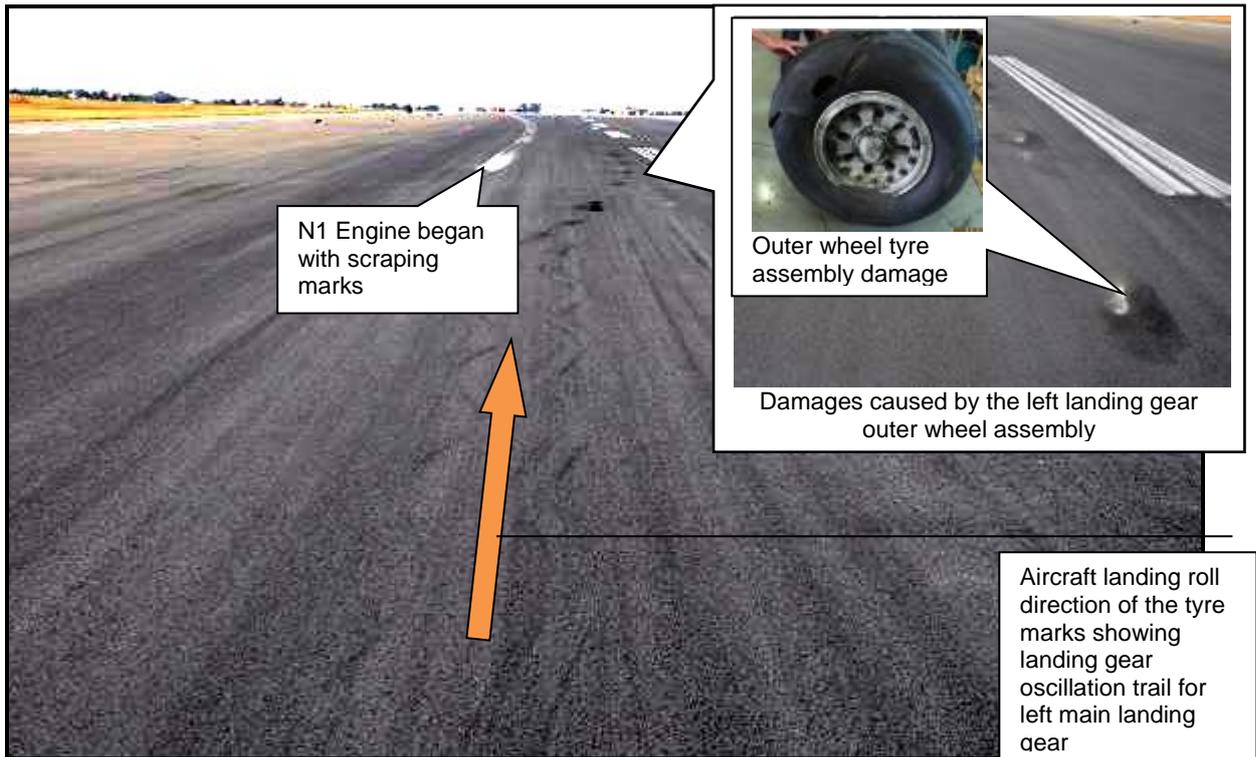
Figure 5: Shows the left-hand side landing gear tyre marks as it wiggled

1.12.2 The aircraft's left-hand main landing gear shuddering tyre marks occurred for a distance of approximately 200 m, whereby the runway surface damage was observed at the same place where the No.1 engine began scraping along the runway surface. At this time the left main landing gear had collapsed and was dragged along, causing the left wing to drop. There was evidence of runway surface damage at three intervals of approximately 1.7 m apart, appearing together with the hard tyre contact marks. The damage was consistent with damage caused by the outer wheel tyre assembly as it was dragged along. The damage on both wheel tyres was consistent with damage caused by an object that punched through at the same level with the upper broken torsion link. This may also indicate that both tyres were damaged after the shimmy damper bolt failed and the oscillations were

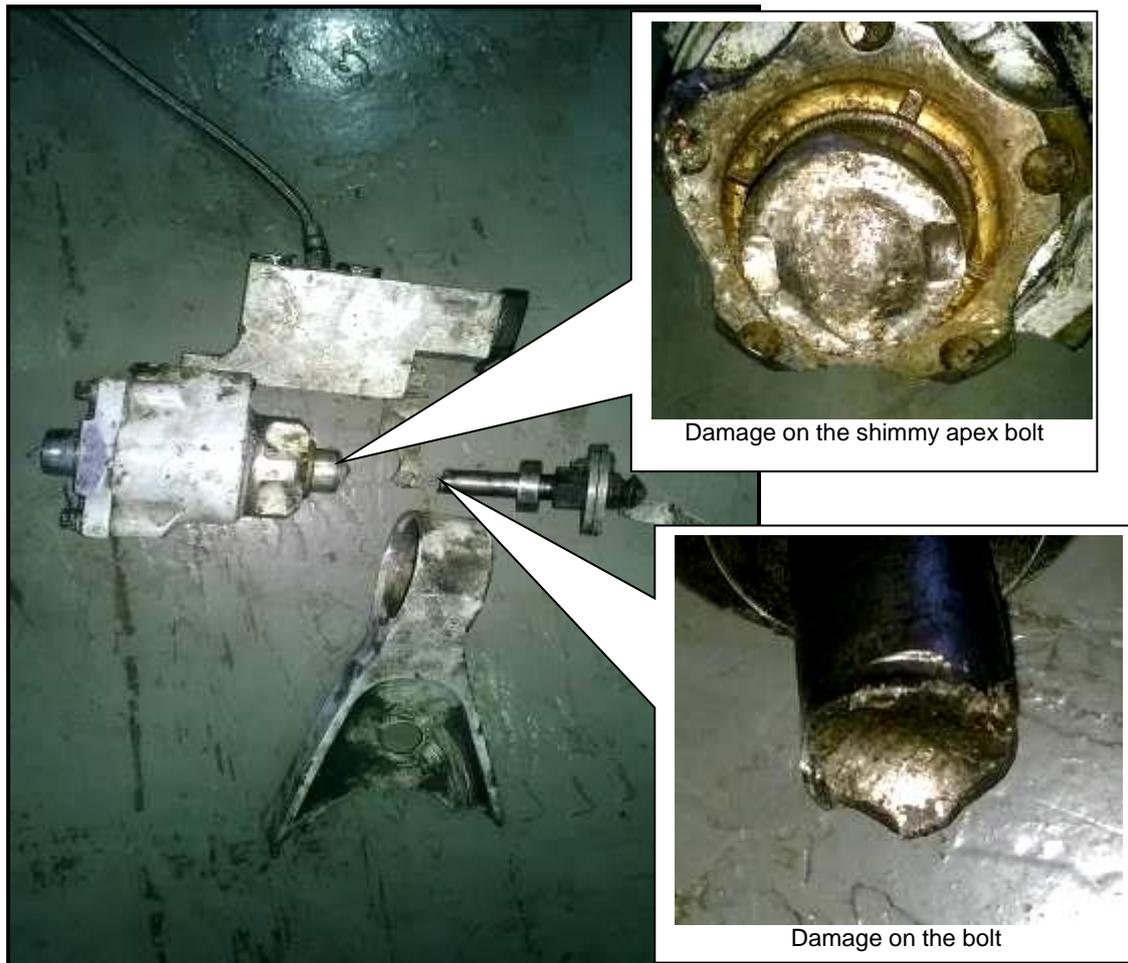
Figure 6: Damage on the shimmy damper component

1.12.3 . There was also evidence of some runway damage which was consistent with the damage caused by the shimmy damper component prior to detaching from the upper torque-link as the landing gear was dragged along. The shimmy damper was found on the left side lying a few metres from the landing gear extension / retraction mechanical actuator, just after the main landing gear doors debris. About several metres away there was an upper torsion link piece of a broken torsion link which connects directly to the shimmy damper. The damage on the shimmy damper is consistent with a component which was subjected to excessive tensile force.

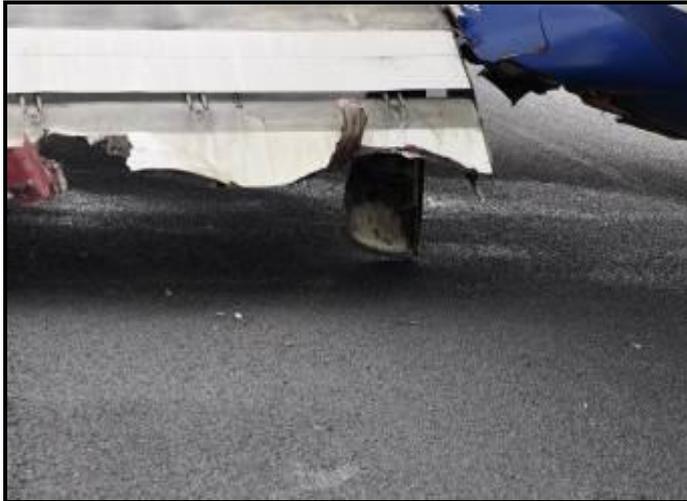
Figure 7: Shows damage on the trailing edge flaps

1.12.4 The damage to the trailing edge of the left wing, towards the wing root, was caused by the landing gear as it detached from the main assembly points. The inner flaps were also damaged by the landing gear. The trunnion forward-bearing bolt is designed to fail if the landing gear receives a severe impact. The observations revealed that the fuse lugs on the trunnion link gave a positive reaction characteristic with regard to design failure as it prevented damage to the left wing

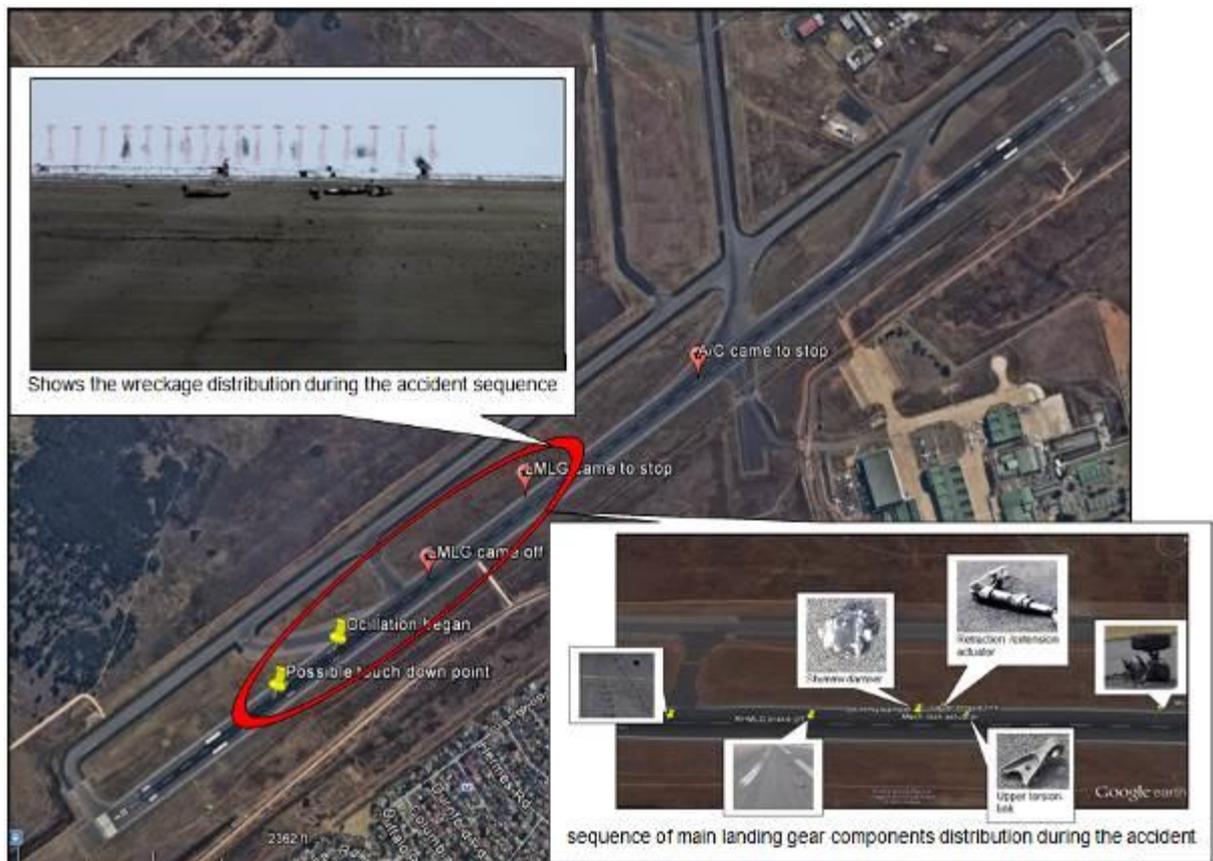
Figure 9: Shows the wreckage trail and accident sequence

1.12.5 The wreckage debris was scattered along the runway length during the accident sequence. There was further visible runway surface damage caused by the left landing gear assembly as it moved towards the left side of the runway. The left landing gear was violently detached from the airframe assembly points, and came

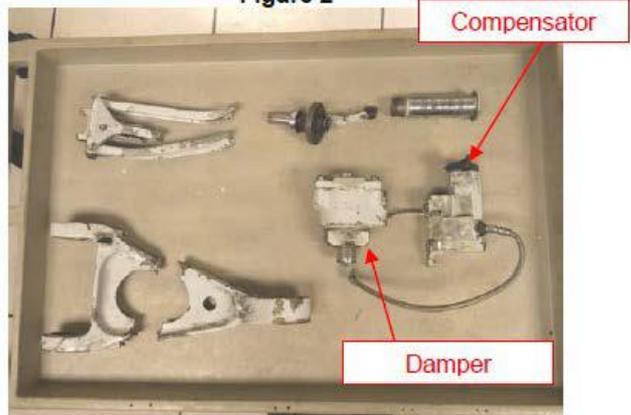
Figure 4

Initial examination showed that the damper assembly was separated into two sections, as seen in Figure 4. Figure 5 shows the main gear damper assembly in its normal assembled configuration.

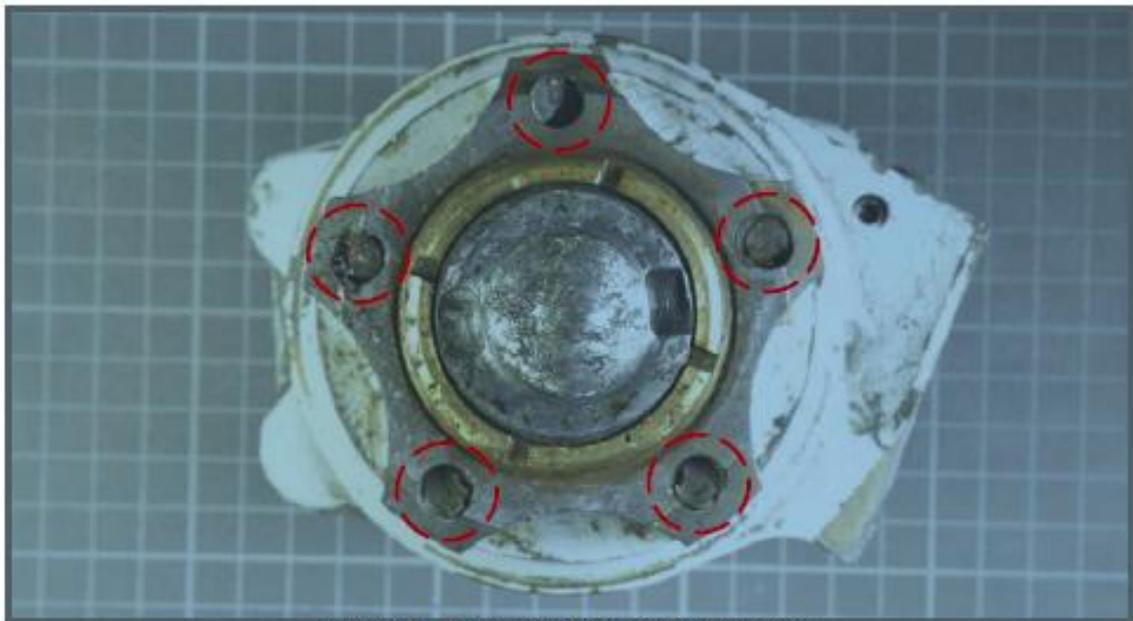
Figure 6 – Fractured bolts encircled in red

The general exterior condition of the parts displayed damage from the event. All of the five attachment bolts that secure the damper assembly to the torsion link were fractured, and portions of the bolts were still in the attachment holes; see Figure 6.

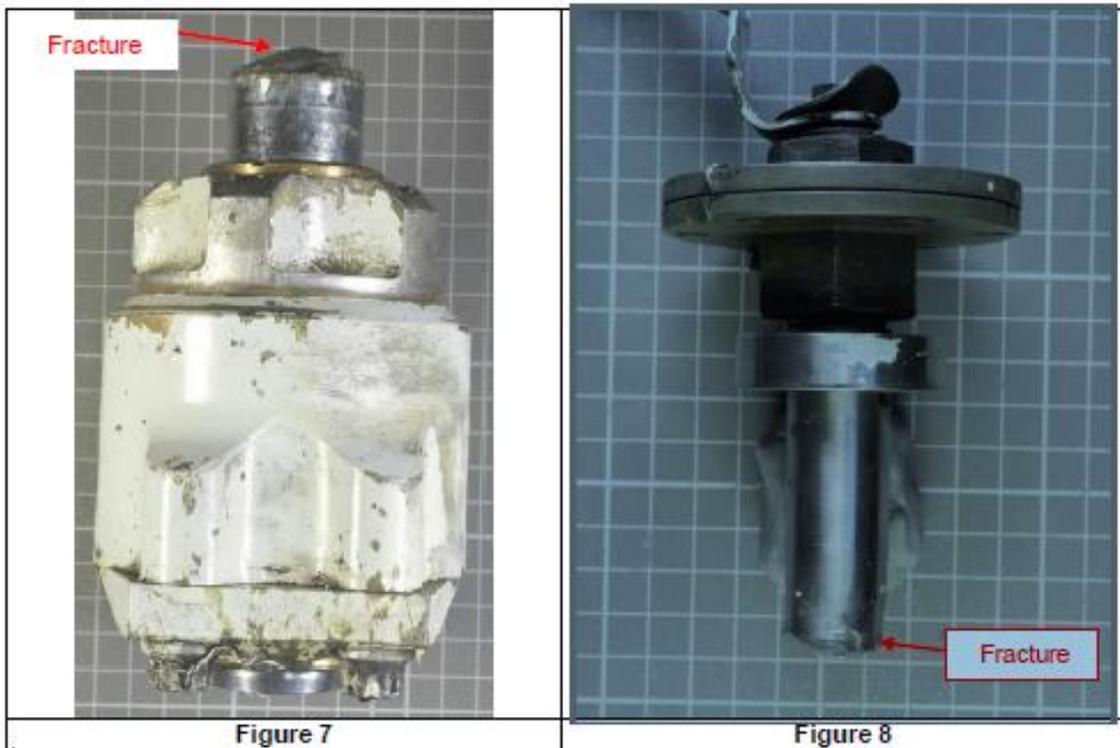
The damper piston shaft was fractured, and a portion of it was separated from the main portion that was still in the damper housing; see Figure 7 and Figure 8.

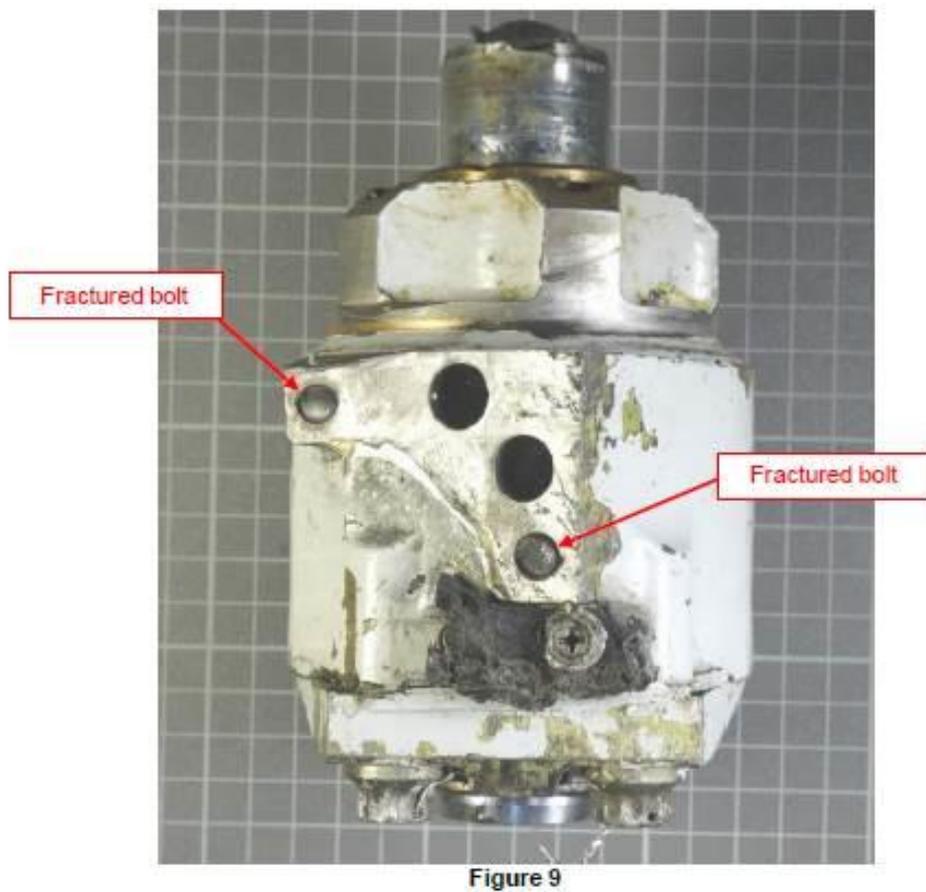
The two bolts that mount the compensator and damper together were fractured, and portions of the two bolts were still in the attachment holes; see Figure 9.

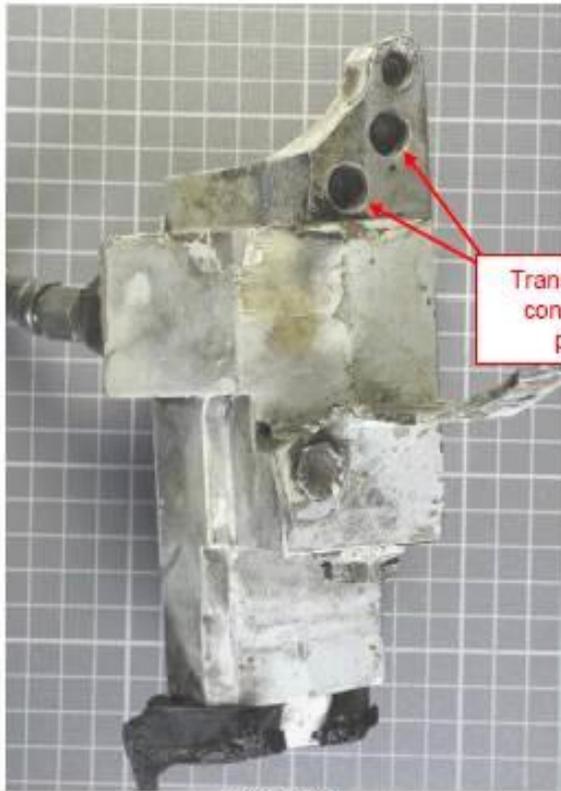
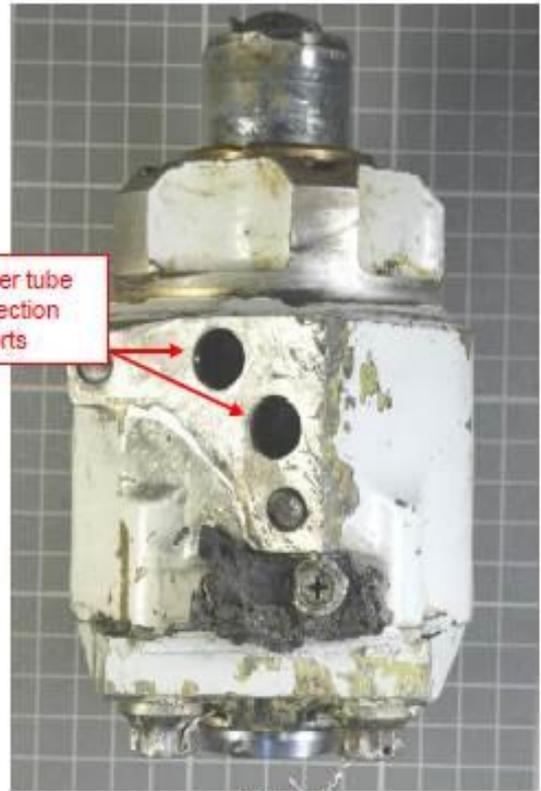
Neither of the two transfer tubes, between the compensator and damper, was present; see Figure 10 and Figure 11.

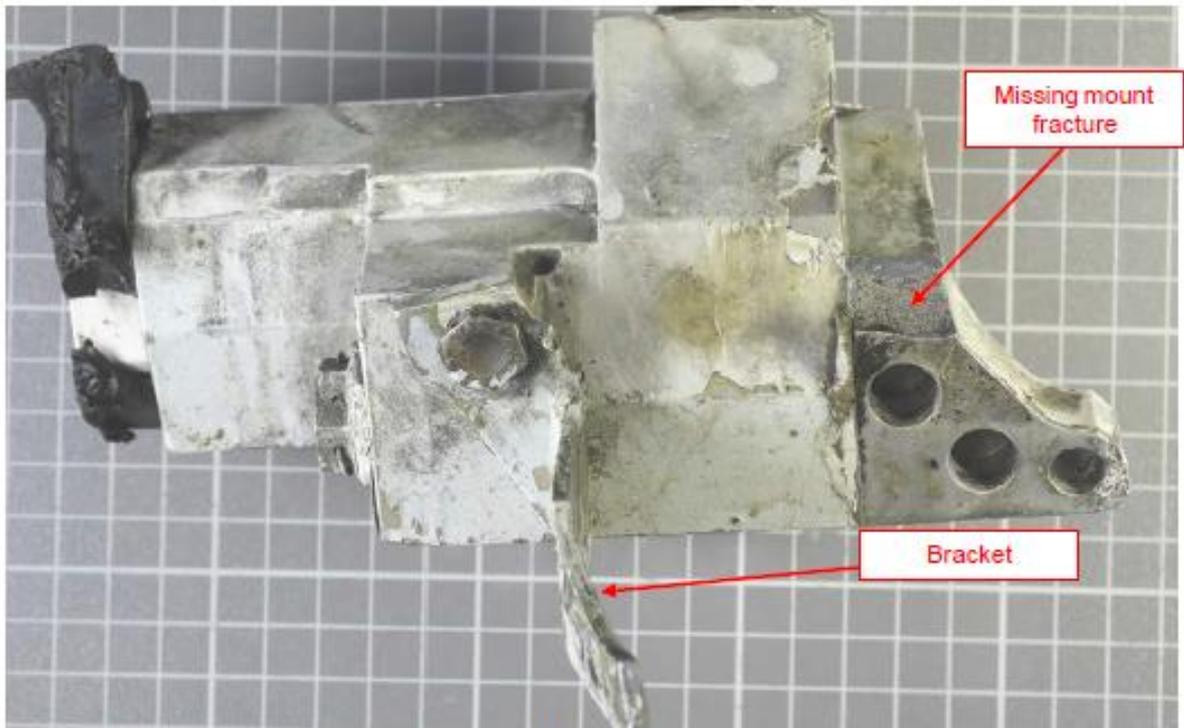
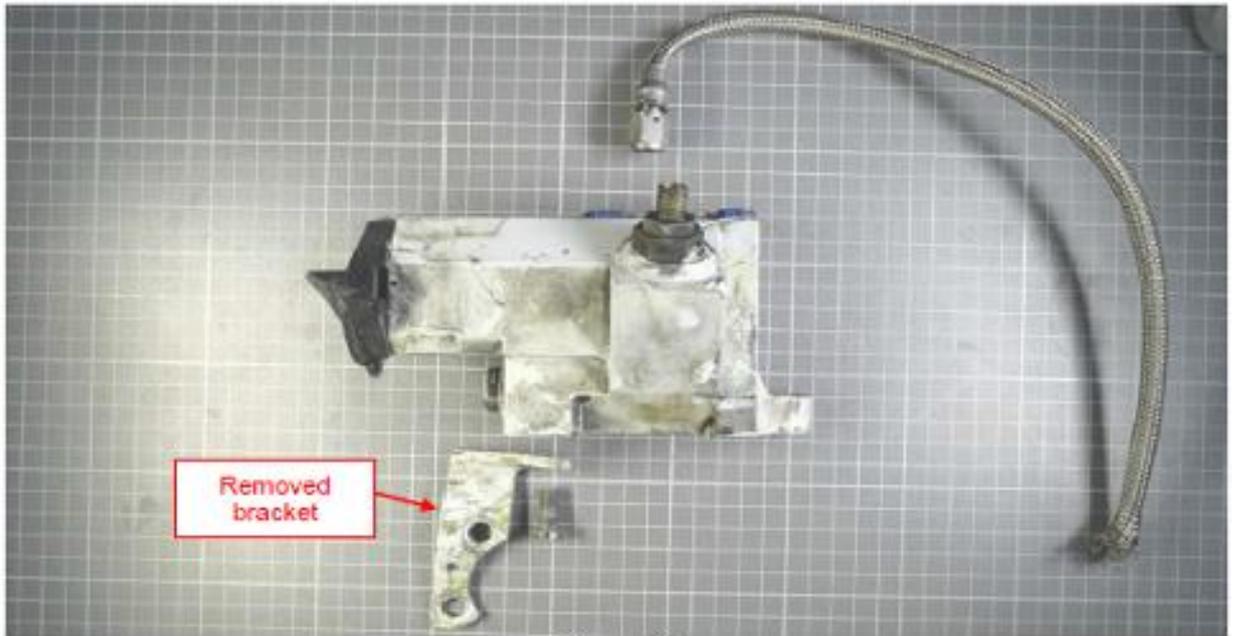
A mounting bracket was still attached to the compensator with a bolt; see Figure 12 and Figure 13. Also seen in Figure 12 is that a portion of the compensator housing, containing one of the bolt holes, had fractured off and was missing.

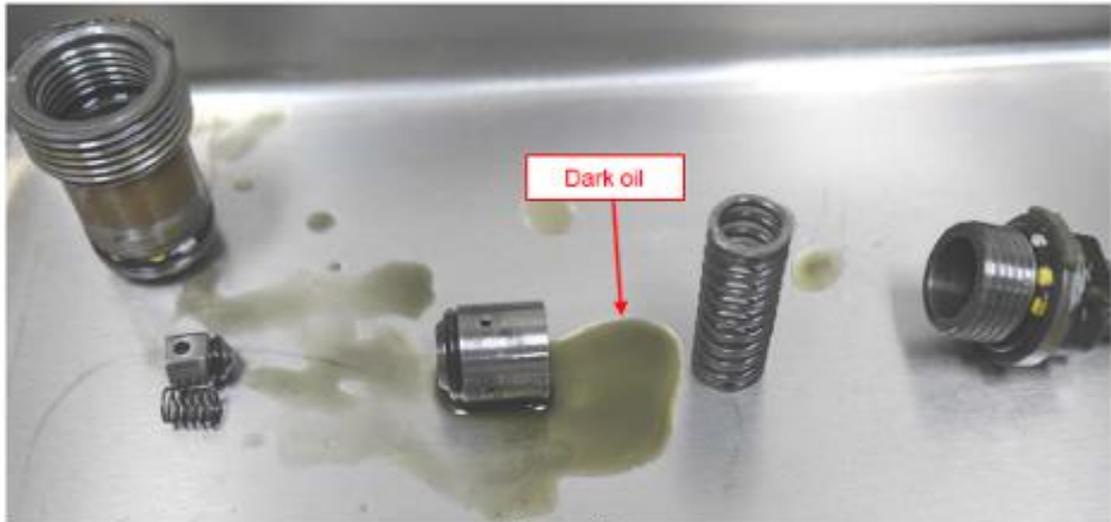
Figure 19

It was noted during the disassembly process that the oil trapped inside the compensator was also a dark colour, and murky in appearance, as depicted in Figure 19. This fluid was representative of the earlier statement that during testing, “the oil that was exiting the compensator was very dark in colour”.

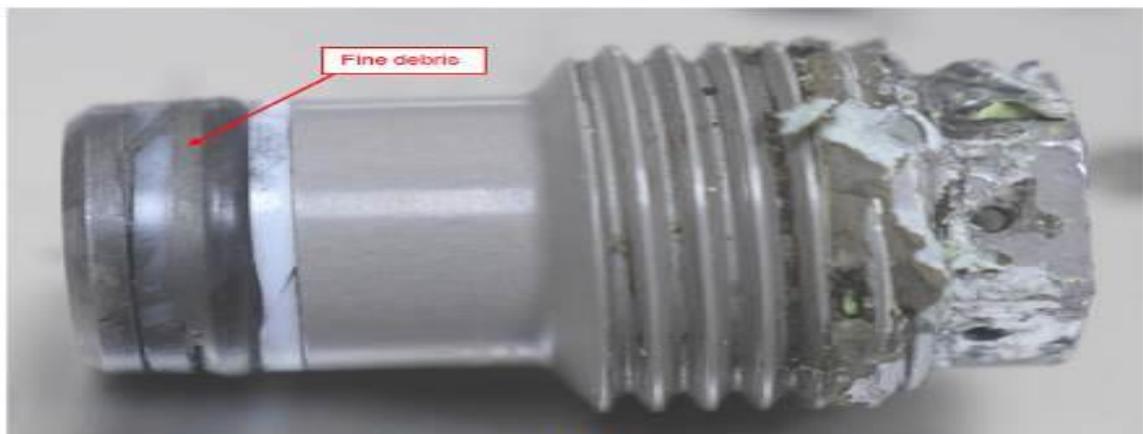
Figure 20

It was also noted that there was fine debris wedged within some of the seals; see Figure 20. This type of debris was found throughout the thermal relief assembly.

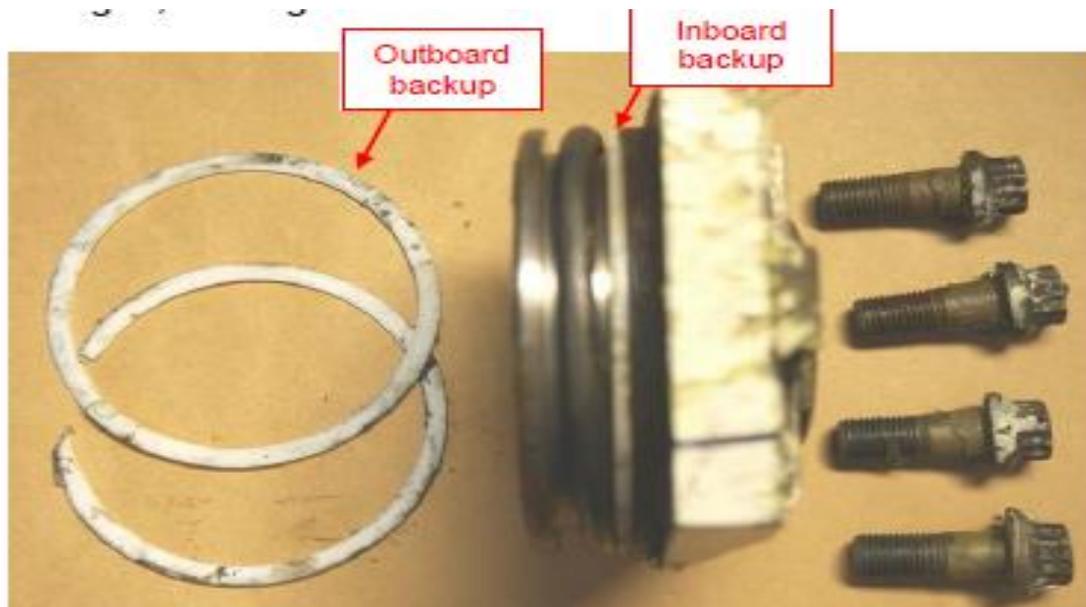
On the basis of the service history, the investigation concludes that the damage to the shimmy damper seal was sustained during assembly on the last overhaul.

After removing the four bolts and the cover of the damper assembly, it was noted that the outboard spiral back-up, which is one of two back-ups that are on either side of the O-ring, was damaged; see Figure 22.

Figure 22 - Damaged backup

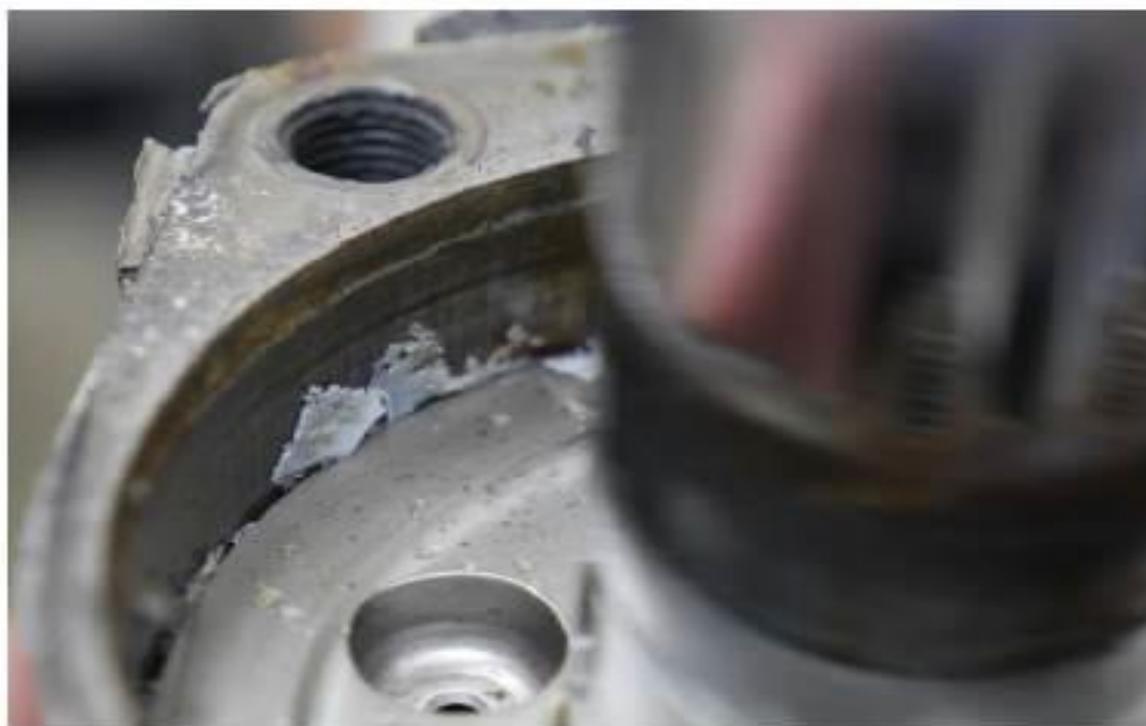
Figure 23

Portions of the damaged back-up were also found inside the damper housing after the cover was removed; see Figure 23.

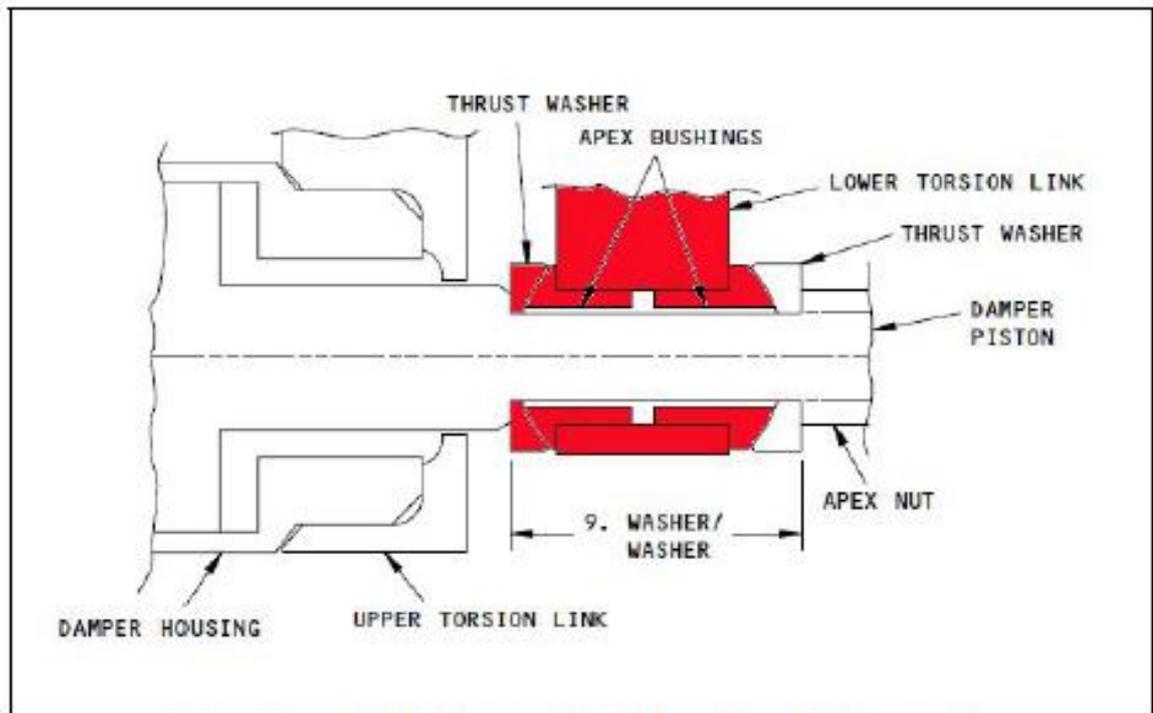
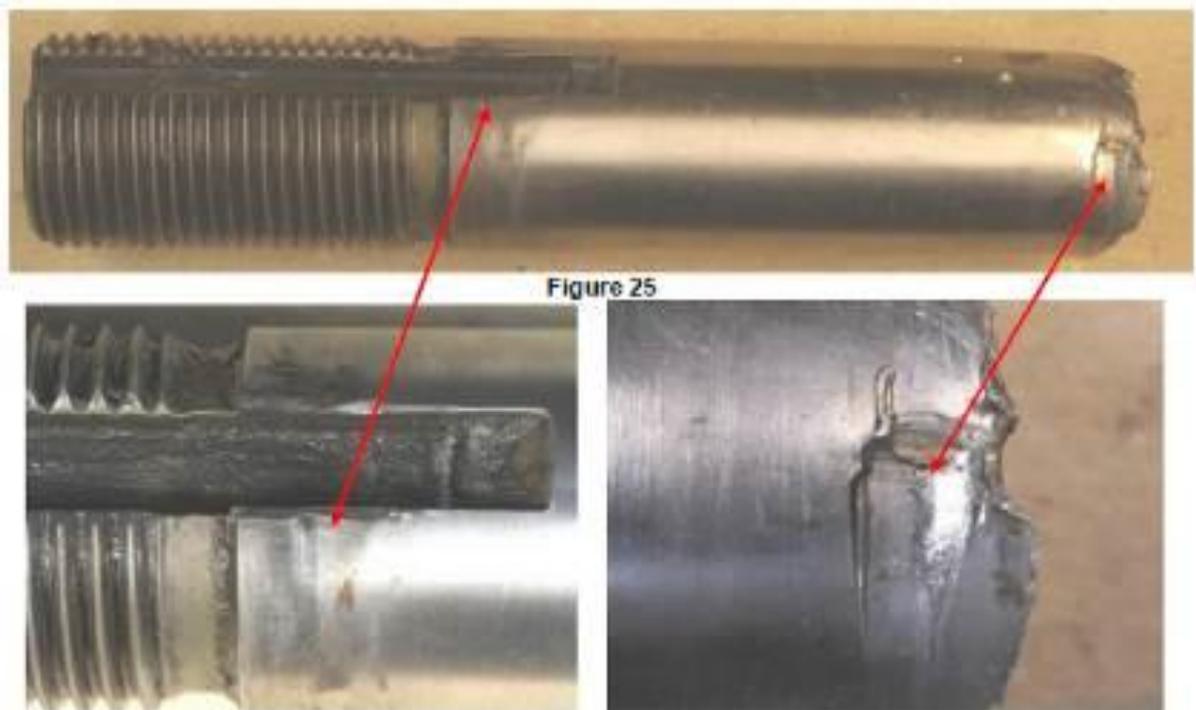
Although portions of the damper assembly were not present to verify wear, it was noted that there were, what appeared to be, two wear areas on the portion of the damper

shaft that had fractured off; see Figure 24 and Figure 25.

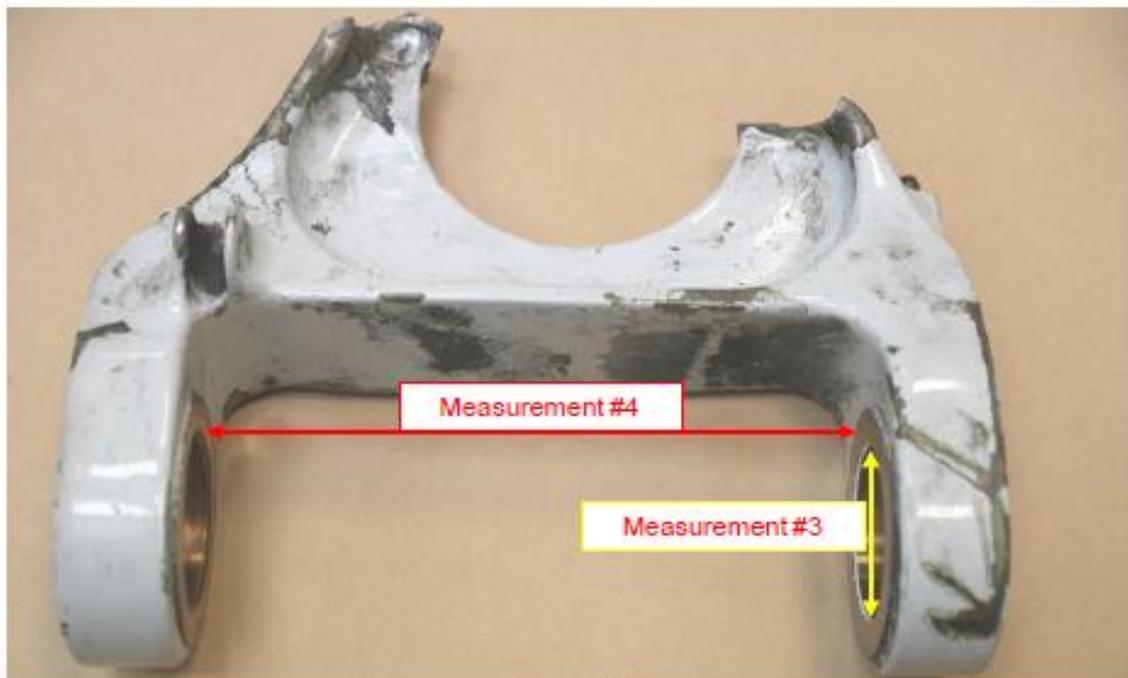
Figure 27

- Also, according to the test results, significant wear was found on the upper torsion link's bushing and the flanges. Although the wear was not far beyond limits it could also play a role due to undamped vibrations continuing to increase shimmy events.

Measurements identified by numbers 3 and 4 in Figure 26 were taken from the bushing end of the fractured upper torsion link; see Figure 27.

Per reference (b), section 32-11-51, page 603, the number 3 maximum wear dimension should be 1.7535". The left bushing inside diameter (ID) measured 1.755" and the right measured 1.756".

Per reference (b), section 32-11-51, page 603, the number 4 maximum distance between flange faces of bushings dimension should be 6.382". The distance between the flange faces of the bushings measured between 6.406" and 6.438".

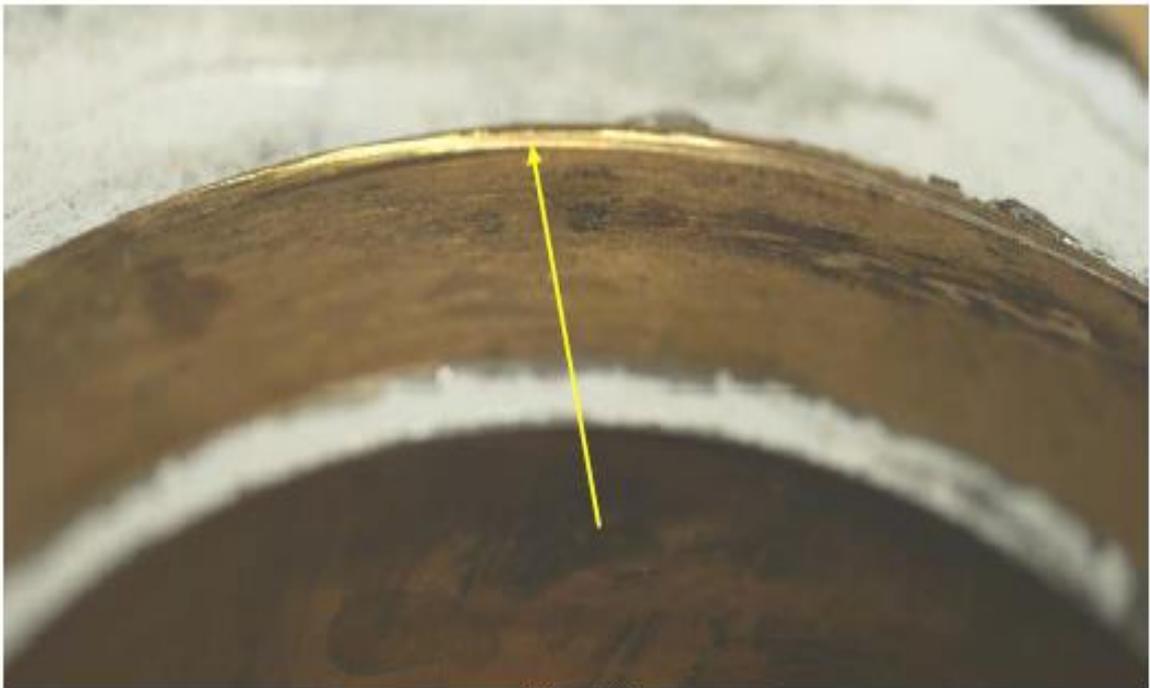
Figure 28

While measuring the number 4 maximum distance, it was noted that there was a wear lip on one of the face flanges of one of the bushings; see Figure 28.
