AIR TRANSPORTATION SAFETY INVESTIGATION REPORT A19W0015

Loss of control and collision with terrain

Air Tindi Ltd.

Beechcraft King Air 200, C-GTUC

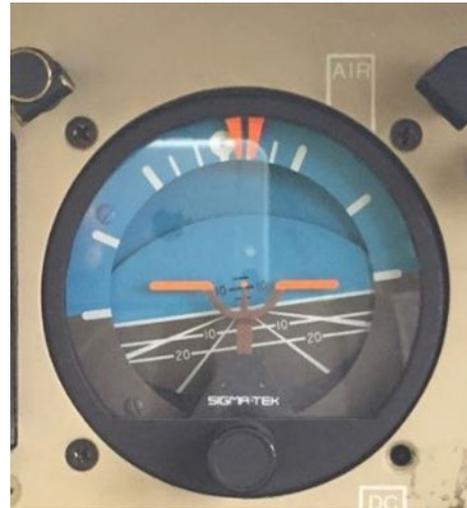
The TSB Engineering Laboratory completed a detailed examination of the attitude indicator and found no signs that the gyro rotor was rotating at the time of impact. The rotor bearings were examined and no anomalies were found. Due to the extent of damage to the aircraft and its systems, the investigation was unable to determine why the attitude indicator was not operating correctly.

The maintenance history for this model of attitude indicator installed in King Air 200 aircraft operated by Air Tindi was reviewed. Since 2015, this attitude indicator model had been removed for unscheduled repairs 15 times from various aircraft in the Air Tindi fleet. Of those, the cause of the reported fault was not determined in 5 cases.¹⁵ The instrument repair facility confirmed the causes of the faults in the remaining 10 cases and repaired the attitude indicators. The time in service for the 10 confirmed cases ranged from a low of 2.9 hours to a high of 766.2 hours. At the time of the occurrence, the attitude indicator installed in the occurrence aircraft had 636.4 hours in service.

A review of TC's service difficulty reporting system for the period of April 2014 to April 2019 revealed 3 reported instances¹⁶ of the SIGMA-TEK Model 5000B attitude indicator exhibiting indication issues requiring instrument replacement (Appendix A). A corresponding search of the U.S. Federal Aviation Administration's (FAA's) service difficulty reporting system for the same period revealed 1 reported incident¹⁷ of a SIGMA-TEK Model 5000B attitude indicator installed in the right side of the instrument panel of a King Air C90A that tumbled 5 minutes into the flight. The pilot returned to the maintenance base and, during the return, the attitude indicator began to operate normally again. The attitude indicator was replaced as a precautionary measure.

Figure 2. Right-side attitude indicator with no vacuum applied (Source: Air Tindi Ltd.)

While completing the after-start checklist, the first officer (FO) noted that the right-side attitude indicator was not erect. However, the captain expressed that he believed the condition of the attitude indicator was only temporary. While the captain did express that he had not experienced this anomaly in C-GTUC in the past, it is likely that at some time in his flying career, he had experienced a situation when there was the delayed initiation of a pneumatically operated attitude indicator. It is therefore likely that this past experience influenced the belief that the current condition of the instrument was only temporary, and the decision to depart CYZF was made.

Although just before take off the crew acknowledged that the right-side attitude indicator was not operative, they expected it to become operative at some point in the flight. As a result, they did not refer to the MEL, and departed into instrument meteorological conditions with an inoperative attitude indicator.

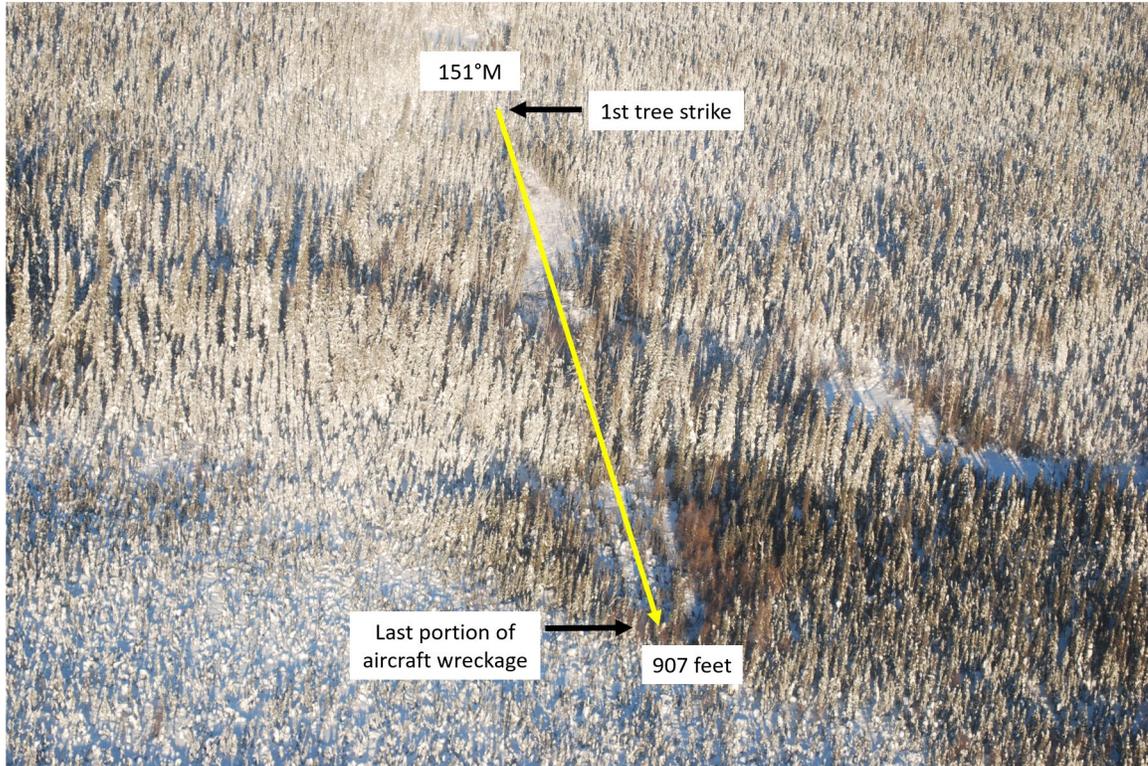
and at high speed, causing the aircraft to break up into a large number of pieces. The wreckage trail was approximately 900 feet long, oriented on a heading of 151°M (Figure 4).

Figure 4. Occurrence site, with yellow line depicting the beginning and end of the wreckage trail (Source: TSB)

All major aircraft structural components were accounted for in the on-site examination of the wreckage; therefore, the investigation determined that the aircraft did not break up while in flight. Both engines had separated from the aircraft structure during the impact sequence. Both propellers had broken free from their respective engines. All propeller blades were still attached to their respective propeller hub. Because the aircraft was destroyed, continuity of primary flight controls could not be established.
