# National Transportation Safety Board Aviation Accident Final Report

<b>Location:</b>	Fort Walton Beach, Florida	<b>Accident Number:</b>	CEN18FA358
<b>Date &amp; Time:</b>	August 30, 2018, 10:30 Local	<b>Registration:</b>	N1876L
<b>Aircraft:</b>	Beech B60	<b>Aircraft Damage:</b>	Destroyed
<b>Defining Event:</b>	Controlled flight into terr/obj (CFIT)	<b>Injuries:</b>	4 Fatal
<b>Flight Conducted Under:</b>	Part 91: General aviation - Personal

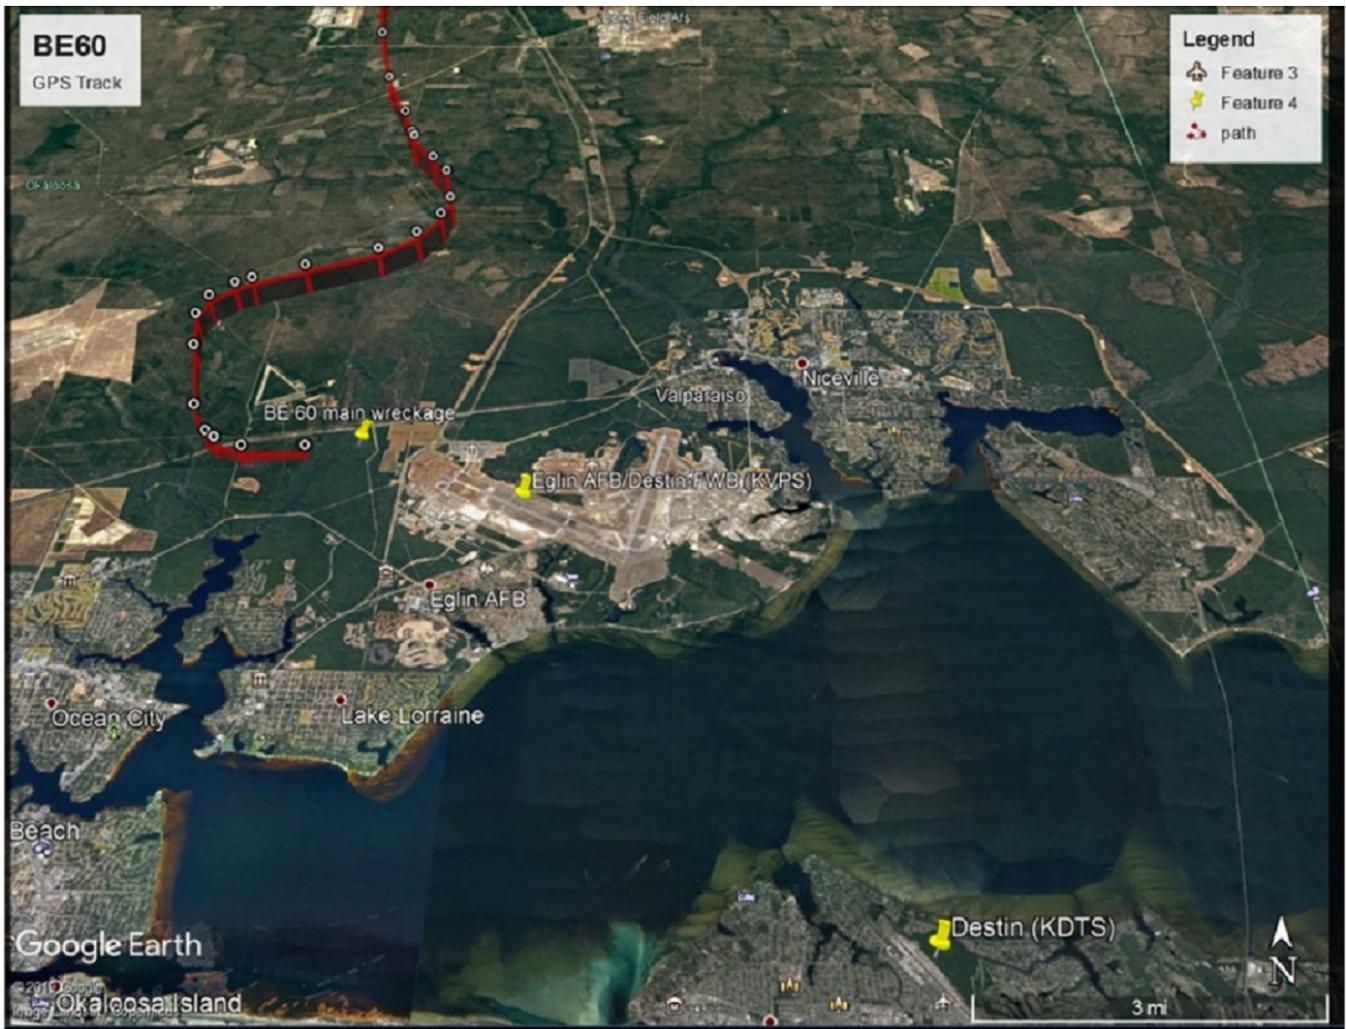
Figure 1: GPS Track

GPS data recovered from a portable onboard unit showed the airplane's track as it approached DTS. The last data point, at 1032, indicated that the airplane was at an altitude of 489 ft and a ground speed of 118 knots. At 1033, the approach controller asked the tower controller if the airplane had Eglin AFB and DTS in sight, and the tower controller responded that the pilot reported that the airplane was 2 miles out. The approach controller then stated that the airplane was 200 ft over Eglin AFB. The tower controller tried to contact the pilot, but the pilot did not respond to these transmissions. The airplane wreckage was located in a remote wooded area about 8 miles northwest of DTS and 2.5 miles northwest of Destin-Fort Walton Beach Airport (VPS), Eglin AFB, Florida.
