National Transportation Safety Board Aviation Accident Final Report

Location:	Geneva, Florida	Accident Number:	WPR18FA045
Date & Time:	December 8, 2017, 11:15 Local	Registration:	N19LW
Aircraft:	Beech C90	Aircraft Damage:	Destroyed
Defining Event:	Loss of control in flight	Injuries:	3 Fatal
Flight Conducted Under:	Part 91: General aviation - Instructional

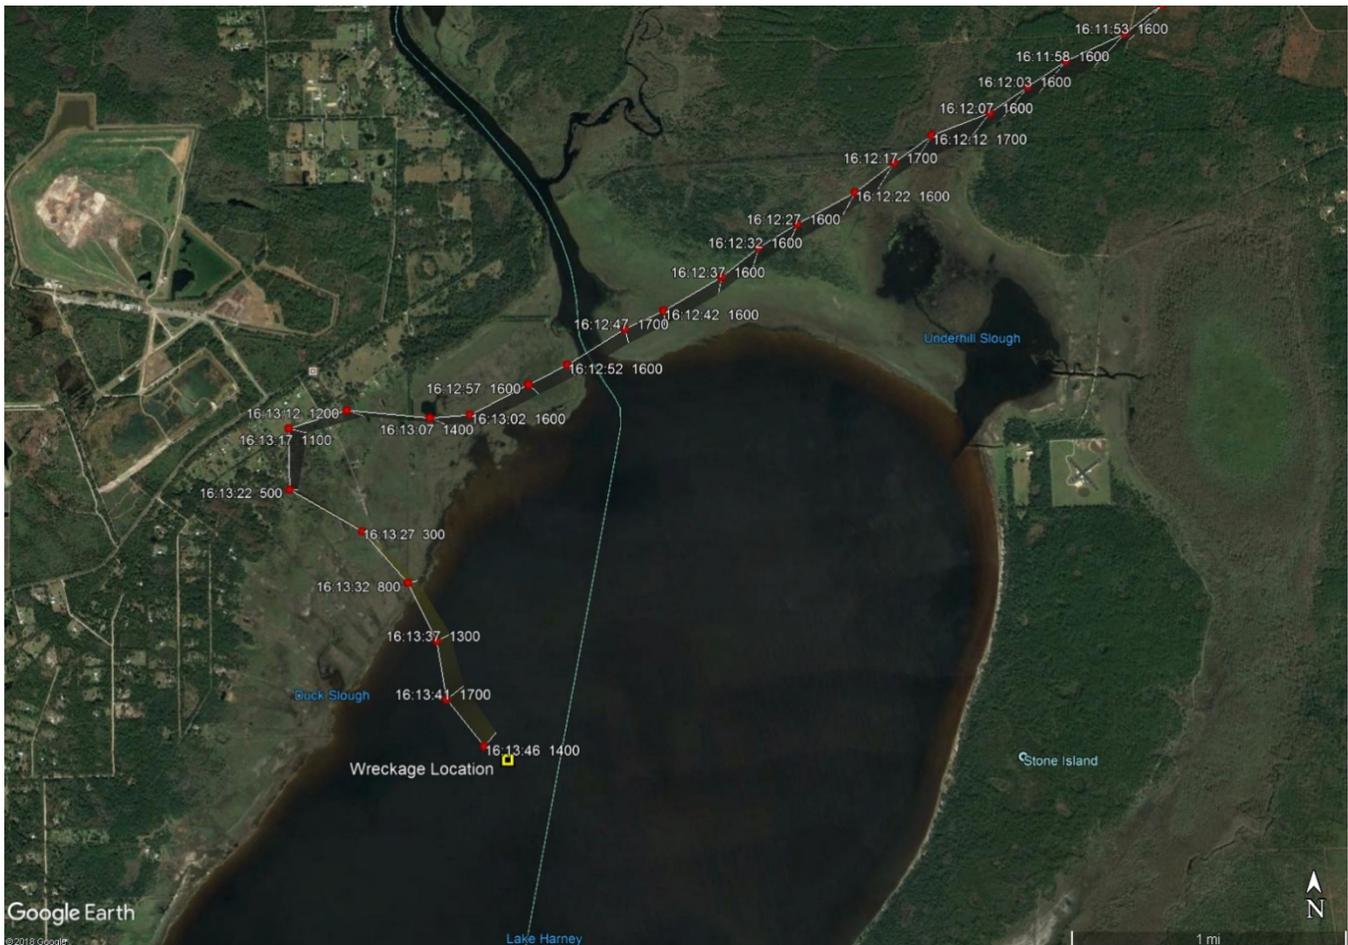
Figure 1: Final portion of recorded radar data

The flight instructor, commercial pilot receiving instruction, and commercial pilot-rated passenger were conducting an instructional flight in the multi-engine airplane during instrument meteorological conditions. After performing a practice instrument approach, the flight was cleared for a second approach; however, the landing runway changed, and the controller vectored the airplane for an approach to the new runway. The pilot was instructed to turn to a southwesterly heading and maintain 1,600 ft until established on the localizer. Radar information revealed that the airplane turned to a southwesterly heading on a course to intercept the localizer and remained at 1,600 ft for about 1 minute 39 seconds before beginning a descending right turn to 1,400 ft. The descent continued to 1,100 ft; at which time the air traffic control controller issued a low altitude alert. Over the following 10 seconds, the airplane continued to descend at a rate in excess of 4,800 ft per minute (fpm). The controller issued a second low altitude alert to the crew with instructions to climb to 1,600 ft immediately. The pilot responded about 5 seconds later, "yeah I am sir, I am, I am." The airplane then climbed 1,400 ft over 13 seconds, resulting in a climb rate in excess of 6,700 fpm, followed by a descent to 1,400 ft over 5 seconds, resulting in a 1,500-fpm descent before radar contact was lost in the vicinity of the accident site.

At 1612:37, the controller told the pilot that he would appreciate any cloud base reports on final, to which the pilot responded, "ok, wilco." Radar data showed that the airplane remained at 1,600 ft until 1612:12, then climbed to 1,700 ft briefly before descending back to 1,600 ft. At 1613:07, the airplane had turned to a westerly heading, descended to 1,400 ft, and continued a descent through 1,100 ft while initiating a left turn to a southerly heading. Shortly thereafter, the controller issued the airplane two low altitude alerts, about 10 seconds apart, and instructed the pilot to "maintain 1,600 immediately" until established on the approach. Radar data showed that, during this time, the airplane continued its descent, reaching 300 ft before climbing back to 800 ft, as it continued on a southeasterly heading. At 1613:31, the pilot stated, "yeah I am sir, I am, I am." No further radio communication was received from the airplane. The last three radar targets recorded at 1613:37, 1613:41, and 1613:46 showed the airplane at 1,300, 1,700, and 1,400 ft msl, respectively, in the vicinity of the accident site. (Figure 1)

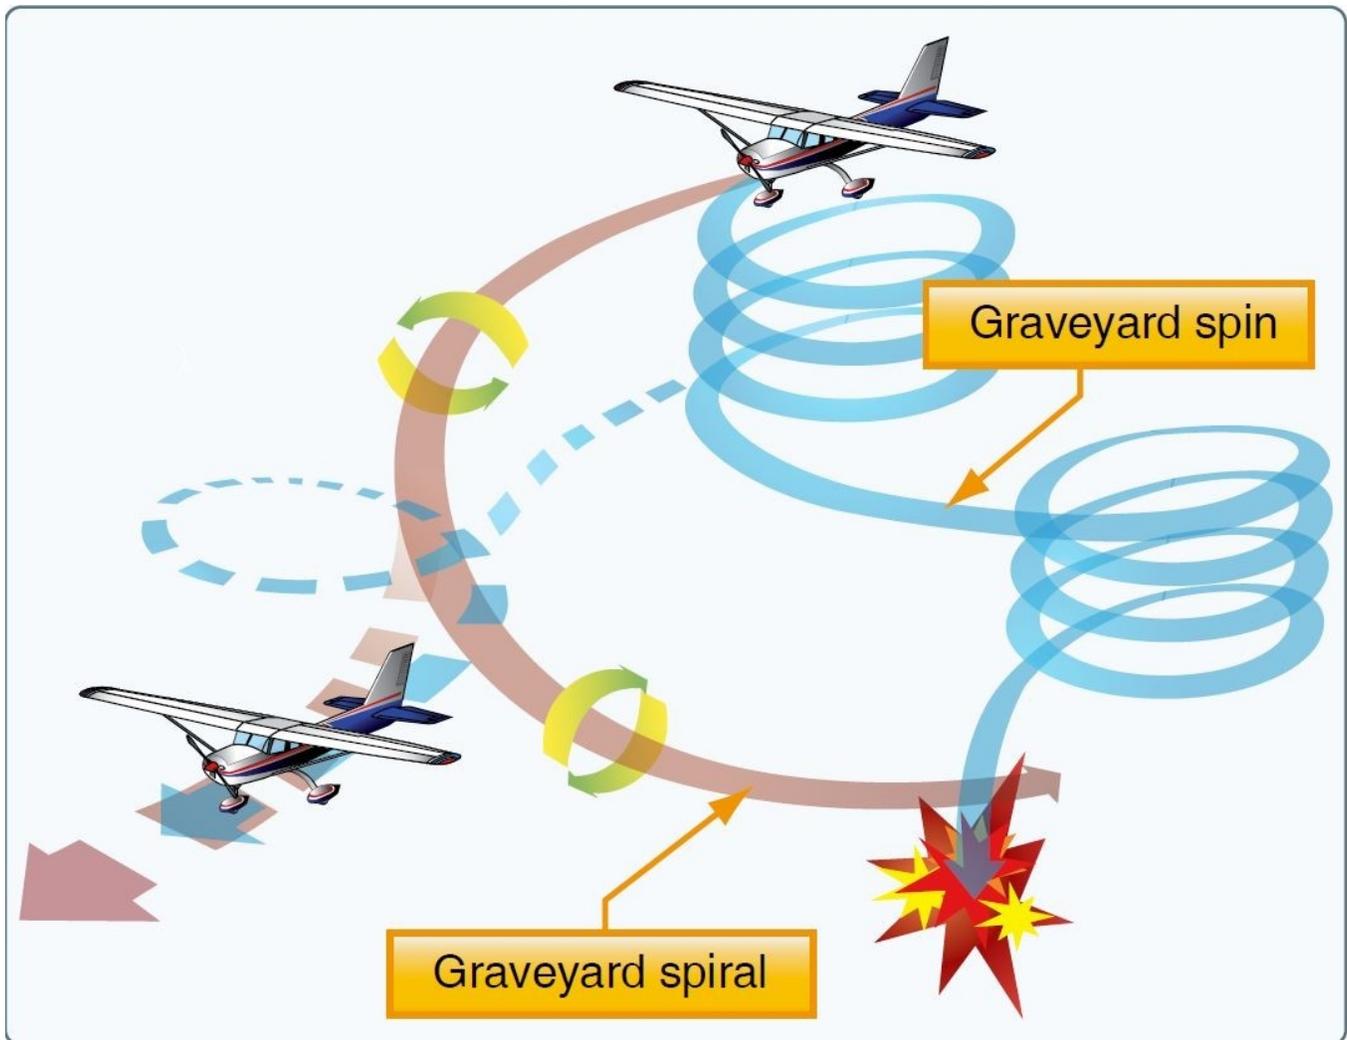
Figure 2: Graphic depicting a graveyard spin and graveyard spiral.

The graveyard spiral...is associated with a return to level flight following an intentional or unintentional prolonged bank turn. For example, a pilot who enters a banking turn to the left will initially have a sensation of a turn in the same direction. If the left turn continues (~20 seconds or more), the pilot will experience the sensation that the airplane is no longer turning to the left. At this point, if the pilot attempts to level the wings this action will produce a sensation that the airplane is turning and banking in the opposite direction (to the right). If the pilot believes the illusion of a right turn (which can be very compelling), he/she will reenter the original left turn in an attempt to counteract the sensation of a right turn. Unfortunately, while this is happening, the airplane is still turning to the left and losing altitude. Pulling the control yoke/stick and applying power while turning would not be a good idea—because it would only make the left turn tighter. If the pilot fails to recognize the illusion and does not level the wings, the airplane will continue turning left and losing altitude until it impacts the ground.

Figure 2 is a graphic from the FAA's Pilot's Handbook of Aeronautical Knowledge, showing a graveyard spin and a graveyard spiral.
