National Transportation Safety Board Aviation Accident Final Report

Location:	Baton Rouge, Louisiana	Accident Number:	CEN18LA285
Date & Time:	July 20, 2018, 14:30 Local	Registration:	N327BK
Aircraft:	Smith Aerostar601	Aircraft Damage:	Substantial
Defining Event:	Loss of engine power (total)	Injuries:	2 None
Flight Conducted Under:	Part 91: General aviation - Personal

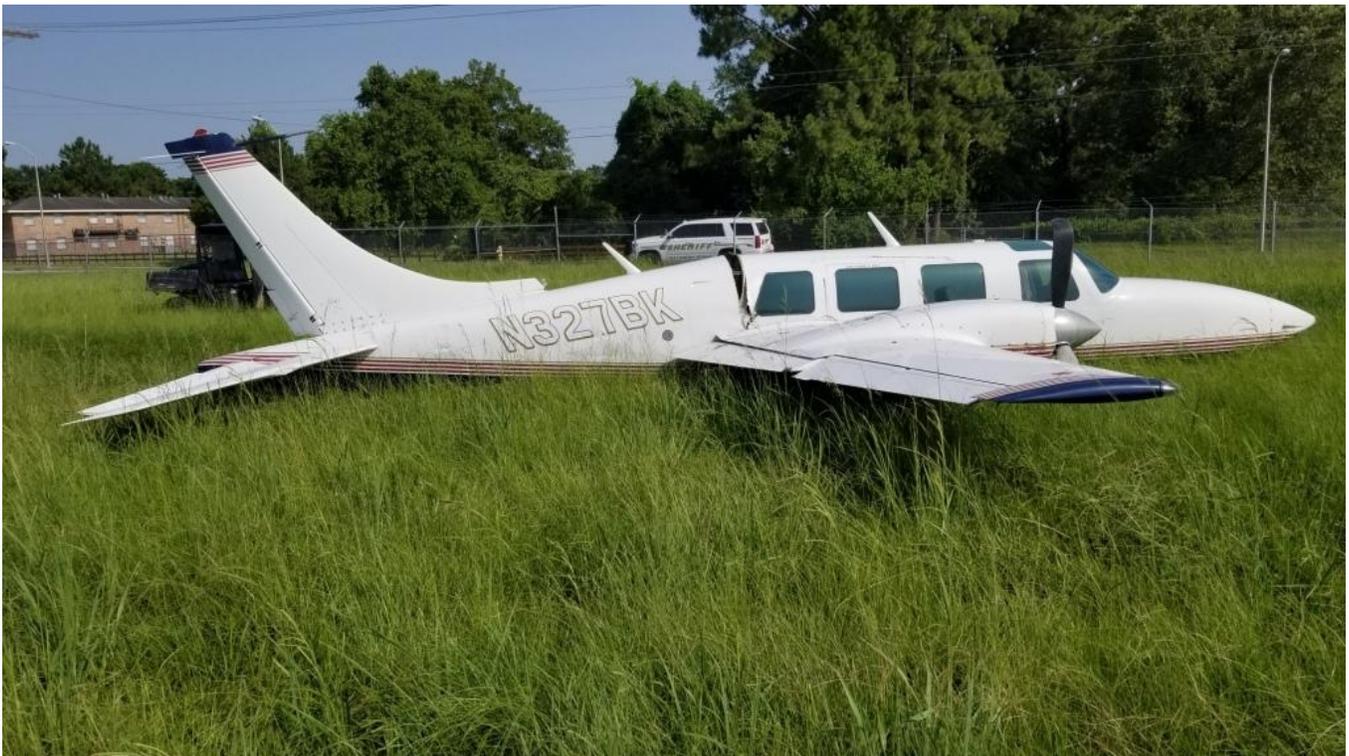
Figure 1 – Accident airplane

After the accident the pilot stated that he completed a preflight inspection about 1400, then boarded the airplane and started both engines. While holding short of runway 31, he performed a pre-takeoff check of the airplane including a run-up for each engine with no anomalies noted. During the takeoff roll he advanced the throttles to takeoff power, then rotated. Shortly after rotation he noticed the right engine was not producing full power and the engine speed was decreasing. With no remaining runway available to land, he continued and looked for an off-field landing location. He retracted the landing gear and feathered the right propeller. The airplane was unable to maintain altitude so the pilot made a hard forced landing to a grass-covered field (figure 1) about 1 mile northwest of the departure end of runway 31.
