National Transportation Safety Board

Aviation Accident Final Report

Location:	Hydaburg, Alaska	Accident Number:	ANC18FA053
Date & Time:	July 10, 2018, 08:35 Local	Registration:	N3952B
Aircraft:	De Havilland DHC 3	Aircraft Damage:	Substantial
Defining Event:	Loss of visual reference	Injuries:	6 Serious, 4 Minor, 1 None
Flight Conducted Under:	Part 135: Air taxi & commuter - Non-scheduled

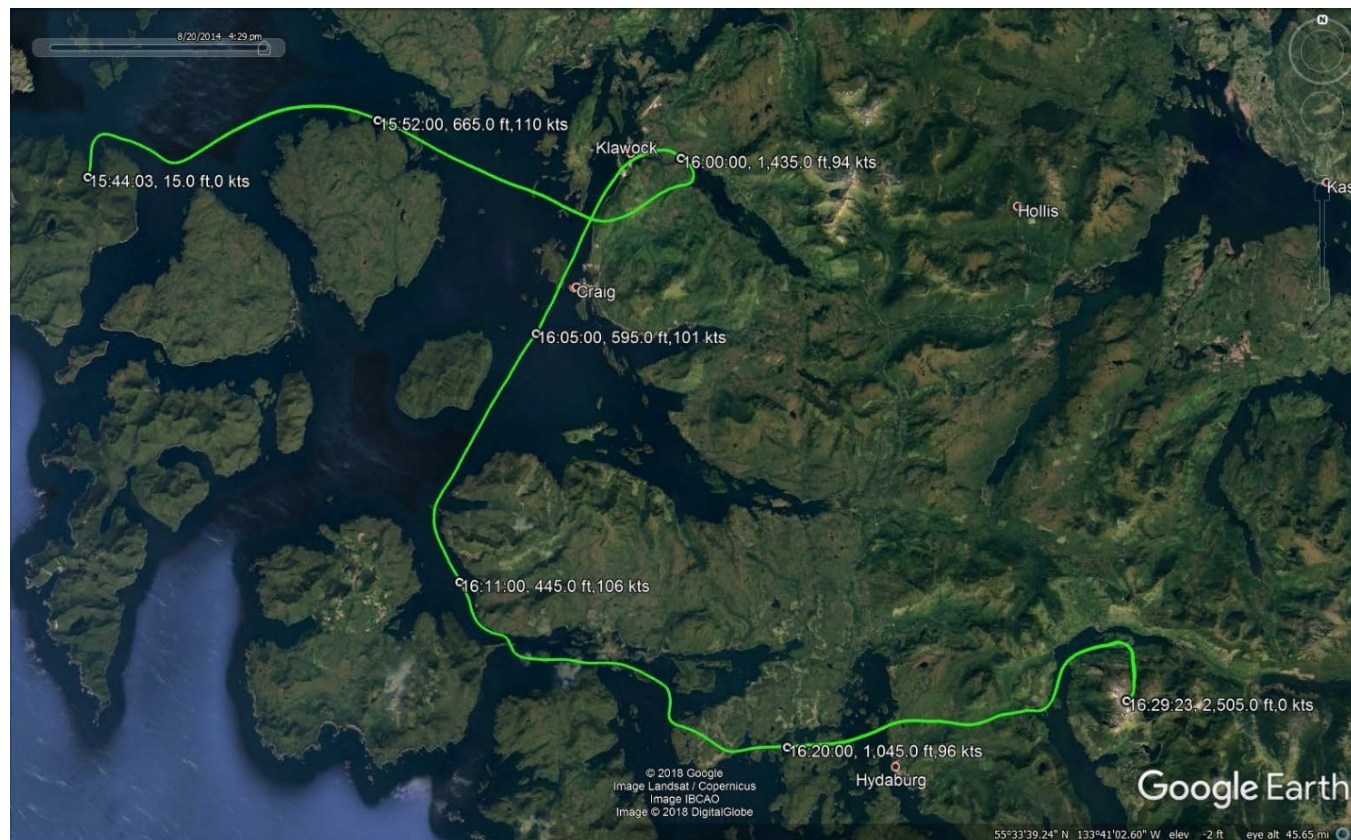
Figure 1. Google Earth overlay of the entire accident flight on July 10, 2018. Indicated airspeed (IAS) values are shown.
