National Transportation Safety Board Aviation Accident Final Report

Location:	Shreveport, Louisiana	Accident Number:	CEN19FA088
Date & Time:	February 28, 2019, 10:40 Local	Registration:	N428CD
Aircraft:	Piper PA46	Aircraft Damage:	Substantial
Defining Event:	Loss of control in flight	Injuries:	2 Fatal
Flight Conducted Under:	Part 91: General aviation - Personal

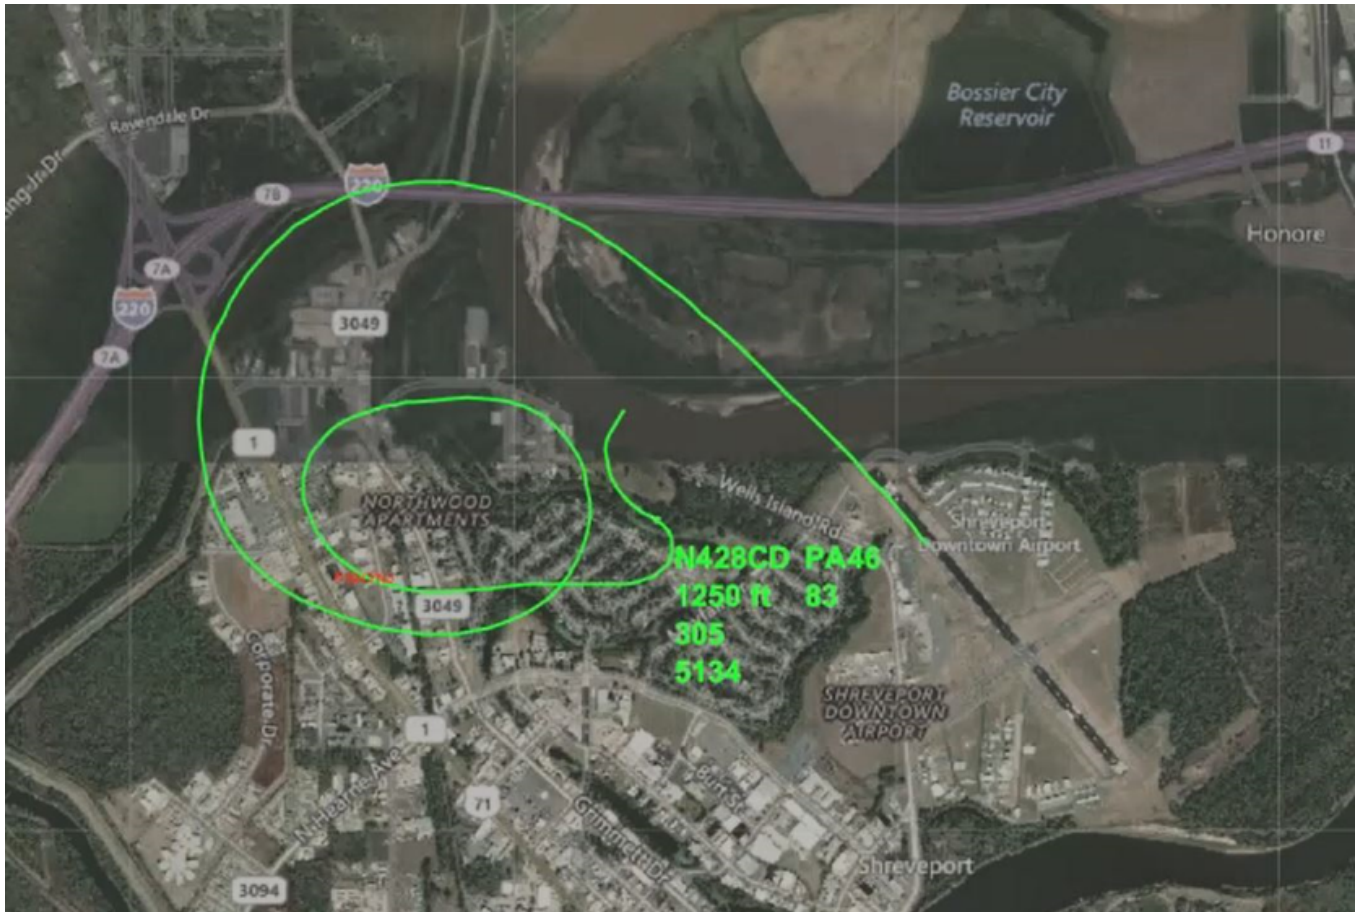
Figure 1 - Air Traffic Control Flight Track of N428CD

After climbing to 1,400 ft msl, the airplane's altitude and airspeed began to fluctuate as it continued in a tightening left spiral (see figure 1). About 35 seconds after transmitting "standby," the pilot stated, "we're in trouble up here." The airplane subsequently made a decelerating right turn then rapidly descended. The last ATC data recorded for the flight indicated a groundspeed of 31 knots at 575 ft msl.

Onboard data showed the airplane's altitude, vertical velocity, and speed oscillated several times and the turn rate increased during the last minute of the flight. From 10:39:25 to 10:39:58, the airplane's altitude varied from 1,987 to 822 to 1,980 ft msl and the vertical velocity fluctuated from -6,001 to +5,834 ft per minute (fpm). The last data captured at 10:40:07 was 1217 ft msl and -6818 fpm.
