# National Transportation Safety Board Aviation Accident Final Report

<b>Location:</b>	Kidron, Ohio	<b>Accident Number:</b>	CEN19LA056
<b>Date &amp; Time:</b>	January 21, 2019, 09:12 Local	<b>Registration:</b>	N467KS
<b>Aircraft:</b>	Douglas DC3C	<b>Aircraft Damage:</b>	Substantial
<b>Defining Event:</b>	Loss of control in flight	<b>Injuries:</b>	2 Fatal
<b>Flight Conducted Under:</b>	Part 91: General aviation - Positioning

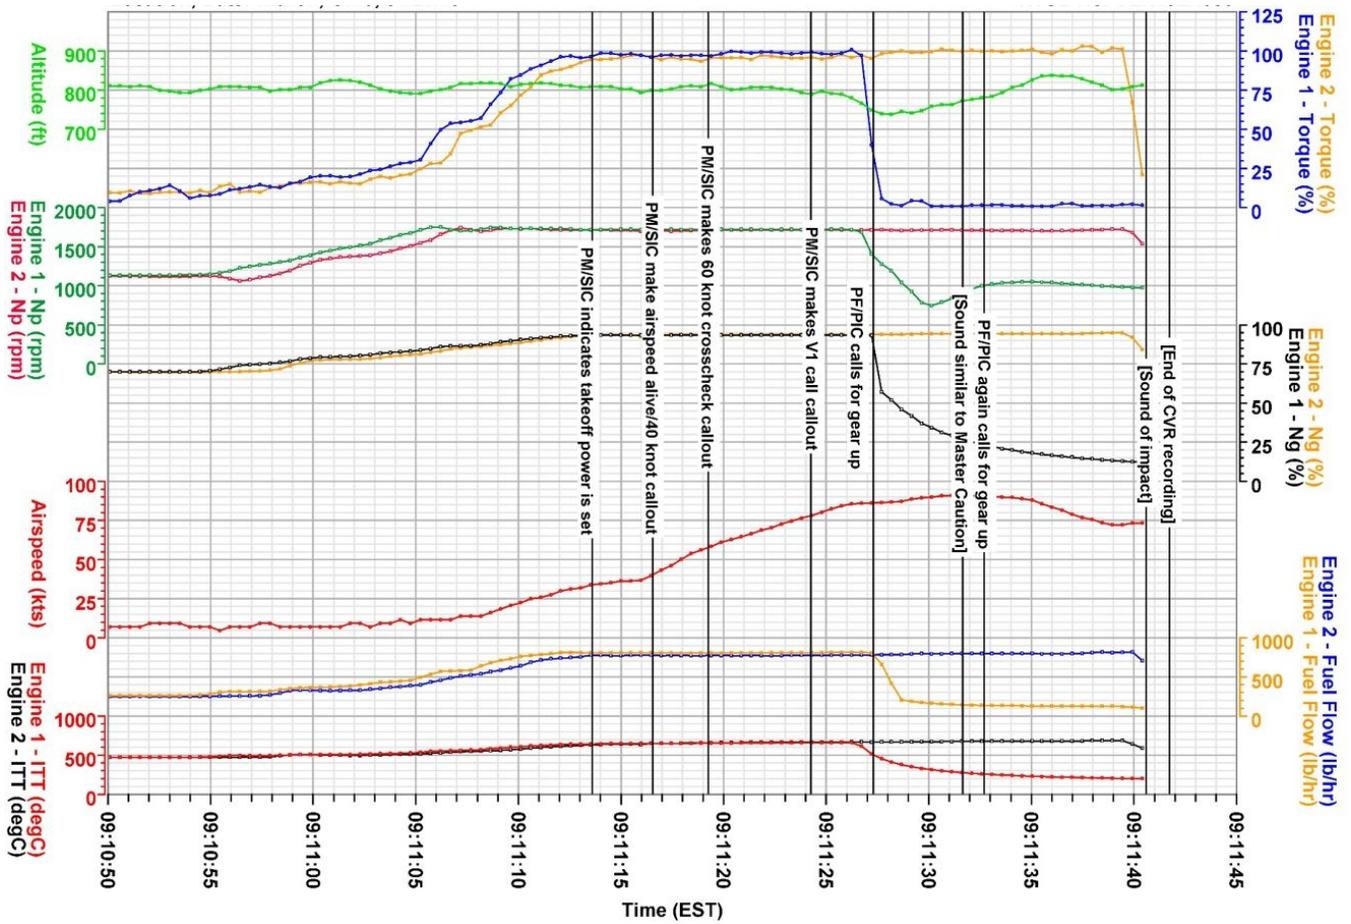
Figure 1 - Correlated ADAS Data and CVR Events

Downloaded automated data acquisition system (ADAS) data indicated left engine torque, fuel flow, gas generator speed (Ng), propeller rpm (Np) rapidly decreased at 0911:26.5. At 0911:27.2, left engine torque dropped to nearly zero and Ng decreased until the end of the recorded data.

Left engine Np dropped to 746 rpm at 0911:30, then increased to 1050 rpm about 4 seconds later. Airspeed reached a maximum of 91 knots at 09:11:31. By the end of recorded data at 0911:41, Np and airspeed had decreased to 971 rpm and 73 knots, respectively.

Correlated ADAS data and CVR events are shown in Figure 1.
