National Transportation Safety Board

Aviation Accident Final Report

Location:	Burnet, Texas	Accident Number:	WPR18FA201
Date & Time:	July 21, 2018, 09:15 Local	Registration:	N47HL
Aircraft:	Douglas DC3	Aircraft Damage:	Destroyed
Defining Event:	Loss of control in flight	Injuries:	6 Serious, 1 Minor, 6 None
Flight Conducted Under:	Part 91: General aviation

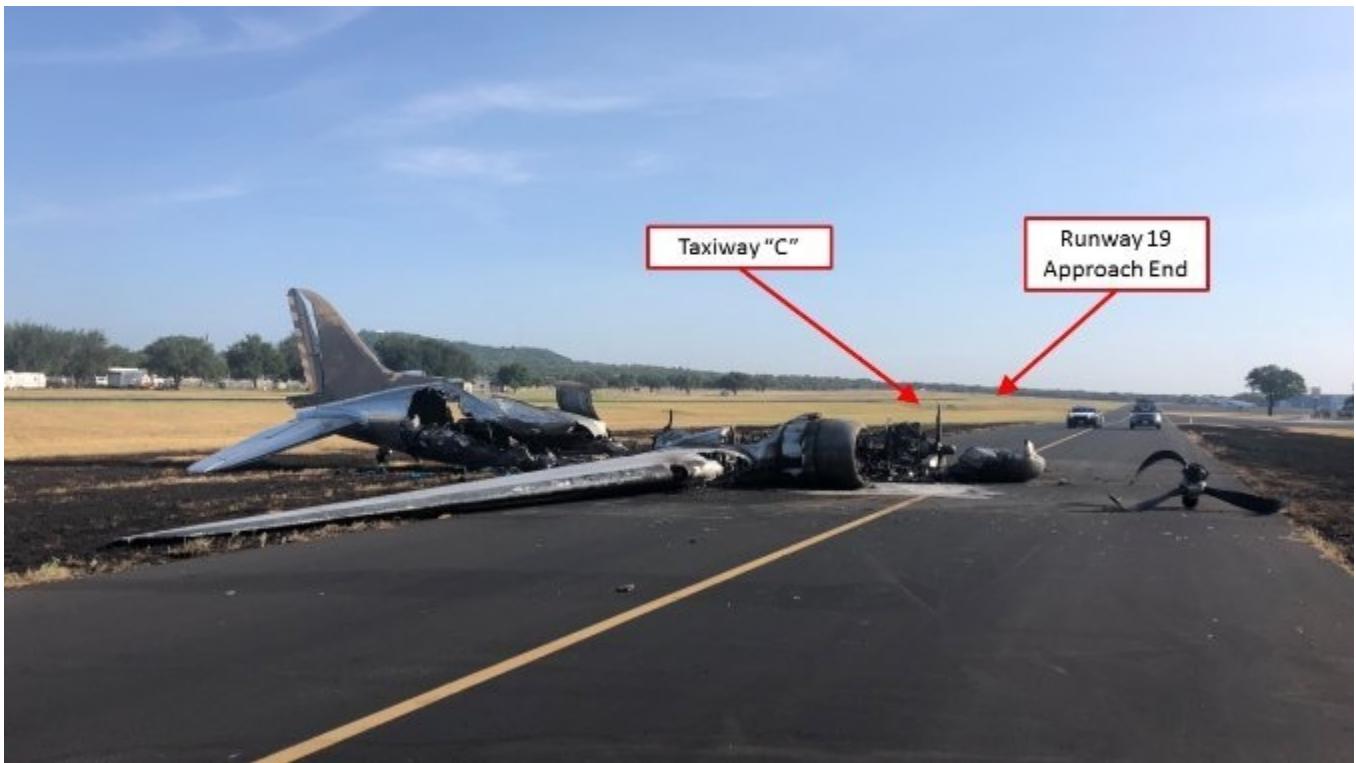
Examination of the accident site revealed that the airplane came to rest upright on a heading about 113° magnetic, about 145 ft east of the left side of runway 19, partially on the taxiway. (Figure 1)

Figure 1. A photograph showing the main wreckage in relation to runway 19 and taxiway C.

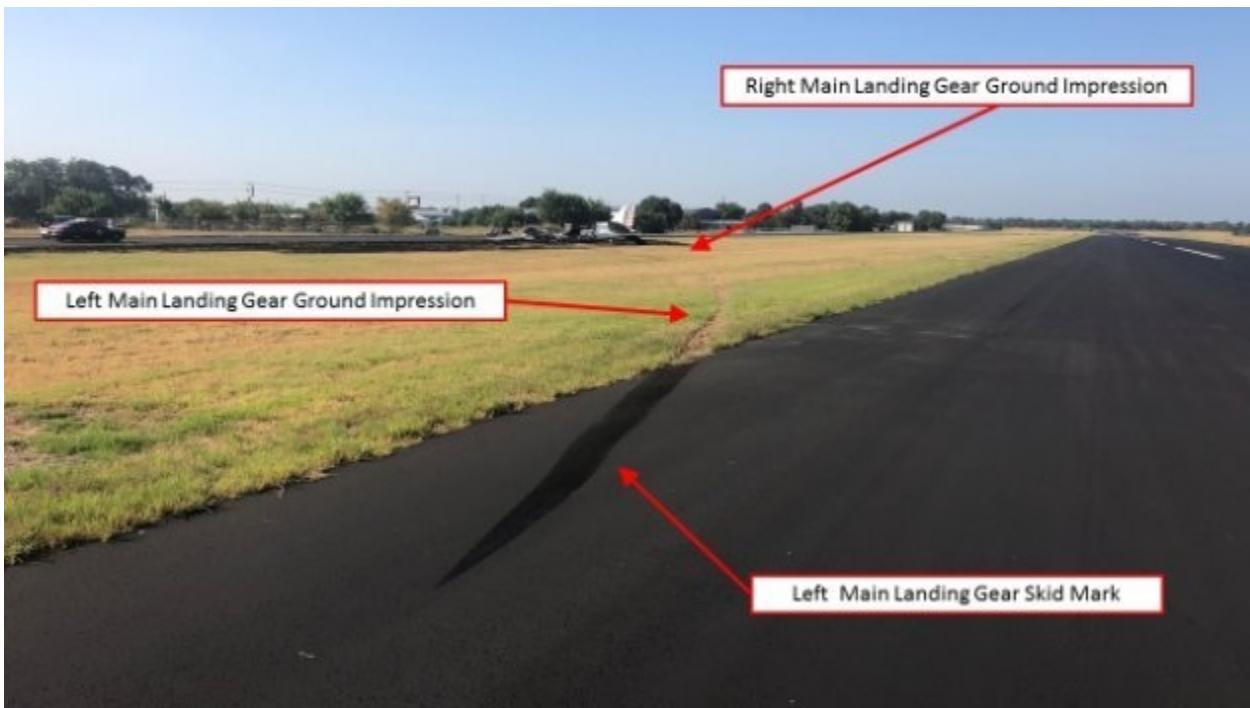
Another ground impression was observed about 2,377 ft from the approach end of the runway, which extended from the wheel skid mark toward the main wreckage, consistent with the left MLG exiting the left side of the runway. See figure 2 for a photograph showing the wheel skid mark on the runway and the ground impressions left of the runway.

Figure 2. A photograph showing the left MLG wheel skid mark on the runway and the left MLG ground impressions left of the runway.

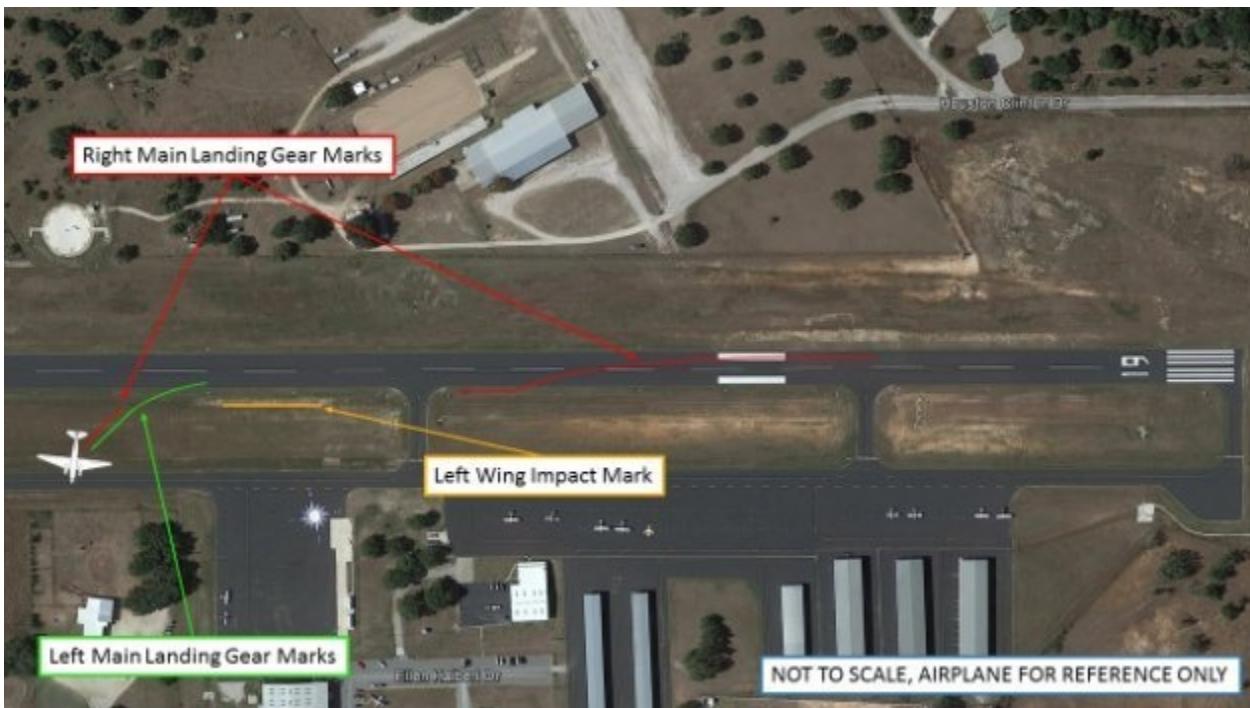
Another ground impression was observed about 2,436 ft from the approach end of the runway, consistent with the right MLG. The main wreckage came to rest about 2,638 ft from the approach end of the runway. (See figure 3 for an overhead view of the left MLG wheel skid mark, right and left MLG wheel impressions, and the left-wing impact mark locations.)

Figure 3. An overhead image of the right MLG wheel skid mark, the right and left MLG ground impressions, and the left-wing impact mark locations observed at the accident site.

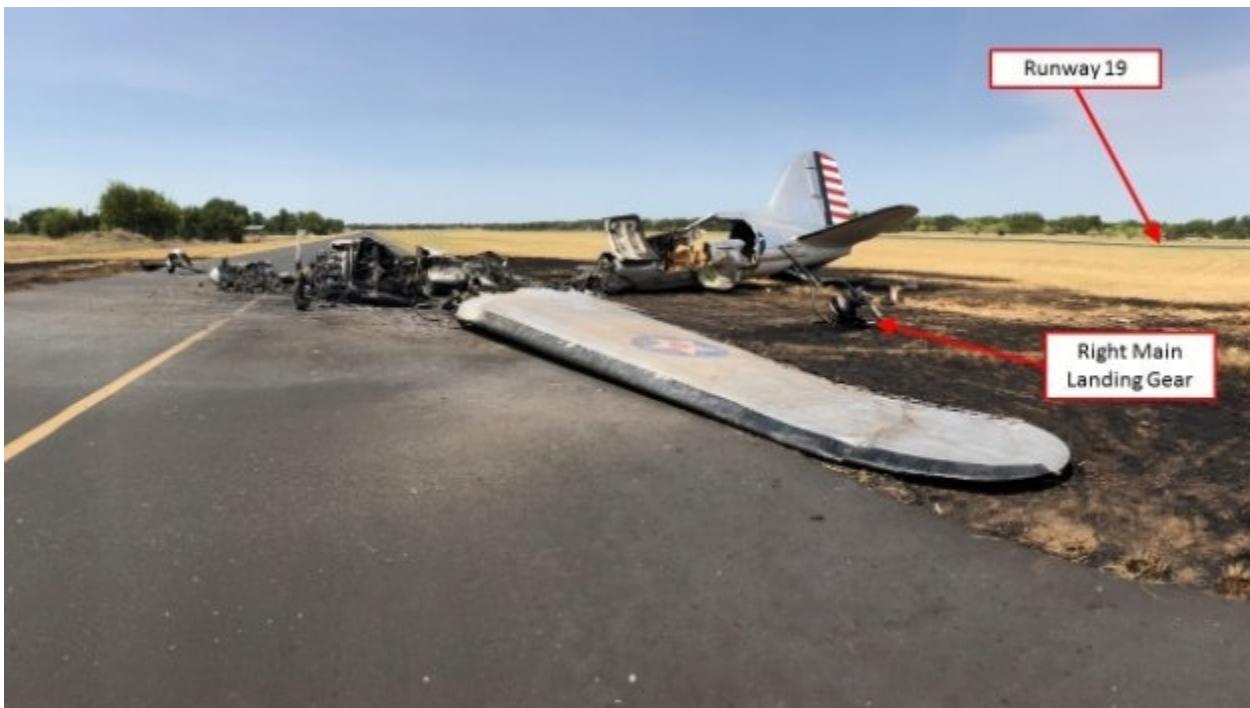
Grass within about 200 ft of the main wreckage was burnt by postimpact fire, which consumed the fuselage from the nose cone aft to about 3 ft forward of the left cargo door. The wing center section of the fuselage was mostly consumed by fire and extended outboard to the right-wing attachment point and about 2 ft outboard of the left-wing attachment point. (See figure 4 for a photograph showing the main wreckage and postimpact fire damage.) All cables in the throttle quadrant remained attached but exhibited thermal or fire damage. The tailwheel lock engagement handle was not found.

Figure 4. A photograph showing the main wreckage and postimpact damage.
