## Report A-043/2016

Accident involving a  
Beechcraft E90 aircraft,  
registration N-79CT, in Sotillo  
de las Palomas (Toledo, Spain)  
on 4 December 2016

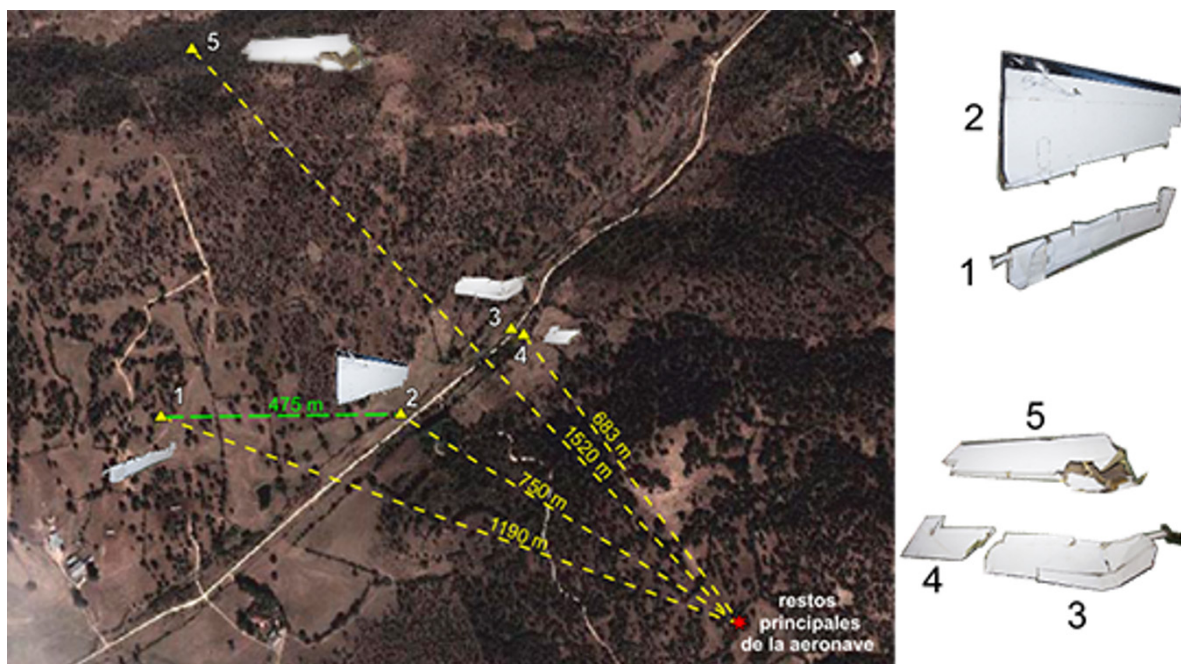
Illustration 11: Diagram of the debris field

The horizontal tail detached from the aircraft in flight, separating into five pieces that were located at different points:

- The right elevator (#1, in the figure of the debris field) was found at coordinates  $40^{\circ} 05' 07.72''$  N,  $4^{\circ} 51' 50.43''$  W, at a distance of 1190 m from the main wreckage.

- The right horizontal stabilizer (#2 in the diagram) was found at 40° 05' 07.72" N, 4° 51' 30.41" W, 750 m away from the main wreckage and 475 m away from the right elevator.
- As for the left elevator, it was found in two parts, one of them (#4 in the diagram) at coordinates 40° 05' 13.17" N, 4° 51' 21.07" W and the other (#3 in the diagram) at 40° 05' 12.86" N, 4° 51' 20.16" W. They were very close to one another and 683 m away from the main wreckage.
- The left horizontal stabilizer (#5 in the diagram) was found at 40° 5' 30.84" N, 4° 51' 47.52" W. It was the most distant component from the main wreckage, which was 1520 m away.

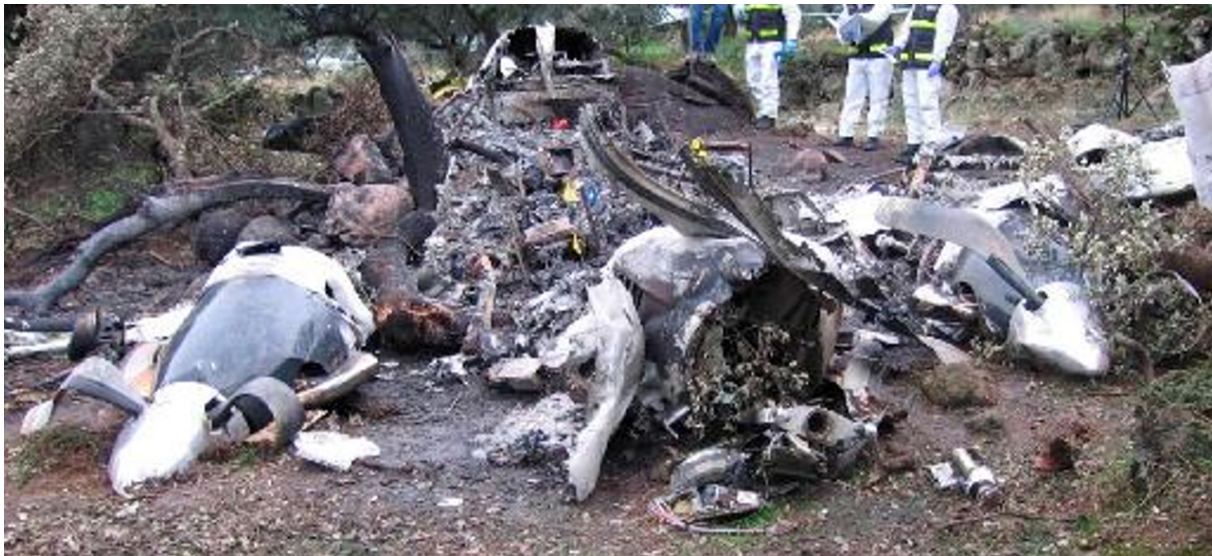
Illustration 12: Overview of the engines in the field

The photo below shows the condition in which the PT6-135A engines were found at the accident site after the crash and subsequent fire.

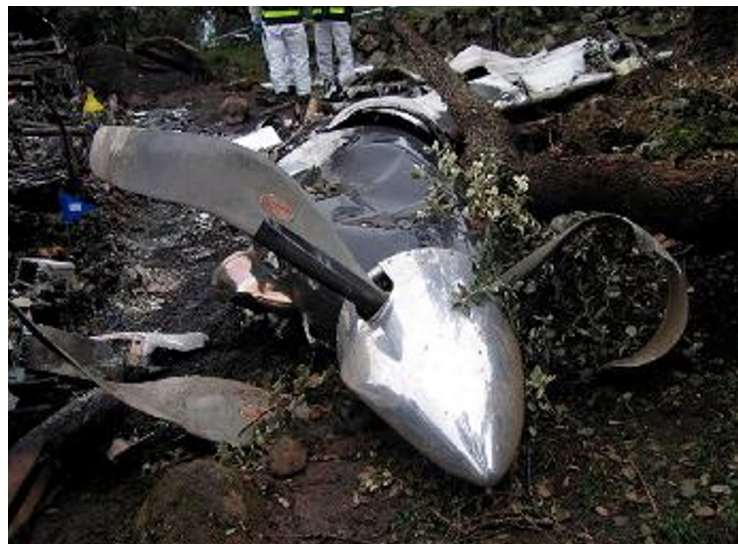
Illustration 13. Left engine at the crash site

- a. Mechanically the compressor was in good condition. All of its compression stages were good, meaning no foreign object damage was noted.
- b. The compressor turbine blades were not broken. The tips of the blades were severely rubbed on the compressor shrouds

- a. The power turbine disc did not turn with the propeller.
- b. There were scratches and circular marks on several elements caused by friction between moving and static parts.
- c. The power turbine blades were broken and deformed in the opposite direction of rotation. Fragments of the blades were found inside the engine exhaust.

5.- The first stage carrier at the shaft radius in the reduction gearbox was broken by torsional overload.

In conclusion, the damage found outside and inside the left engine and the fractures to the various engine components did not occur in flight; rather, they were compatible with the impact with the ground and the subsequent fire that broke out. At the moment of impact, the engine was turning.

The fact that all of the compression stages were in good condition rules out ice ingestion into the left engine.

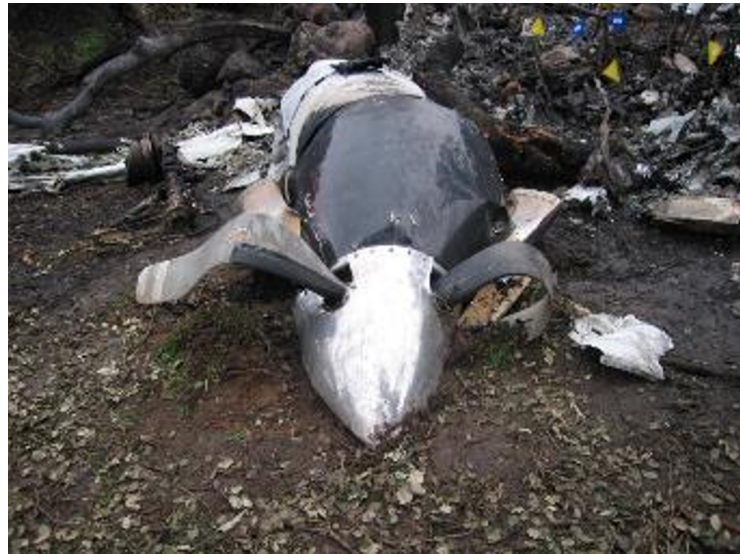
Illustration 14: Right engine at the crash site

- a. The power turbine disc did not turn with the propeller.
- b. As in the other engine, the power turbine blades were not uniformly broken. The power turbine blades exhibited the same deformation as the other engine and the turbine disc had circular scratches due to friction between moving and static parts.
- c. Two of the four N° 4 bearing bolts and their associated washers, from the power turbine shaft and its support bearing were missing. As described earlier, one of the two missing bolts and its washer were found in the screen filter that detects metal particles. The other bolt and its washer were found in a rear cavity in the RGB. The bolts were bent and threads exhibited material extracted from the power turbine shaft housing. These features suggest these damages occurred during the impact. Their washers were undamaged.

5.- The first stage carrier at the shaft radius in the reduction gearbox was broken by torsional overload.

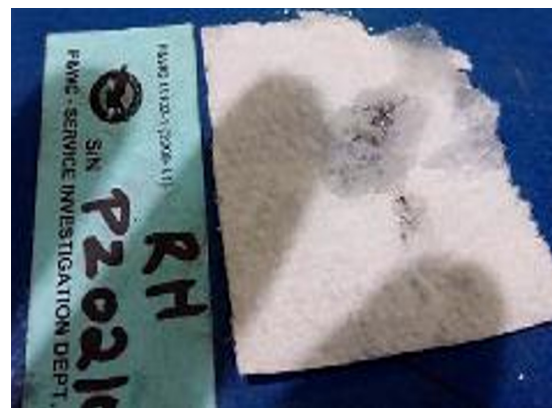
- a. There was a small number of metal particles in the accessory gearbox chip detector.
- b. Since the chip detector had particles, the screen filter was removed<sup>11</sup>. When this screen filter was taken out, a screw and washer were found, and there were more particles at the bottom.
- c. The main oil filter was clean, like the one in the left engine, with no particles but burned.

Illustration 15. Close-up of metal particles found in the chip detector in the right engine

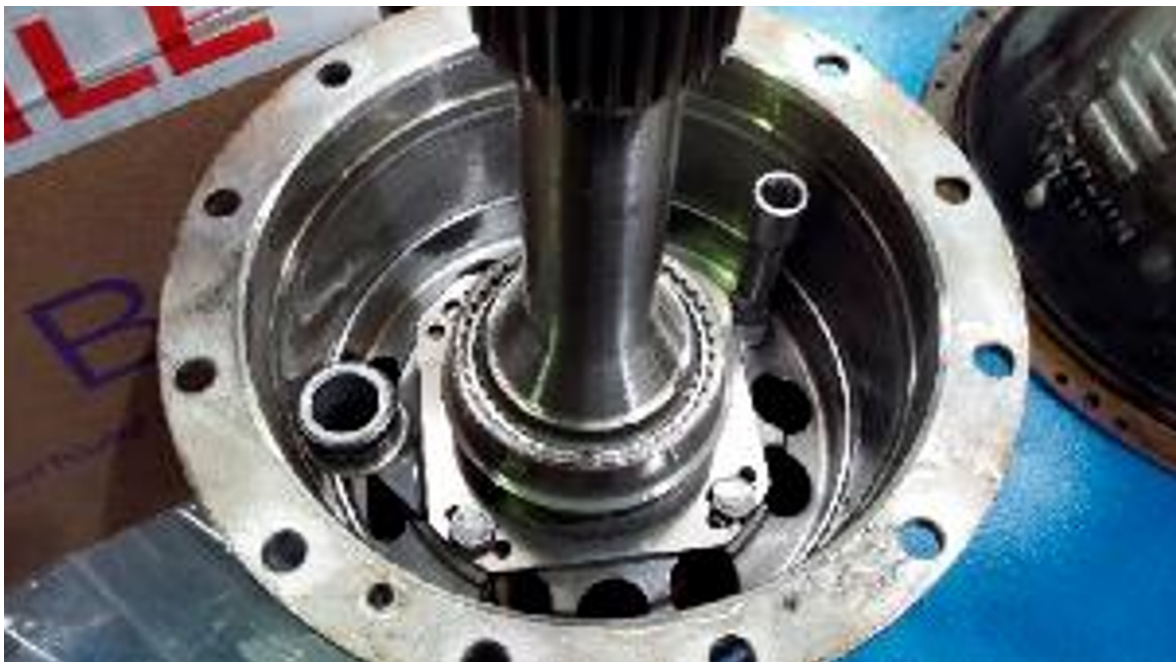
Illustration 16: Close-up of gear box, showing only two of the four bolts

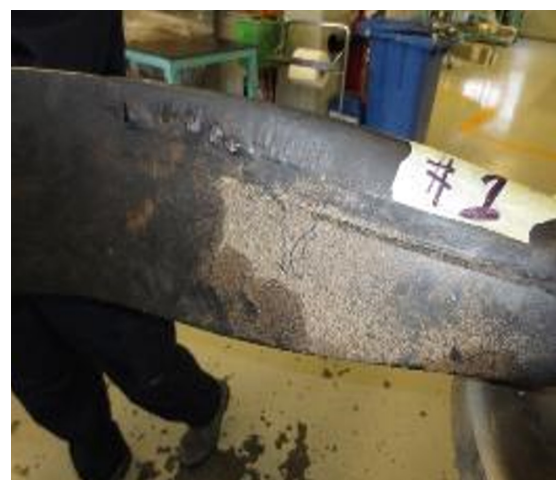
Illustration 17: Close-up of a blade on the left propeller

The left propeller, with serial number FY-2774, was disassembled piece by piece to check its condition. One of the four blades on this propeller broke in the accident. Another blade had its counterweight broken, most likely when the aircraft impacted the ground.

The heated area on blade #1 exhibited a localized burn mark. A lightning strike was ruled out since the metal parts on the propeller were not magnetized.

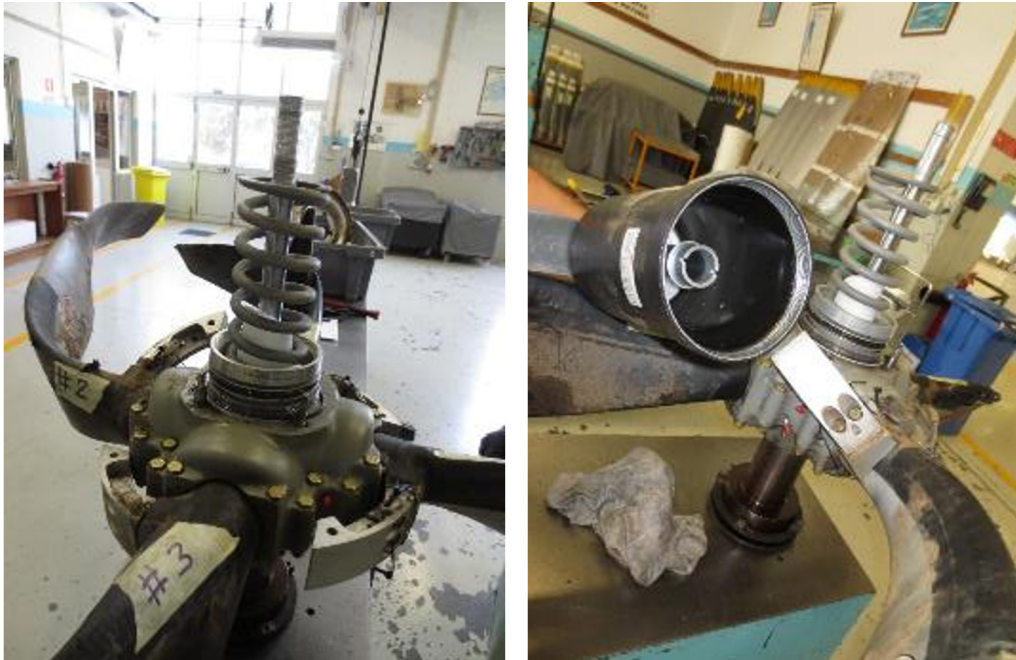
Illustration 18: Close-up of the spring and cylinder on the left propeller

Following a visual inspection, the propeller was disassembled. The photos below show the condition of the spring and the absence of hydraulic fluid in the cylinder.

The spring guide, made of a white plastic material, was broken. When the piston and each of the propeller blades were removed, several screws and stops were found to be broken.

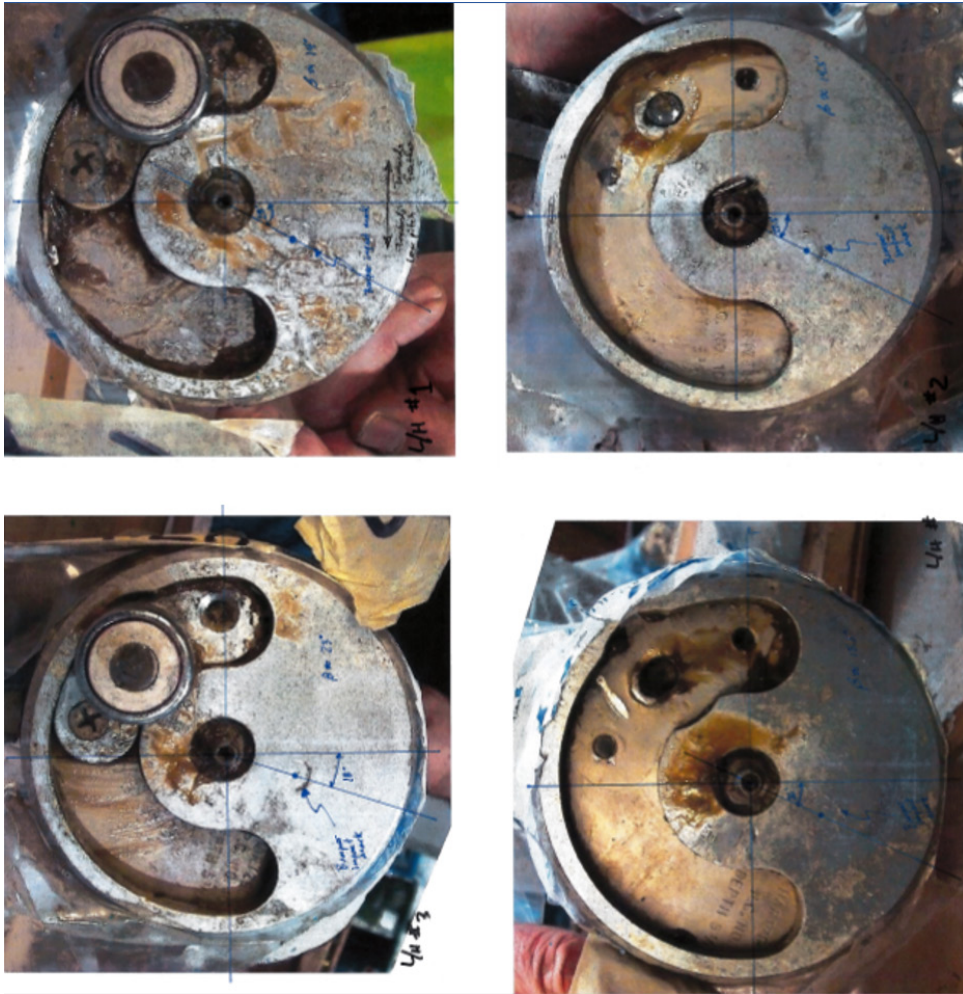
Illustration 19: Close-up of the four blades on the left propeller

The angle of impact of the bumper on the fork with the pre-load plates on the propeller indicates the angle of the blades. The blades were at a pitch angle between  $14^{\circ}$  and  $23^{\circ}$ . A pitch angle of  $14^{\circ}$  in flight corresponds to an idle or low speed/low power situation.

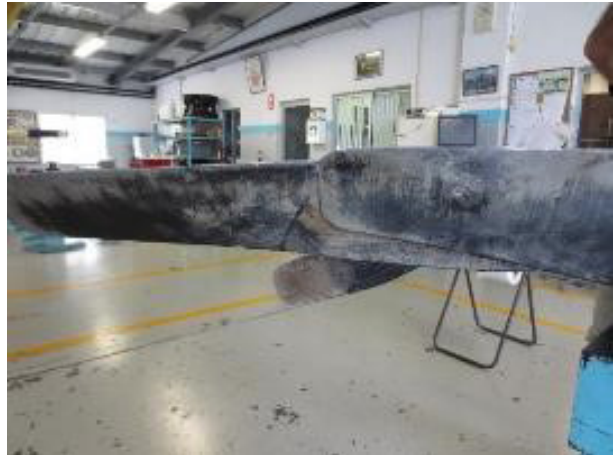
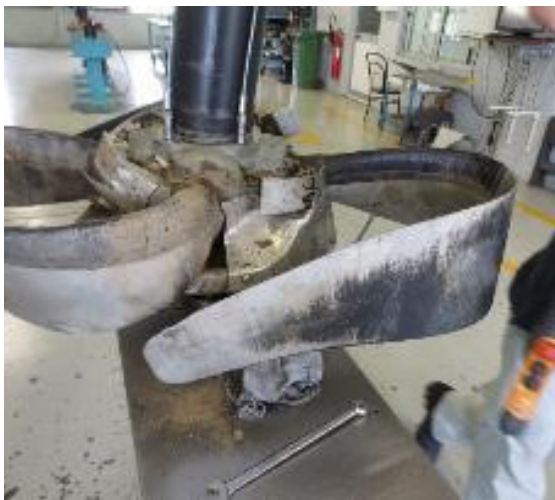
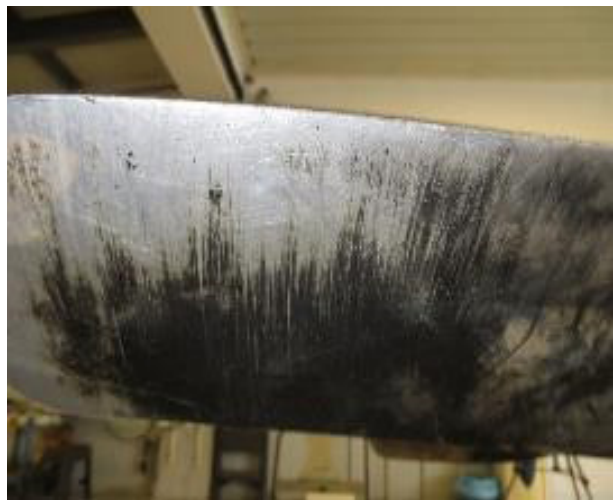
Illustration 20: Close-up of the four blades on the right propeller

The blades on the right propeller had numerous friction marks caused by the ground. It is obvious that this propeller was moving at the time it impacted the ground. The photos below show how the blades were deformed and the friction marks.

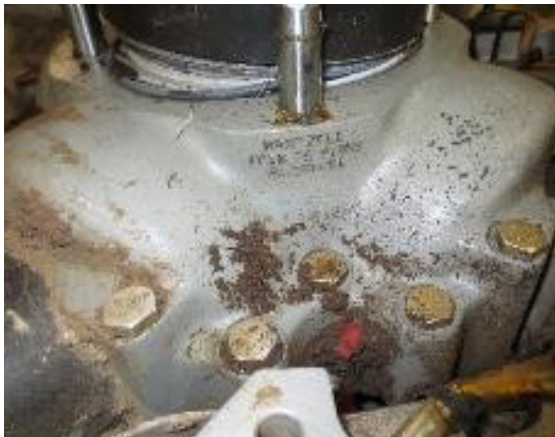
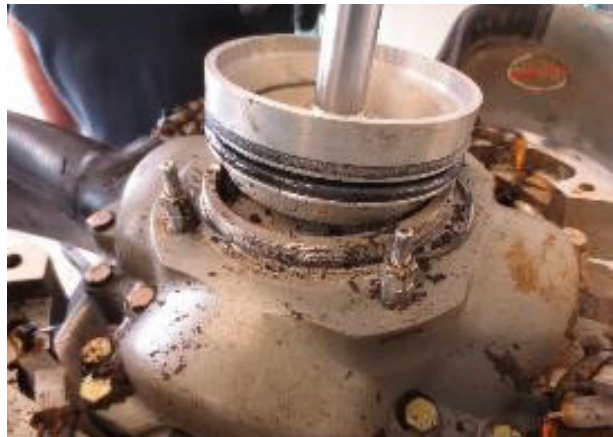
Unlike the left propeller, the cylinder that houses the spring for the right propeller had broken, as the photos below show, allowing a large amount of dirt to be collected inside.

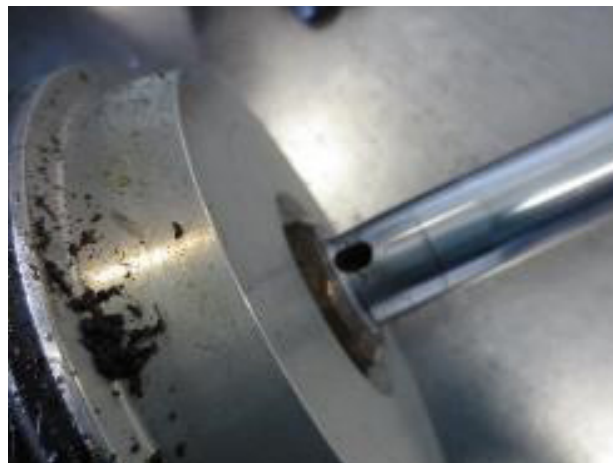
Illustration 21: Close-up of the cylinder and piston shaft on the right propeller

Once the cylinder was removed, the piston shaft was found to be completely off-center as a result of the impact between the moving propeller and the ground.

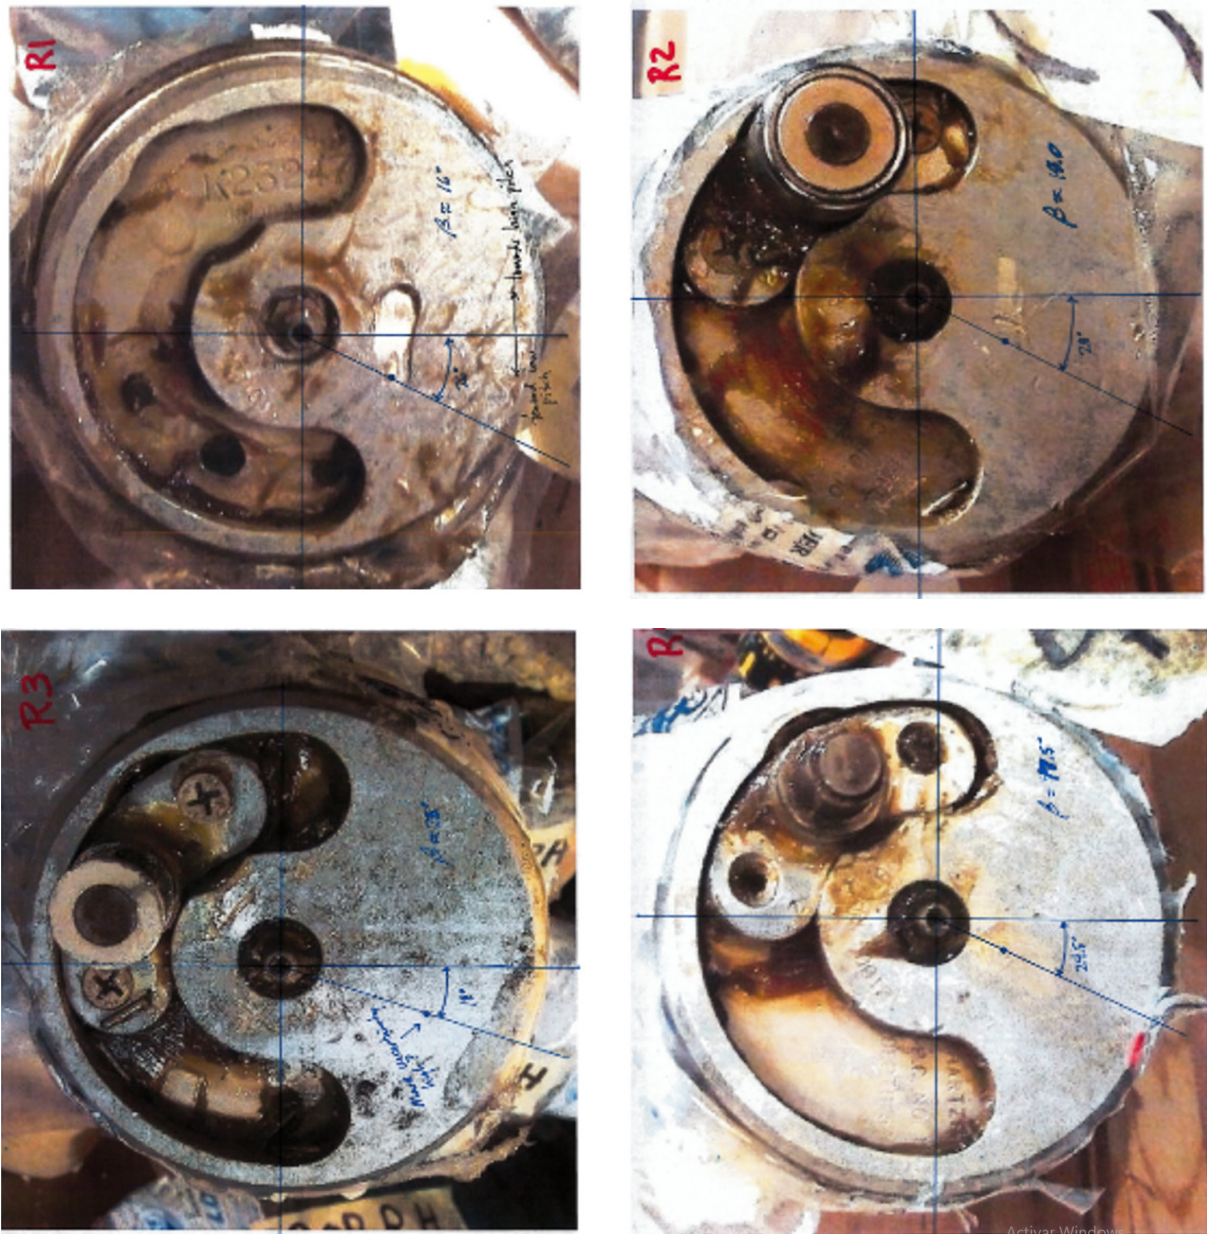
Illustration 22: Close-up of the four blades on the right propeller

In this case, the pitch angle of the blades was between 14° and 23°; however, Hartzell stated that it was hard to identify the impact mark on the propeller blade identified as R3.

Since three of the blades on this propeller were bent forward in the direction of thrust, and the fourth blade was bent into an S-shape, it was concluded that the impact occurred with the blades at a positive pitch angle and at higher power than for the left propeller.

Considering the damage to the propeller, Hartzell stated that the pitch angle would have been close to  $23^\circ$ , similar to the other propeller.

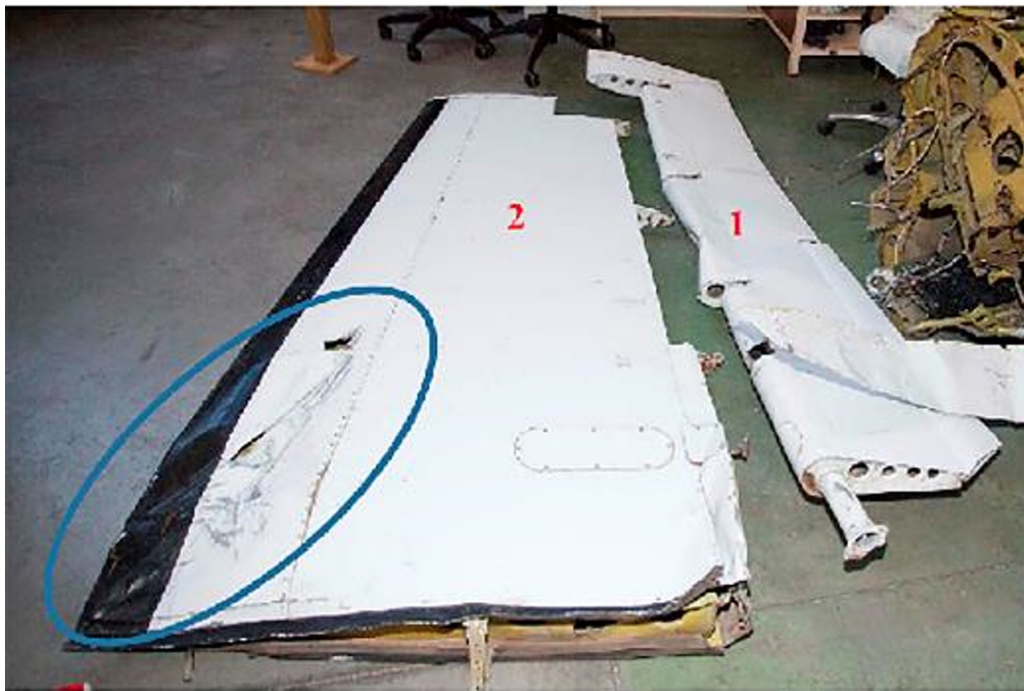
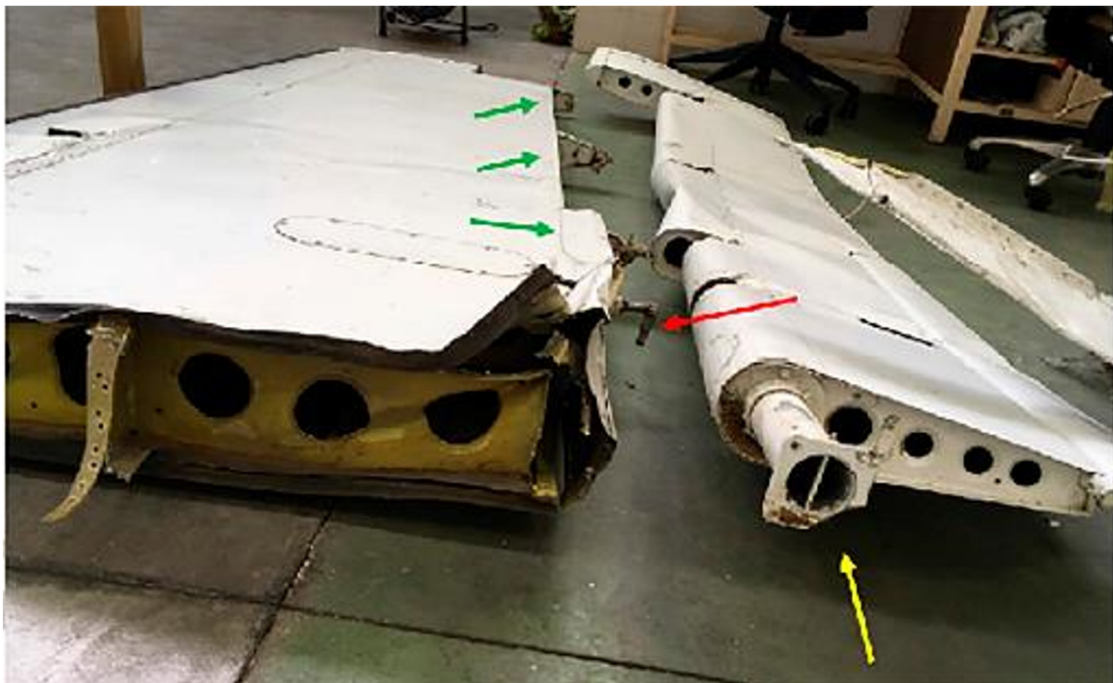
Illustration 23: Wreckage from the right side of the horizontal tail

Illustration 24: Side view of the wreckage from the right part of the horizontal tail

- The right elevator separated from the tail cone at the part where the rotating tube joins the actuator, caused by the instantaneous fracture of two screws, the tearing and pulling out of another screw, and the fracture of a fragment on the component.

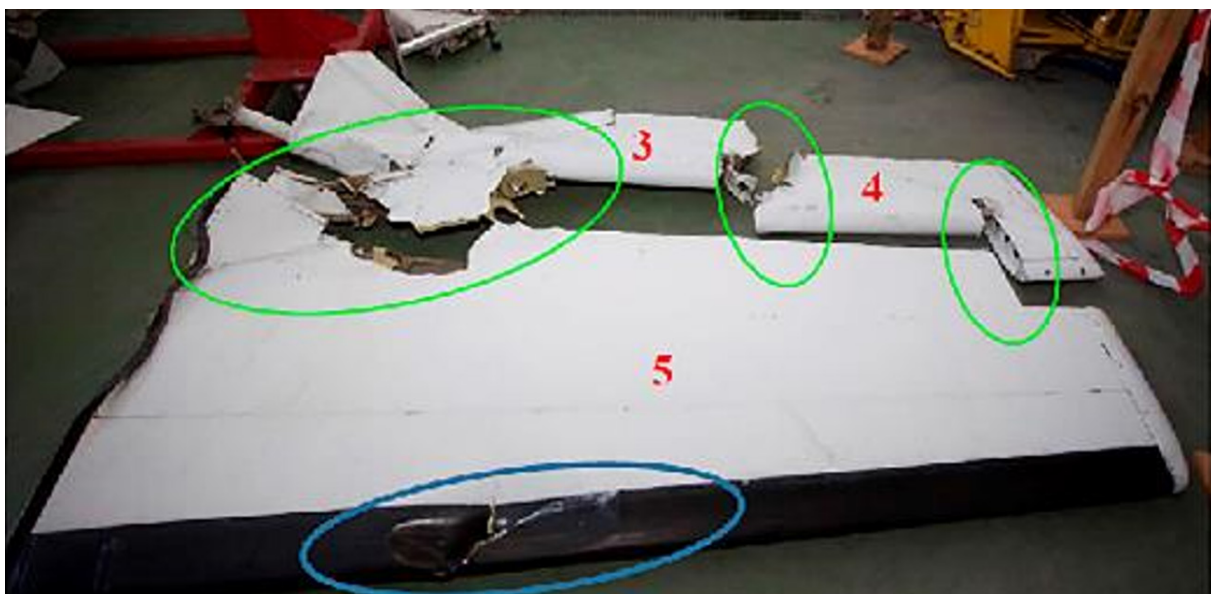
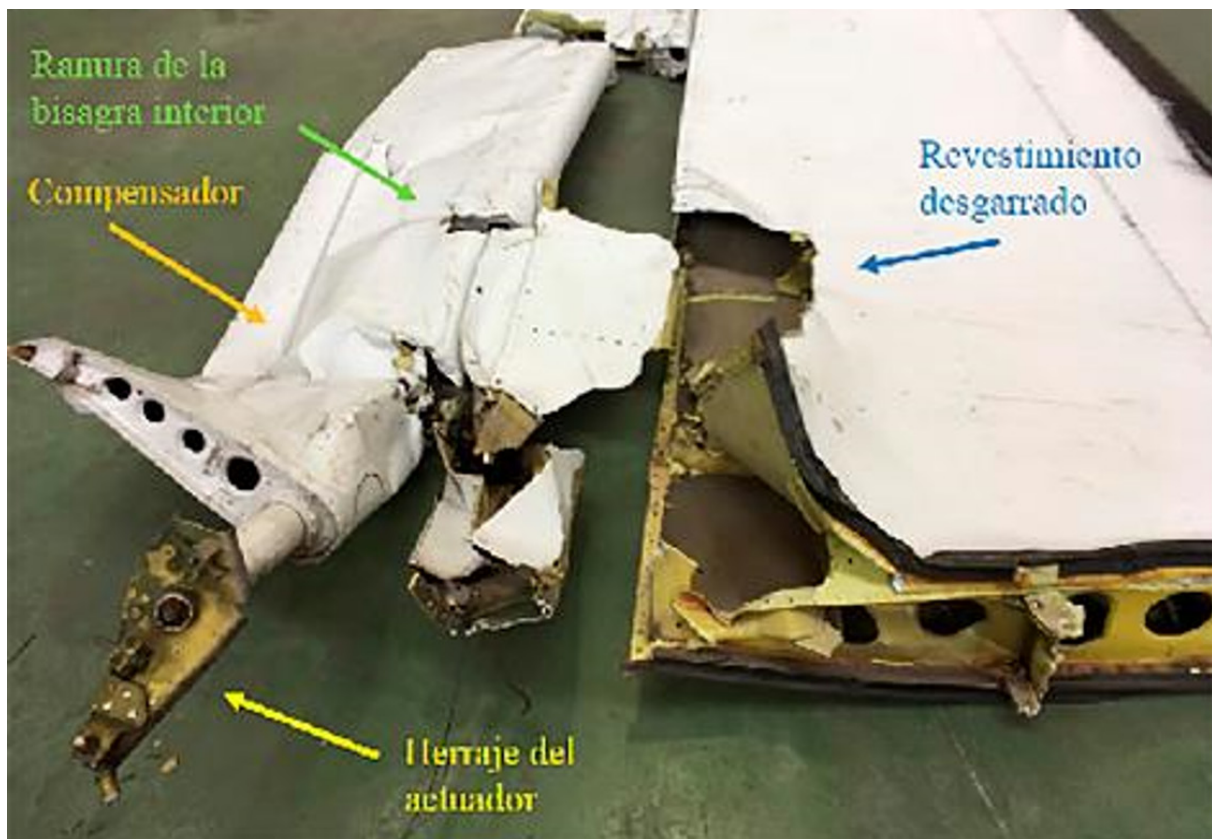
Illustration 25: Wreckage from the left part of the horizontal tail

Illustration 26: Side view of the parts of the left stabilizer and elevator closest to the tailcone

- The left stabilizer was not significantly bent. The elongated dent (circled in blue in Illustration 28, Wreckage from the left part of the horizontal tail) on the top surface of the leading edge was compatible with an impact with a horizontal fin (antenna) located on the vertical stabilizer. This stabilizer experienced an instantaneous ductile failure and was subjected to upward bending and torsional forces.
