## AVIATION SHORT INVESTIGATION BULLETIN

**REPORT # AO-17-001054**

**INVESTIGATION TITLE: N8TS INCIDENT**  
**INVESTIGATION STATUS: COMPLETED**

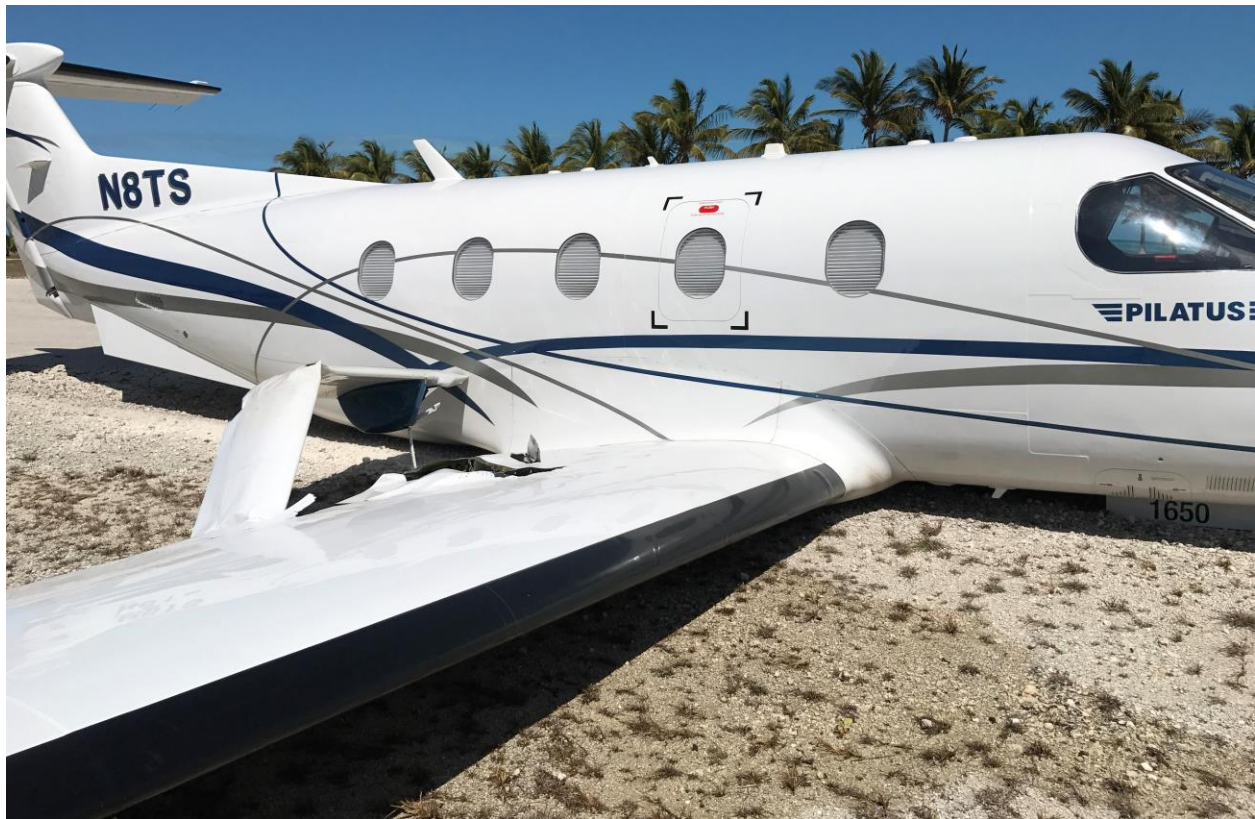
Pilot advised that upon making his approach to land at Cat Cay (MYCC), on short final he experienced an unexpected accelerated sink rate. To compensate for the sink rate he increased the pitch of the aircraft. While going over the threshold, a slight impact was felt as the landing gear came into contact with the seawall. He flew the aircraft until it came to a stop about 600 feet down the runway. No injuries were sustained, aircraft received substantial damage.
