**KOMITE NASIONAL KESELAMATAN TRANSPORTASI
REPUBLIC OF INDONESIA**

Aircraft Accident Investigation Report

Cessna 208; PK-FSO

Anem Mountain, Oksibil

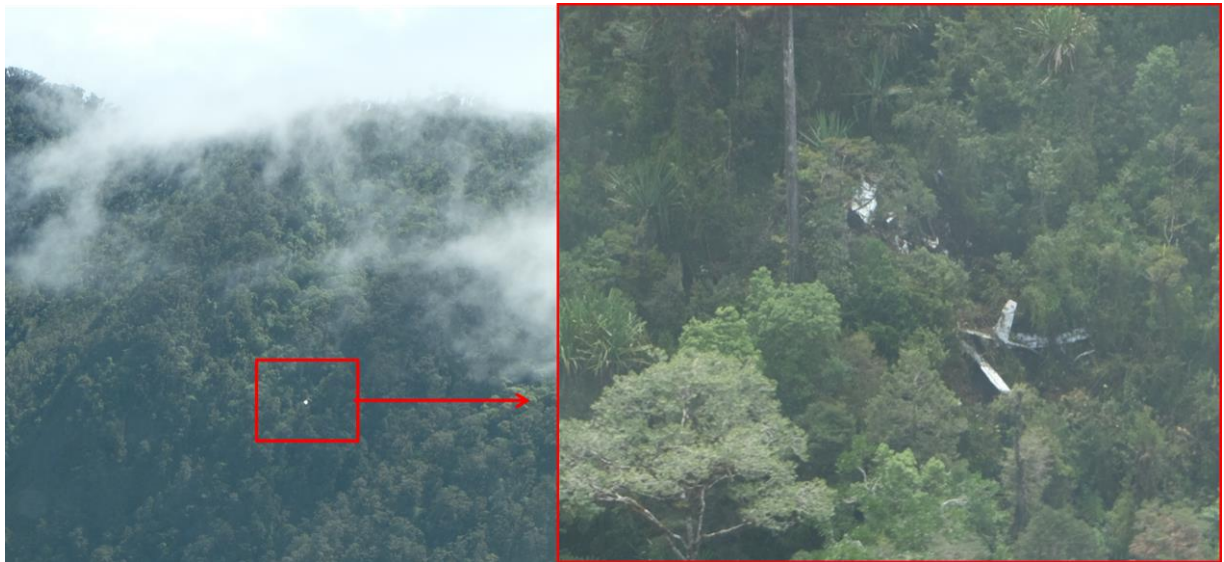
Figure 6: The accident site

The aircraft wreckage was found at altitude approximately 7,100 feet on ridge of Anem Mountain, which located at about 7 Nm north of Oksibil with coordinate 04°47.79' S; 140°39.77' E. The distance between the last recorded position in the Spystertracks to the accident site was about 1 Nm (see figure 2).

The aircraft destroyed by impact forces and the wreckage distribution was found toward 010° direction.

The aircraft wreckage was found on a ridge at approximately 7,100 feet, which located at about 7 Nm north of Okisbil and the wreckage distribution was found toward 010° direction. Comparing to the last recorded aircraft bearing on the Spidertracks which was 011°, the aircraft was maintaining the altitude and heading until the impact. Based on the wreckage information, indicated that there was no pilot input to change the aircraft altitude or heading until the impact. The altitude and heading could be maintained indicated that the autopilot was engaged.

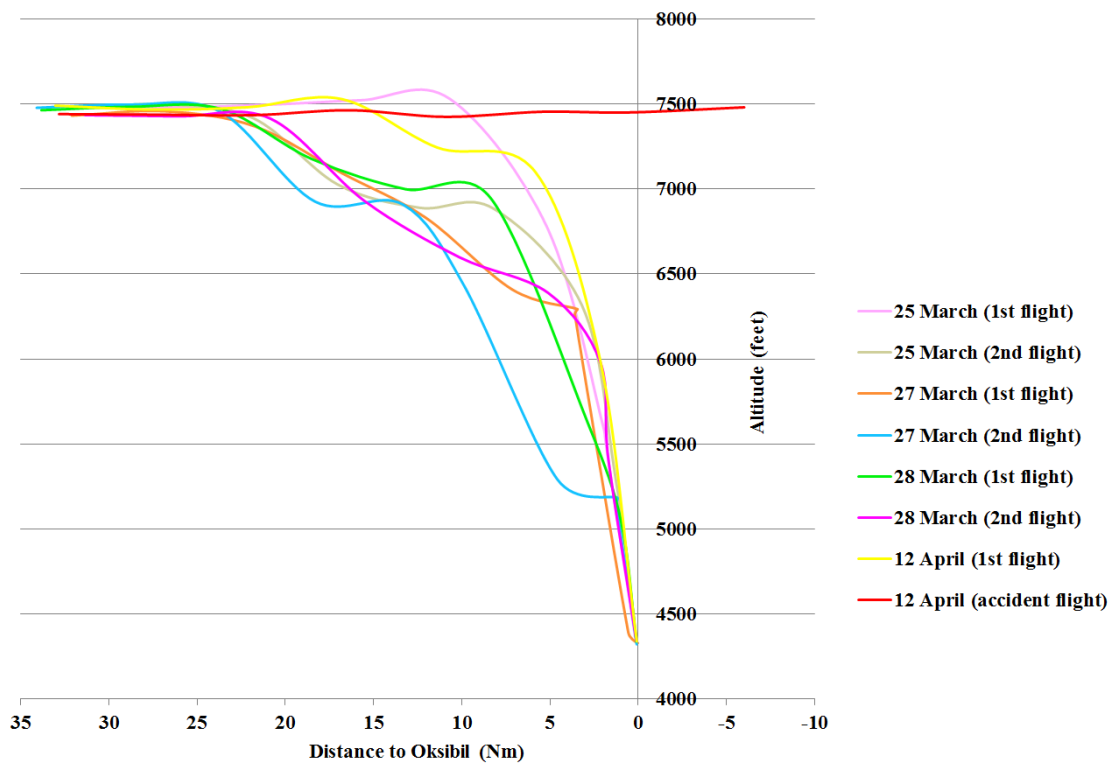
Figure 8: The recorded altitude

The investigation downloaded the reporting Spidertracks data of the seven flights from Tanah Merah to Oksibil by the pilot prior to the accident flight. The last recorded position of the aircraft on the accident flight was at 1217 LT.
