COMANDO DA AERONÁUTICA
CENTRO DE INVESTIGAÇÃO E PREVENÇÃO DE
ACIDENTES AERONÁUTICOS

FINAL REPORT
A - 054/CENIPA/2017

OCCURRENCE:	ACCIDENT
AIRCRAFT:	PP-EPB
MODEL:	PA-42
DATE:	31MAR2017

This is the Final Report of the 31MAR2017 accident with the PA-42 aircraft, registration PP-EPB. The accident was classified as “[FUEL] Fuel / Fuel Starvation”.

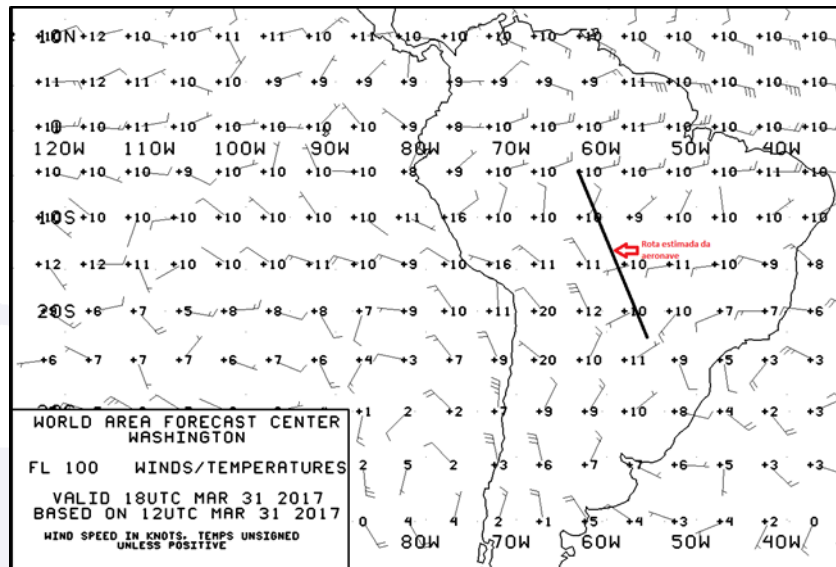
The wind and temperature chart on FL 100, valid until 1800 (UTC) on 31MAR2017, showed that the wind on the route traveled by the aircraft varied significantly, in direction and intensity.

Initially there was tailwind. In the course of the flight, it has changed to crosswind and may also have had a head component.

Figure 1 - Wind and temperature chart with estimated PP-EPD route marked.

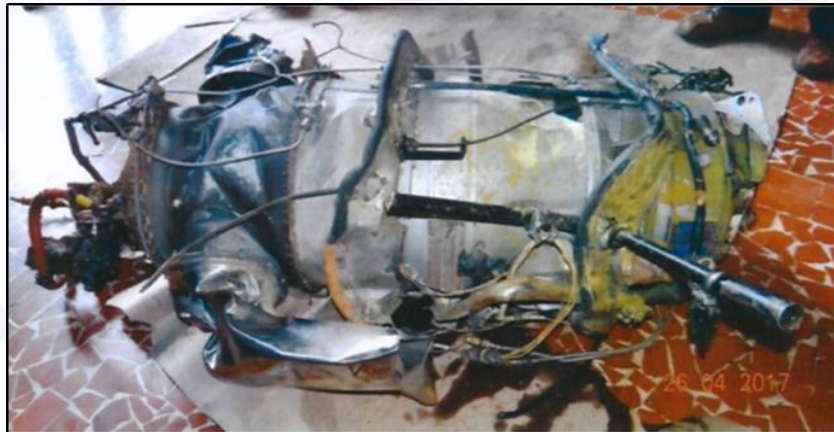
On the right engine, there were scratch marks and damage to the compressor centrifugal stage vanes, light scratch marks on the segmented ring and fragments deposited on the compressor stator blades.

Still on the right engine, in relation to the power turbine, it was verified rubbing in the root of the first stage rotor vanes and in the ends of the second stage vanes. The power axis had broken.

Figure 2 - View of the right engine of the aircraft.

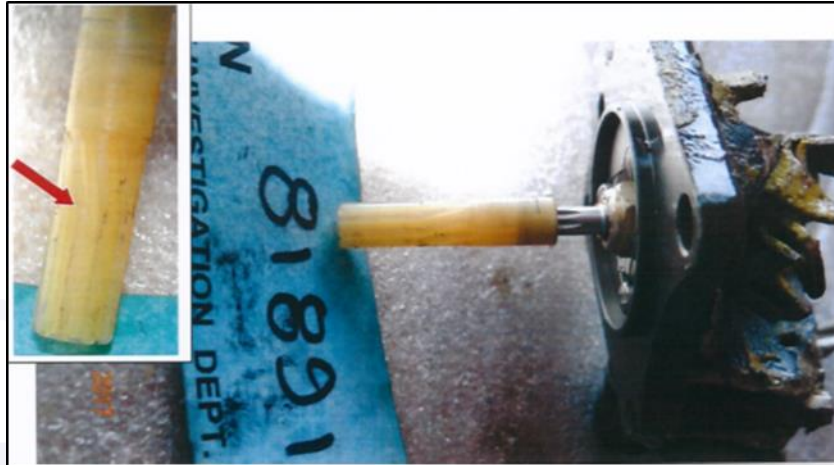
The Fuel Control Unit (FCU) drive shaft of the right engine showed misalignment in the stretch marks (Figure 3).

Figure 3 - Right engine FCU drive shaft. In detail, the misalignment of stretch marks.

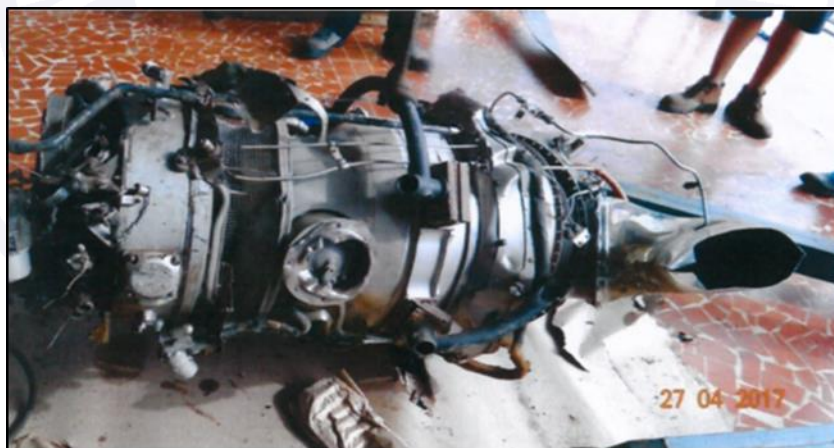
In the compression turbine, damage and rubbing were found at the ends of the rotor vanes. In the power turbine, the ends of the blades were rubbed and some of them fractured.

Figure 4 - View of the left engine of the aircraft.

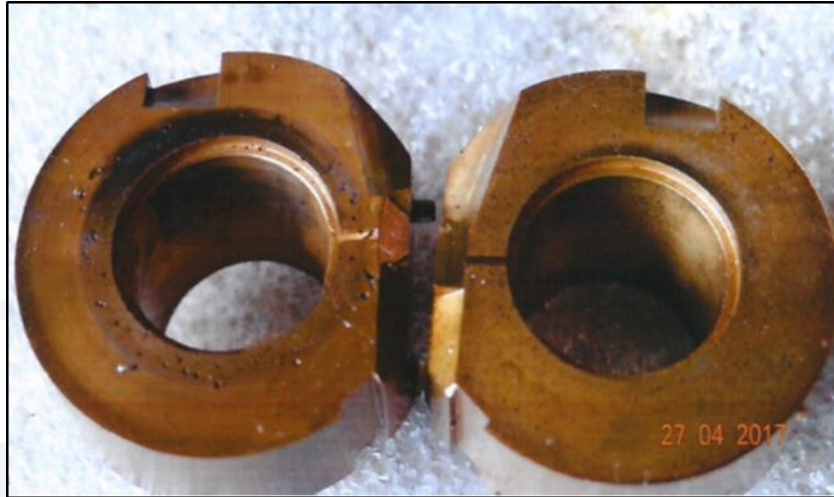
On the left engine fuel pump, signs of cavitation were found in the gear bushings, indicating low or no fuel operation (Figure 4).

Figure 5 - View of left engine fuel pump bushings with evidence of cavitation.

In addition, the gear teeth showed characteristic of overheating discoloration. Gear housings are marked by their rotation, which is a characteristic situation in cases of lack of fuel starvation.

In the fuel pumps, signs of cavitation were found in the gear bushings indicating low or no fuel operation.

- k) in the fuel pumps, signs of cavitation were found in the gear bushings, indicating low or no fuel operation;
- l) the gear teeth of the fuel pumps showed characteristic of overheating discoloration and their housings were marked by their rotation, a characteristic situation in cases of fuel starvation;
