FINAL REPORT
A-151/CENIPA/2018

| OCCURRENCE: | ACCIDENT |
| AIRCRAFT: | PR-TLZ |
| MODEL: | HA-420 |

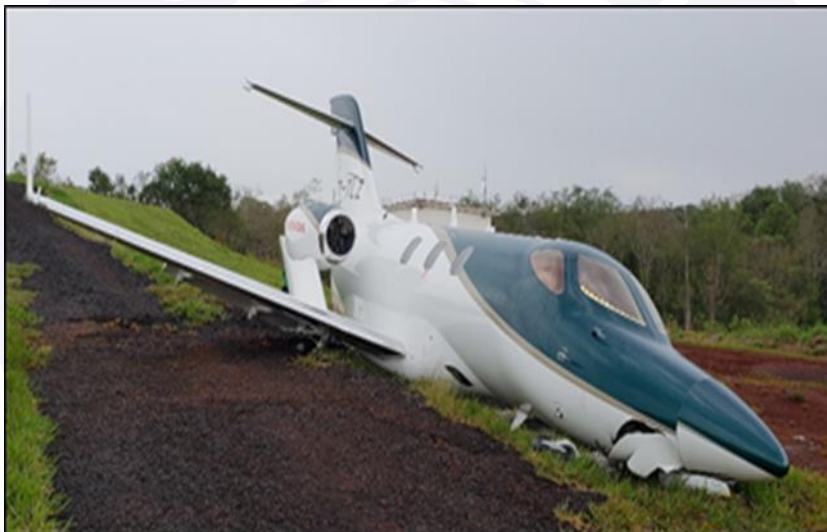
Figure 1 - Aircraft after the occurrence.

The aircraft had substantial damage to the fuselage and landing gear.

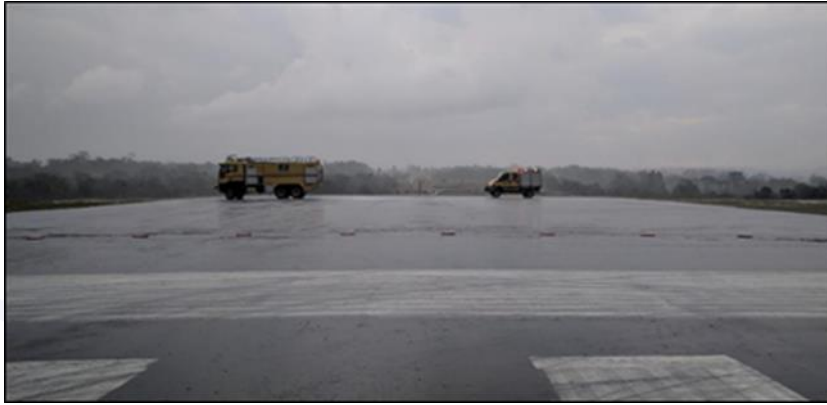
Figure 13 - View of SBFI threshold 14 and Stopway, 10 minutes after the accident.

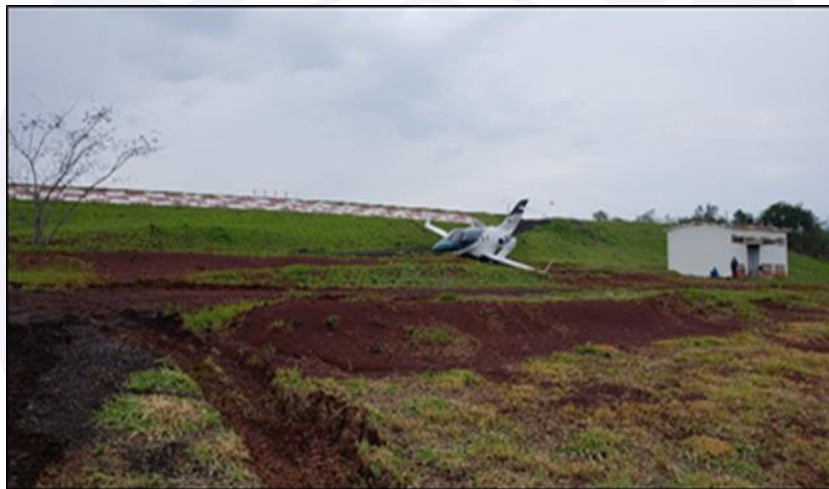
After exceeding the limits of the stopway, the plane crashed into a ravine that was 7 meters deep. There were no parts detached from the aircraft (Figure 17).

Figure 17 - View of the ravine and the aircraft, after full stop.

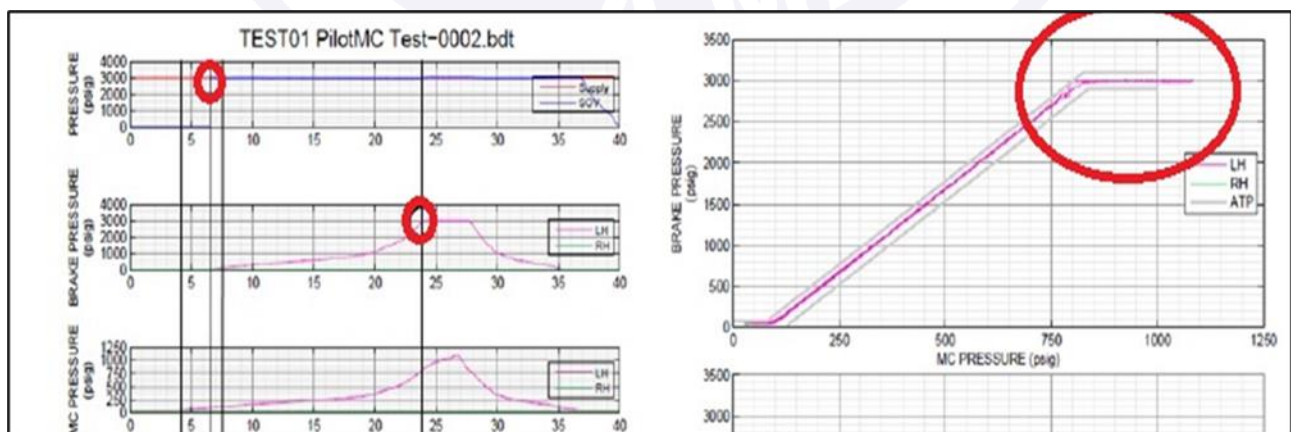
Figure 18 illustrates the results obtained during "test 01", with the pilot master cylinder installed. Note that, throughout the period, the nominal pressure of the hydraulic system remained stable at 3,000 PSI and, when simulating the application of the aircraft brakes through the master cylinder, the system reached the value of 3,000 PSI, as recommended by the manufacturer.

Figure 18 - Result of pressure test 01, performed on the bench.

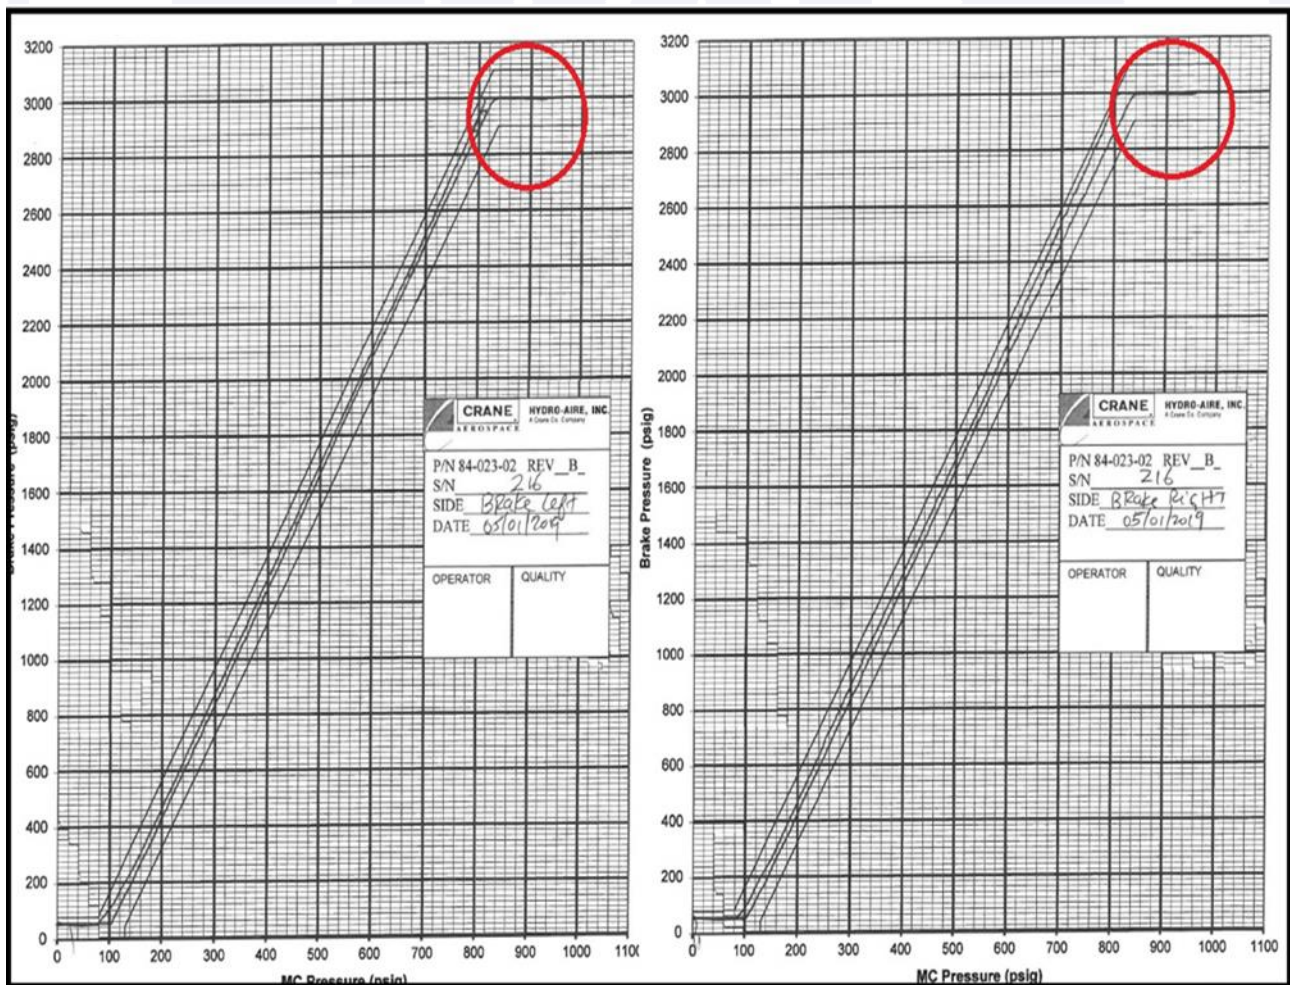
No impurities were found in the oil and the unit passed all the technical requirements of its manufacturer.

From Figure 19 it can be seen that during pressure tests performed with both brakes (left and right) the system reached a pressure of 3,000 PSI.

Figure 19 - Results of pressure measurement tests performed at the PBV.

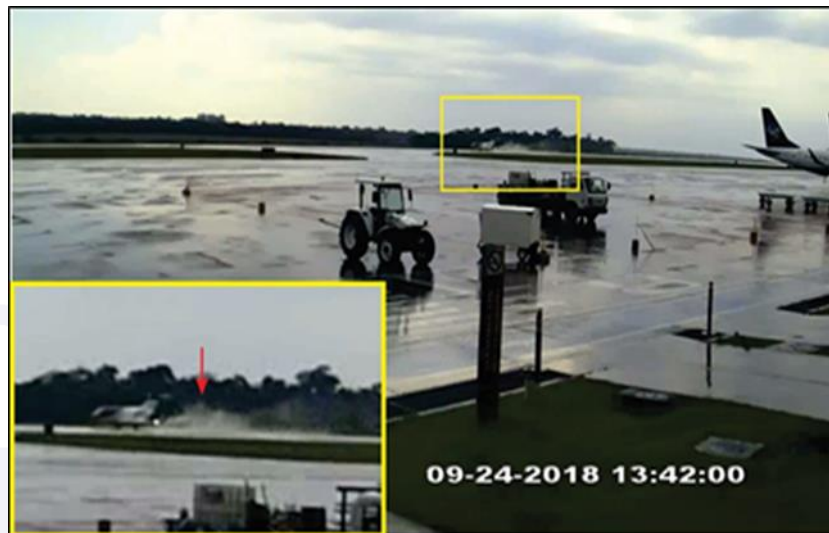
A surveillance camera of the Aerodrome recorded images of the moment of landing, in which it was possible to verify a spray formed on the back of the aircraft, denoting the existence of a significant amount of water on the runway (Figure 20).

Figure 20 - Detail of the landing run, highlighting the spray formed on the back of the aircraft.

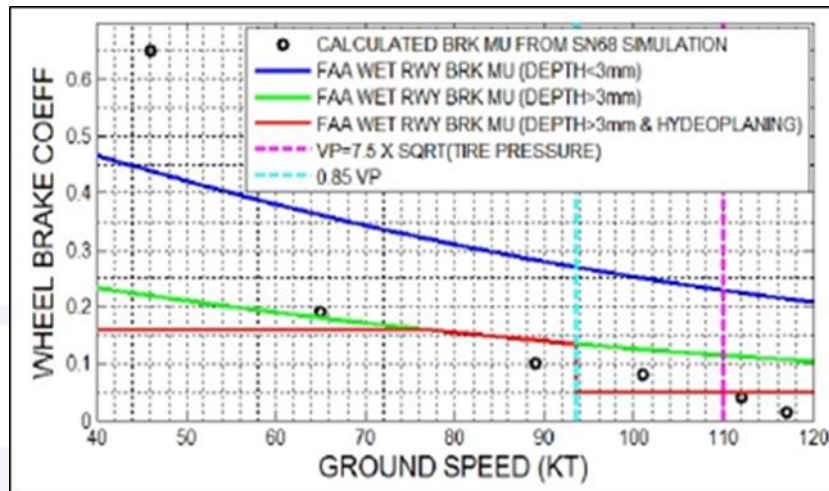
Three of the higher speed braking coefficient values (Touchdown, T+4, and T+18) are below the hydroplaning curve of the aircraft experimentally tested by the FAA. At these points, the estimated aircraft deceleration corresponds to what would be expected from a hydroplaning aircraft. Two data points (T+12 and T+34) are above the FAA hydroplaning curve.

Figure 30 - Braking coefficient data points (black circles) compared to the FAA model braking curves for a wet runway with various water depths.

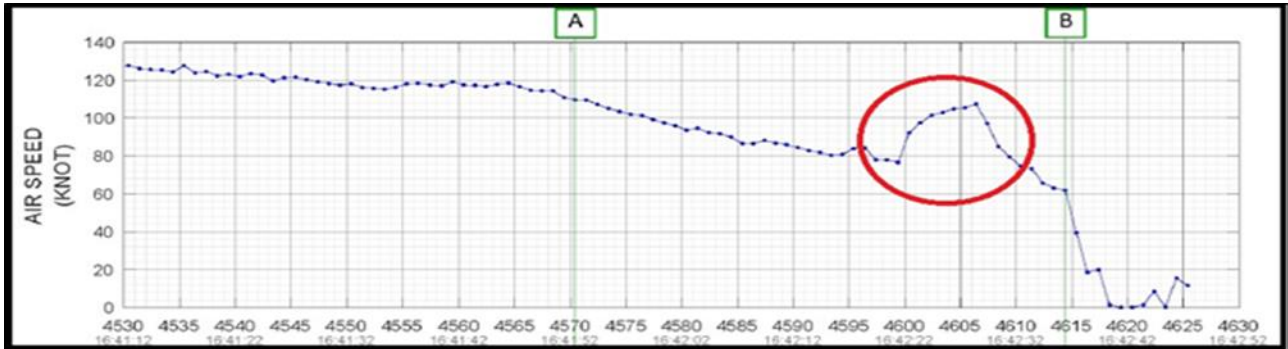
Data extracted from the CMF showed that, during the run after landing, some kind of indicated speed anomaly occurred, which caused a sudden increase in the calibrated speed of the aircraft.

Figure 33 - Variation in the calibrated speed of the aircraft.
