**FINAL REPORT**  
**A - 094/CENIPA/2018**

<b>OCCURRENCE:</b>	<b>ACCIDENT</b>
<b>AIRCRAFT:</b>	<b>PT-FLW</b>
<b>MODEL:</b>	<b>208B</b>
<b>DATE:</b>	<b>22MAY2018</b>

This is the Final Report of the 22MAY2018 accident with the 208B aircraft model, registration PT-FLW. The accident was classified as “[SCF-PP] System/Component Failure or Malfunction Powerplant – Engine Failure in Flight”.

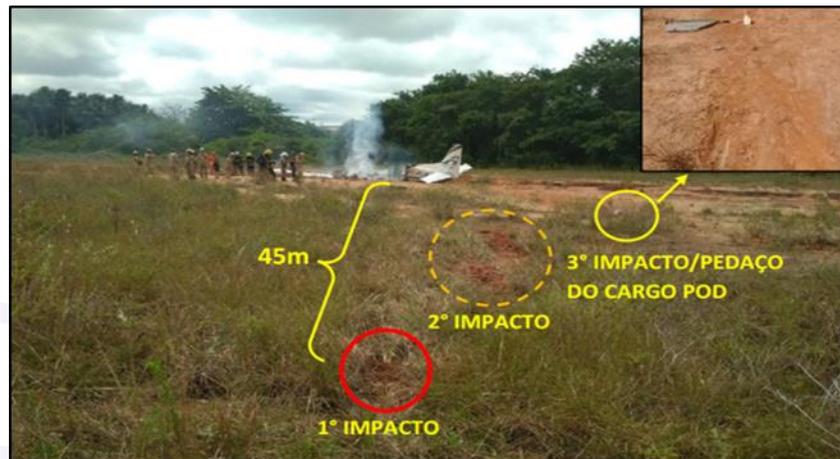
According to the pilot's report, the first and second impacts occurred during the attempted forced landing, in a descending attitude, and a slight left turn. In one of those moments, the landing gear broke down. Then, there was the third impact that caused the breakage of part of the Cargo Pod.

After the impacts, the aircraft yawed about 40 degrees to the left and dragged for 45 meters until it came to a complete stop. After the total stop, the plane caught fire and was destroyed (Figures 4 and 5).

Figure 4 - General view of the wreckage. The red circle indicates the point of the 1<sup>st</sup> impact, the dashed orange circle indicates the 2<sup>nd</sup> impact and the yellow circle shows the 3<sup>rd</sup> impact (part of the Cargo Pod in the detail).

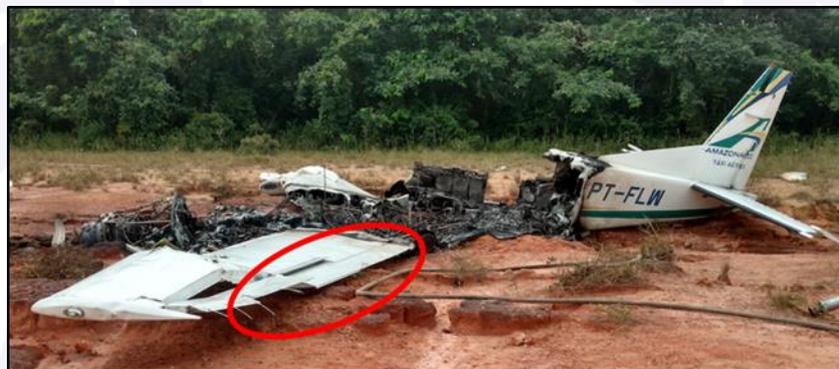
Figure 5 - Approximate view of the aircraft. In detail, it shows that the flaps were retracted.

The retraction of the flaps was an action prevised in the checklist after an engine failure in flight. However, the same support system recommended the flaps to be positioned in "FULL" for a forced landing.

Thus, it is possible that the loss of lift produced by the flap retraction has resulted in a sinking that prevented the plane from reaching the SWFN runway with the residual power that the engine still provided. In this case, an inadequate assessment of the effects of such action on the aircraft performance under those conditions would be characterized.

It is possible that the loss of lift produced by the flap retraction resulted in a sinking that prevented the plane from reaching the SWFN runway with the residual power that the engine still provided. In this case, an inadequate assessment of the effects of such action on the aircraft performance under those conditions would be characterized.

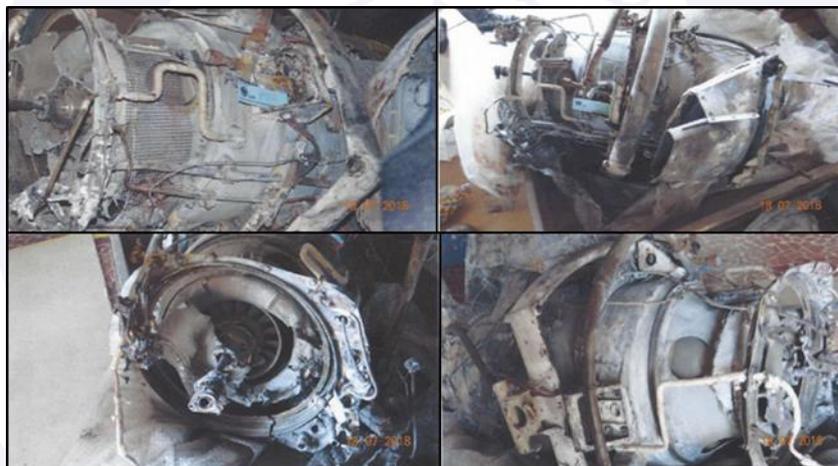
The initial analysis identified that the engine in question was severely damaged by the fire that followed the crash of the aircraft. Therefore, the reduction and accessory boxes were consumed by the fire.

This was mainly because this engine had magnesium in its composition, which, due to its properties, burns with sufficient heat to cause the rupture of the water molecule, releasing hydrogen and oxygen, which in turn, feed the fire instead of extinguishing it.

The FCU and the fuel pump were located at the rear of the engine, next to the accessory box, and were consumed by the fire. Similarly, the pneumatic lines could not be inspected either.

Figure 6 - Images of the engine, in which the damage to the sides and rear resulting from the action of fire is observed.

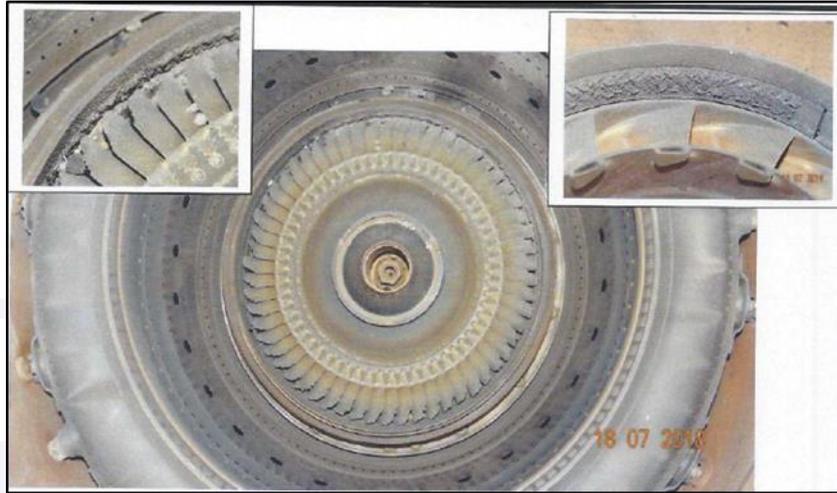
In the hot section of the engine, it was observed that the compressor turbine was subjected to a fusion process and that parts of the vanes melted. A portion of the melted material was centrifuged and deposited on the segmented ring, as shown in Figures 7 and 8.

Figure 7 - Images of the engine showing the compressor turbine rotor with the melted vanes. The highlights show the material of the vanes deposited on the segmented ring.

The damage observed in components of the hot engine section indicated the occurrence of an extrapolation of the ITT limits, which may have caused the melt observed in the blades of the compressor turbine.

The damage observed in the hot engine section components indicated the occurrence of an extrapolation of the ITT limits, which may have caused the melt observed in the blades of the compressor turbine.

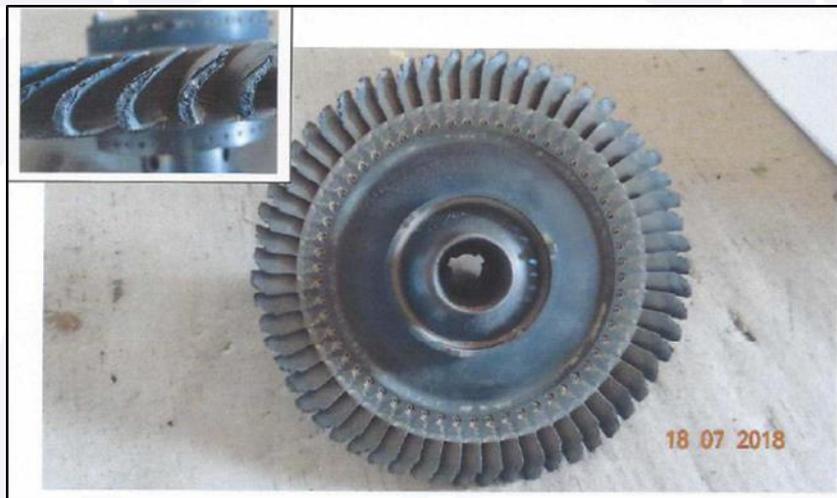
Figure 8 - Images of the compressor turbine rotor. The highlight shows a superior view of the top of the vanes, where part of the material has been melted.

Another part of this material followed the gas flow, damaging the vanes of the power turbine rotor. This may have occurred when part of that material followed the gas flow resulting from combustion to the atmosphere. The impact may have caused the vanes of the power turbine rotor to become weak and result in the observed fractures.

However, the Investigation Report (IR) issued by the APA concluded that the internal signatures showed that the engine still had residual power at the moment the aircraft hit the ground and that the over temperature damage observed in the hot section occurred with the engine working, possibly due to improper handling of the EPL.

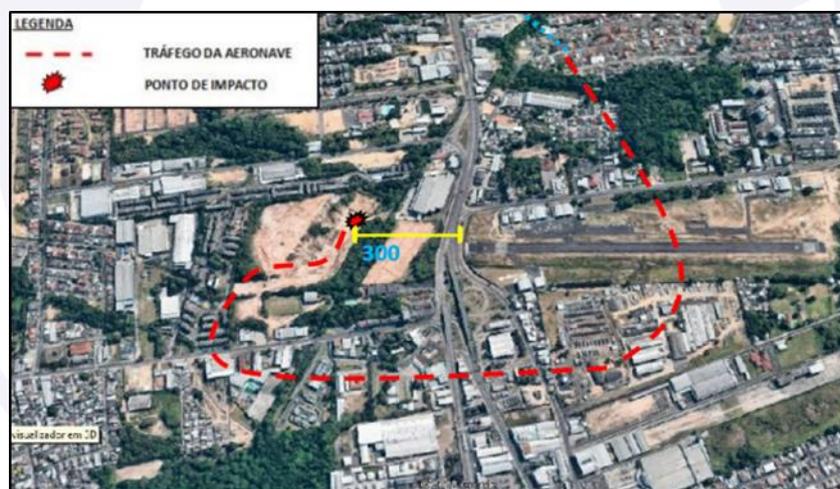
Unable to regain control of the engine, the commander opted to make a forced landing on an unprepared field, located about 300 meters from the runway's threshold.

Figure 9 - Sketch of the accident showing the aerial view of the impact site and its position in relation to the threshold 11 of SWFN. The red dashed line represents the aircraft trajectory until the moment of impact.
