Loss of control and collision with water involving Grumman American Aviation Corp G-73, VH-CQA

10 km west south west of Perth Airport, Western Australia | 26 January 2017

ATSB Transport Safety Report
Aviation Occurrence Investigation
AO-2017-013
Final – 19 November 2019

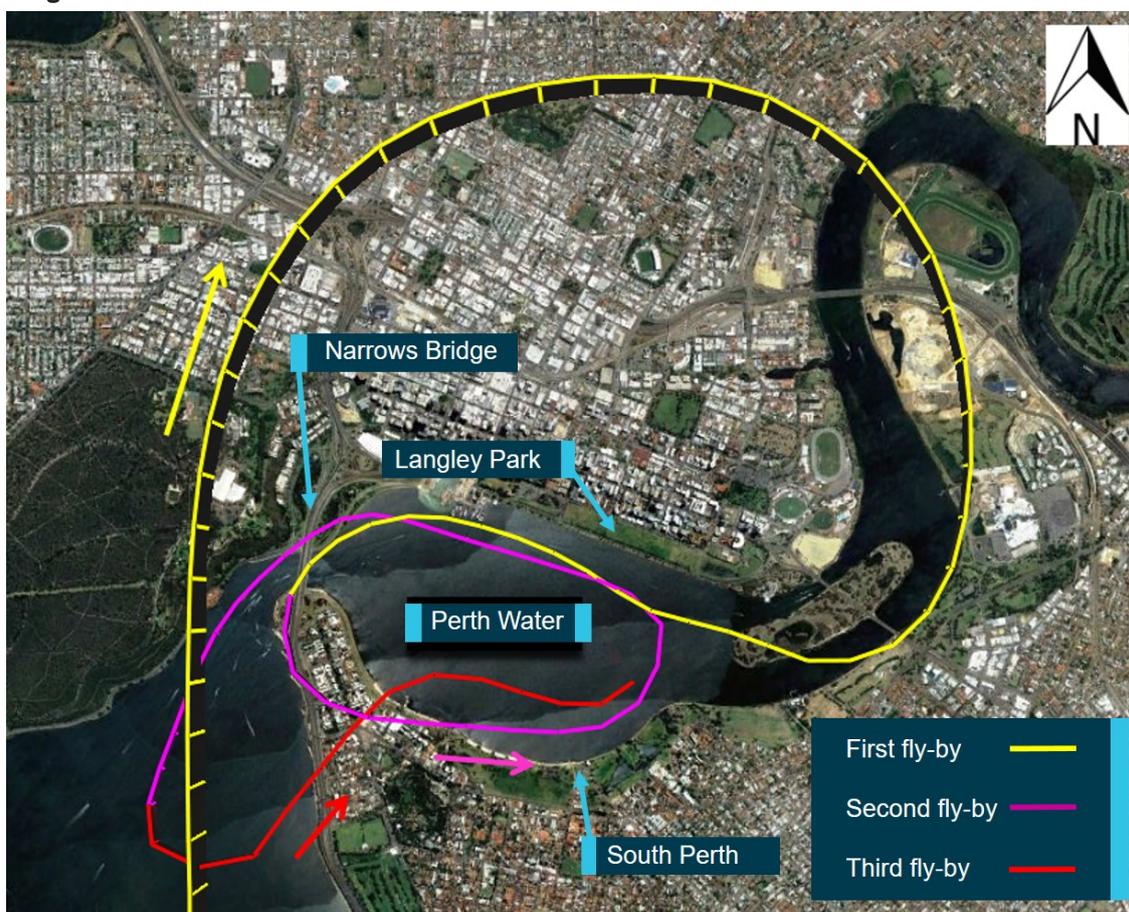
Figure 2: CQA air display flight track, showing the first pass in yellow, the second in magenta and the third in red

Analysis of available track data (as depicted in Figure 2) found that the Mallard's speed on entry to the accident turn was approximately 10 kt slower than at the equivalent point in the previous orbit and within around 10 kt of the aircraft's stall speed for a coordinated turn at an estimated 30° angle of bank at the commencement of the turn.

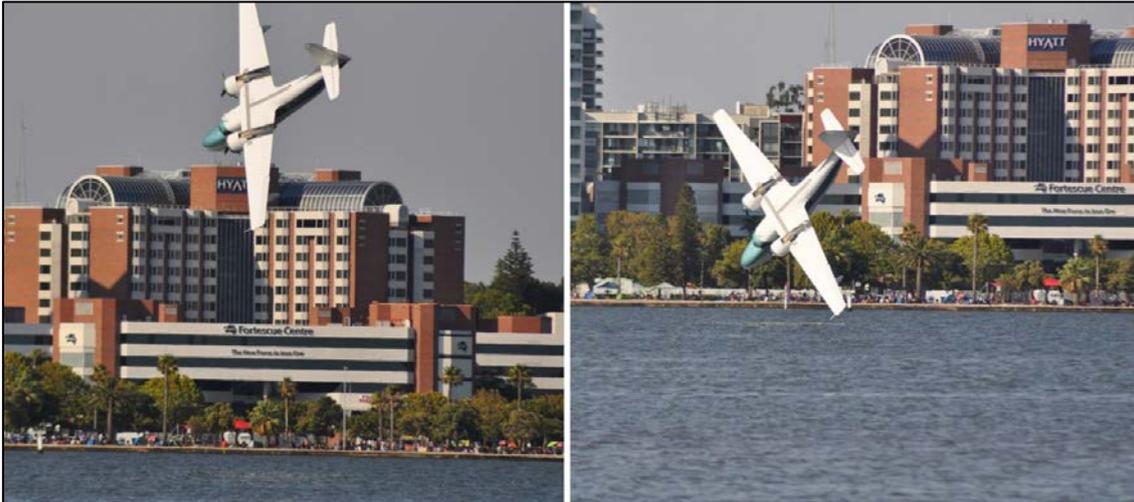
Figure 4: CQA just prior to the collision with water (looking north)

Damage to the aircraft was consistent with the observed collision with water in a steep nose-down attitude and subsequent contact with terrain, about 1.5 m below the surface. Examination of the wreckage did not identify any evidence of in-flight break-up, component failure or other anomalies that may have contributed to the collision with terrain, or that would have prevented the engines and propellers from operating normally. This was consistent with witness reports, images and video of the aircraft during the display.

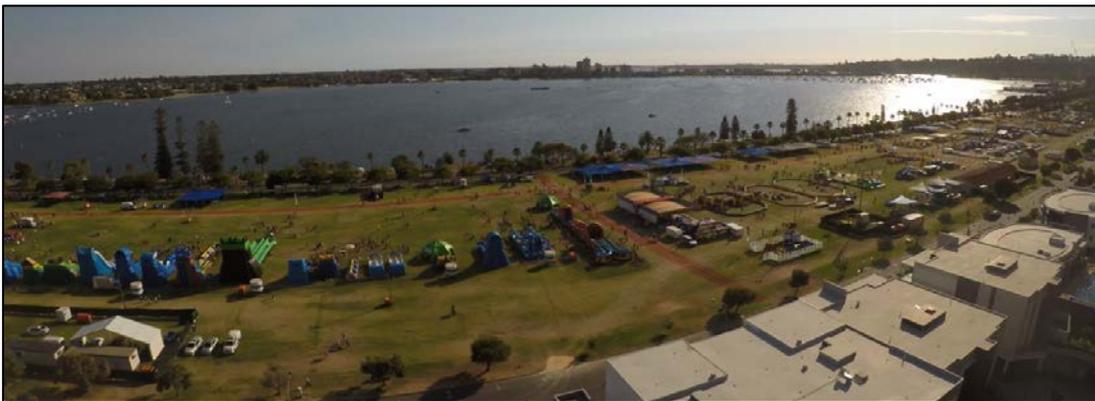
Figure 11: The view of Langley Park from the Ringmaster’s vantage point

When the approval for CQA’s third pass was granted by the Ringmaster, the assistant reported that their vantage point and the position of the sun made it difficult to identify exactly what the aircraft was doing over Melville Water (Figure 11) prior to returning to the display area. Although the Ringmaster did not specify the manner in which the Mallard was to return for the third pass, the assistant expected the approach to be via the standard procedure, behind the city, and was surprised when he realised CQA was re-entering Perth Water directly. He reported that CQA may have flown over boats²² lower than the authorised height, but as the moment had passed, there was no gain in immediately contacting the pilot about it. The Ringmaster advised that she did not observe CQA until just prior to the accident as she was communicating with a banner-towing helicopter via radio.
