Uncontrolled flight into water involving Cessna 208B, VH-FAY

260 km north-east of Narita International Airport, Japan, on 27 September 2018

ATSB Transport Safety Report
Aviation Occurrence Investigation
AO-2018-065
Final – 18 March 2020

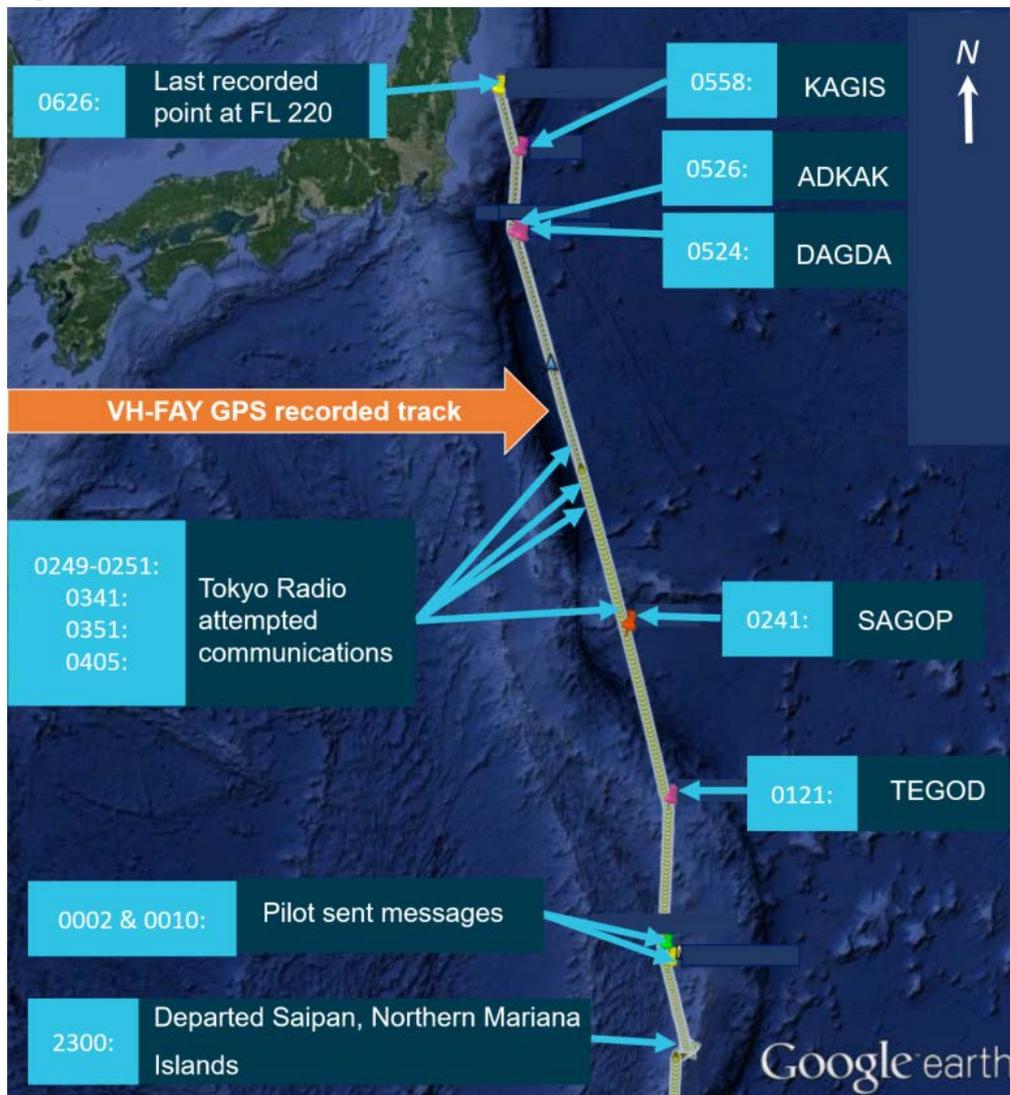
Figure 2: VH-FAY GPS recorded track

At 0121, while overhead reporting point TEGOD (Figure 2), the pilot contacted Tokyo Radio flight information service⁴ on HF radio. The pilot was next due to report when the aircraft reached reporting point SAGOP, which the pilot estimated would occur at 0244. GPS recorded track showed that the aircraft passed SAGOP at 0241, but the pilot did not contact Tokyo Radio as expected. At 0249, Tokyo Radio made several attempts to communicate with the pilot on two different HF frequencies, but did not receive a response. Tokyo Radio made further attempts to contact the pilot between 0249 and 0251, and at 0341, 0351 and 0405.

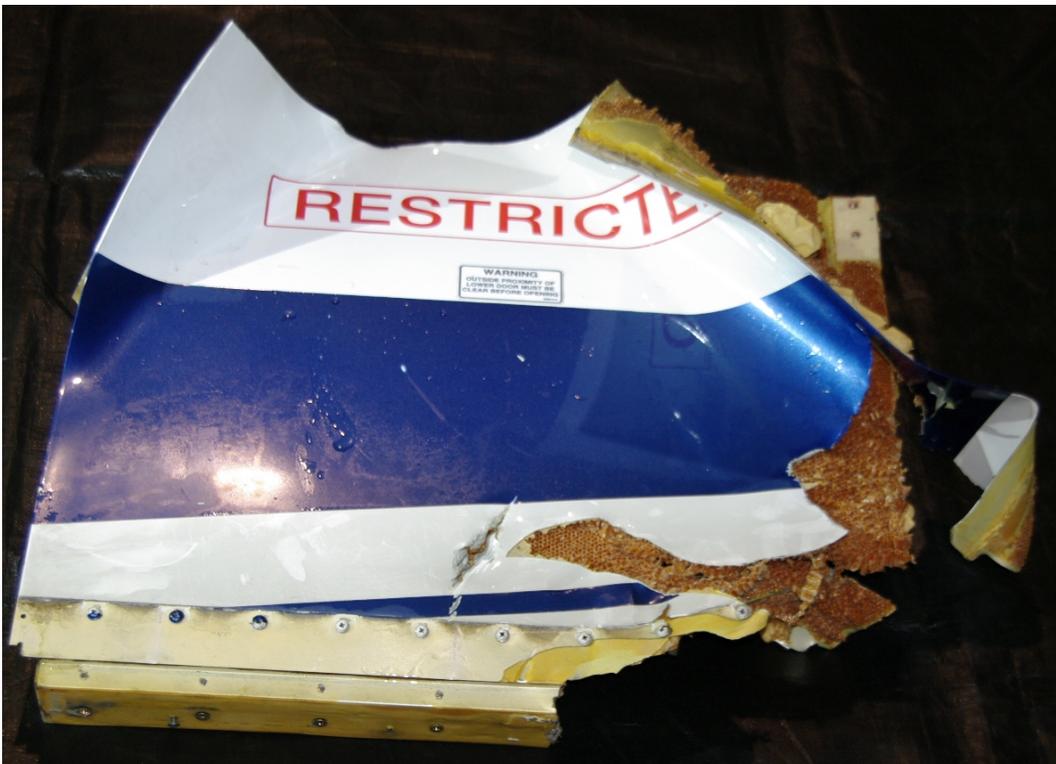
Figure 3: Rear passenger door

At 0626 UTC, the aircraft's GPS tracker stopped reporting, with the last recorded position at FL 220, about 100 km off the Japanese coast and 589 km (318 NM) short of the destination airport. Radar data showed that the aircraft descended rapidly from this point and collided with water approximately 2 minutes later. The Japanese authorities launched a search and rescue mission and, within 2 hours, searchers found the aircraft's rear passenger door (Figure 3). The search continued until the next day, when a typhoon passed through the area and the search was suspended for two days. After resuming, the search continued until 27 October with no further parts of the aircraft found. The pilot was not located.

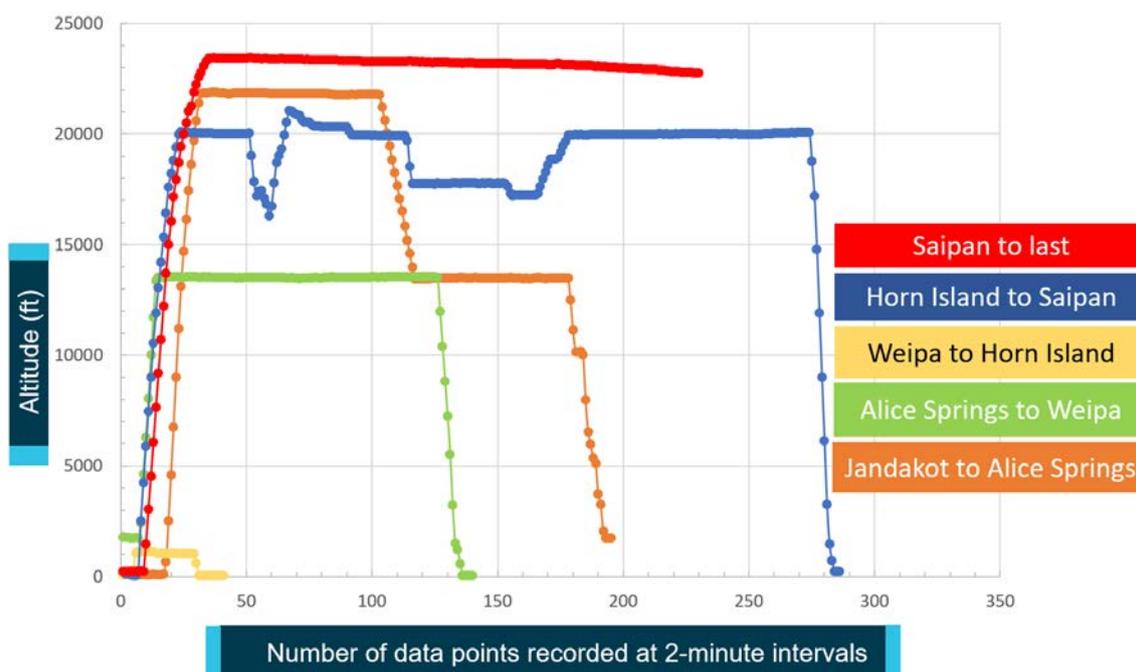
Figure 4: Geometric altitude of all flight sectors

The pilot sent several messages from the Garmin device after departing Saipan and before the aircraft reached reporting point TEGOD. The last position recorded by the Spidertracks and Garmin devices was at 0626 UTC at FL 220. The aircraft took less than 2 minutes to descend from FL 220 to the ocean and there were no GPS recorded points below that altitude.

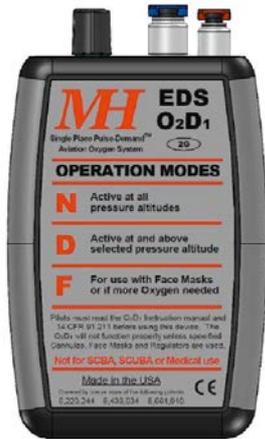
Figure 5: Mountain High Pulse-Demand Electronic Delivery System O2D1

The pilot had a battery-operated Mountain High (MH) Pulse-Demand™ Electronic Delivery System (EDS) O2D1 (single-person) model (Figure 5). The EDS unit supplied a measured pulse of oxygen at the beginning of each inhalation and was oxygen-compensating (increasing flow with altitude). The unit had audible and illuminating flow fault and apnoea alarms. A representative from Mountain High advised that although the ceiling of the MH EDS is 25,000 ft, at 22,000 ft it is at the maximum flow rate requirement for oxygen.

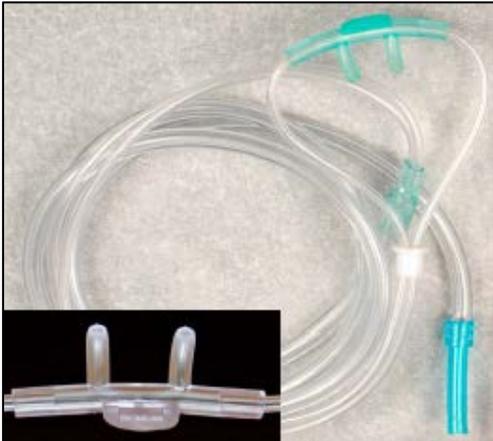
Figure 6: Mountain High nasal cannula

The ATSB could not establish the cannula model used for the ferry, however the MH EDS manual stated ‘Use only the supplied MH EDS cannula, as other cannulas may not work properly with the EDS.’ The standard MH nasal cannula (Figure 6) differed from the Oxymizer specified in CAO 108.26, which had a reservoir that stored oxygen during the exhalation then added it to the delivery during inhalation to increase oxygenation. Mountain High advised that the risks of wearing a cannula are:

- it is ineffective if the pilot has nasal congestion, is eating, talking or mouth-breathing
- it can come away from the nose, which would also trigger the apnoea alert.

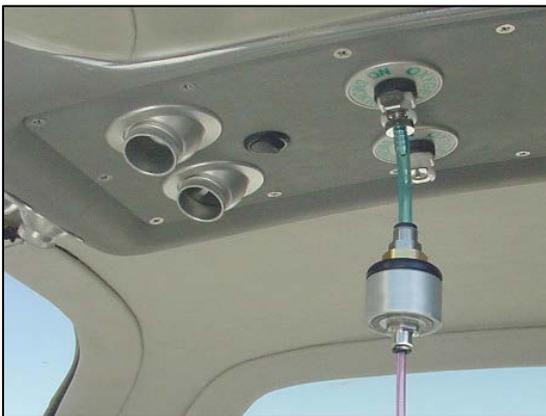
Figure 7: In-line regulator to connect EDS to aircraft oxygen outlet

The EDS was required to be operated with an oxygen inlet pressure between 16 and 20 PSI, which could be achieved with an in-line regulator (Figure 7). The MH EDS manual indicated that the flow of oxygen would be unnecessarily high between 20-30 PSI. The manual also included the warning that higher pressure ‘will not only compromise the performance of the EDS, but is likely to damage the internal breathing sensor, rendering your EDS unit inoperable.’ MH advised that pressures above 30 PSI would cause the valve to open up and result in the EDS working like a constant flow system. In this situation, the apnoea alert would sound out constantly until the oxygen supply was nearly depleted.

The pilot did not have an in-line regulator for the flight. At altitudes above 17,000 ft, the aircraft’s system provided oxygen at 21.55 ± 2.5 PSI, which was higher than the EDS inlet pressure range. At 20,000 ft, this increased 24.45 ± 2.5 PSI. There was no data for the output pressure at 22,000 ft.

The pilot had also indicated his intention to connect the EDS to the aircraft system without the in-line regulator that was required to ensure the EDS operated within its limits. At FL 220, this had the potential for the pilot to receive inadequate oxygen supply or for the EDS to be rendered inoperative, resulting in higher oxygen consumption than anticipated. However, it is noted that the pilot had the Cessna mask available which, if used with the aircraft system, would have mitigated this risk.

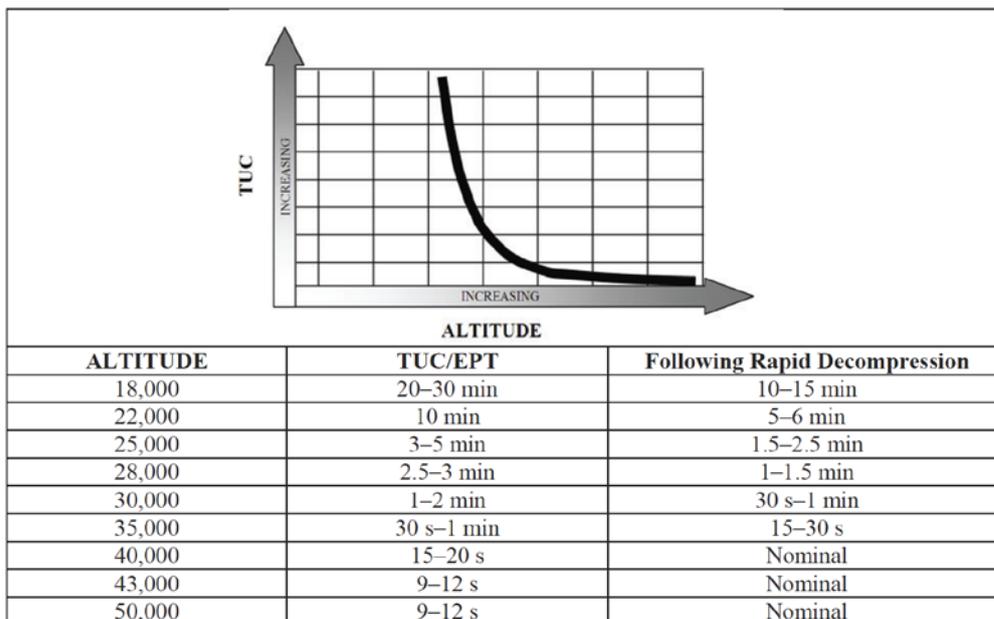
Figure 8: Times of useful consciousness versus altitude

The circular included a graph showing decreasing TUC with increasing altitude (Figure 8). At 22,000 ft, the TUC was 10 minutes, or 5-6 minutes following rapid decompression. However, it goes on to caution that slow decompression is as dangerous as, or more dangerous than, a rapid decompression, as the resultant hypoxia may be unrecognized by the pilot. The circular also carried the warning: ‘The TUC *does not* mean the onset of unconsciousness. Impaired performance *may be immediate*.’
