# VFR into IMC and controlled flight into terrain involving Pilatus Britten-Norman BN2A, VH-OBL

101 km west-south-west of Hobart, Tasmania, on 8 December 2018

**ATSB Transport Safety Report**

AO-2018-078

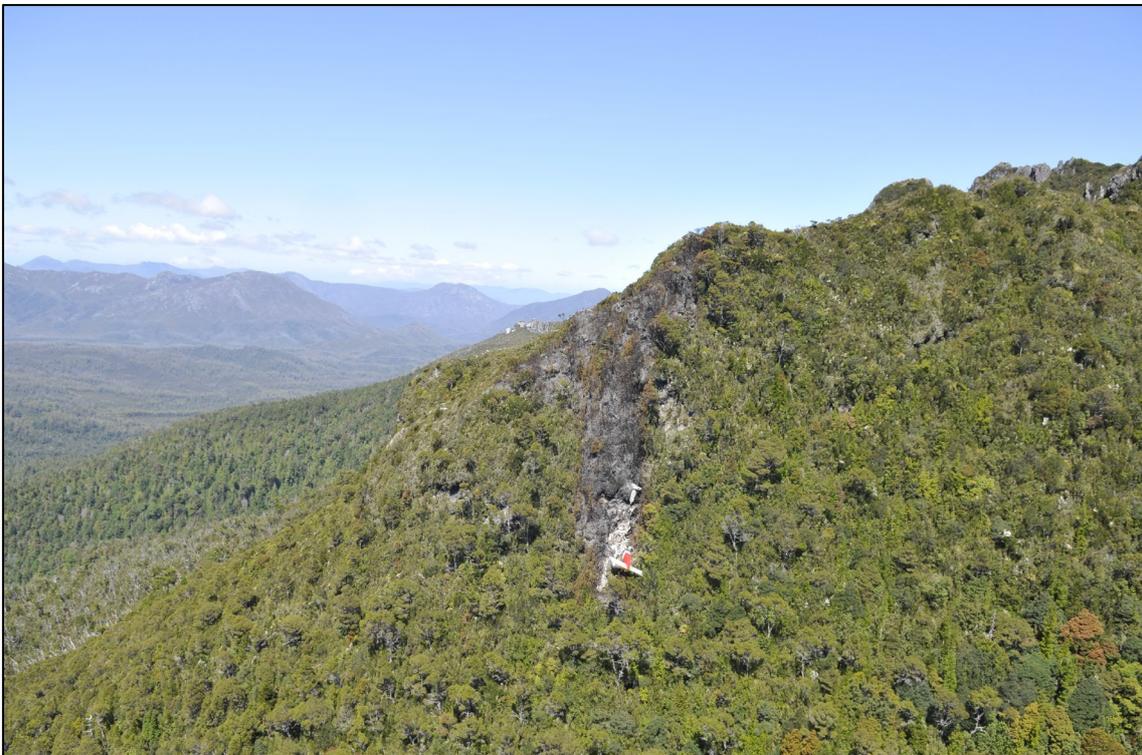
**Figure 2: Accident location of VH-OBL in the Western Arthur Range**

Multiple attempts were made throughout the day to locate the accident site, however, due to low-level cloud, and fluctuating weather conditions, the search and rescue operation was unable to confirm visual location of the aircraft until about 1900. The aircraft wreckage was found in mountainous terrain of the Western Arthur Range in the Southwest National Park (Figure 2) . The search and rescue crew assessed that the accident was unlikely to have been survivable.

The helicopter crew considered winching personnel to the site, however, due to a number of risks, including potential for cloud reforming, the time of day and lighting, and other hazards associated with the mountainous location, the helicopter departed the area. The aircraft wreckage was accessed the following day, when it was confirmed that the pilot was fatally injured.

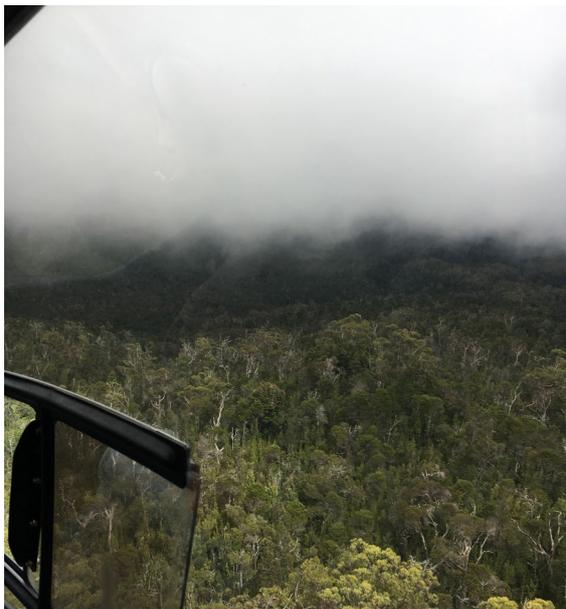
**Figure 6: Photograph taken from the company helicopter in the vicinity of the accident location at about 1100**

After being notified that one of their aircraft was missing, a helicopter pilot from Airlines of Tasmania flew to the site about 1.5-2 hours after the accident. The pilot reported that, on departure from Cambridge, it was looking like a nice day. However, when they arrived at the Arthur Range, the cloud base was initially down to the tree tops (Figure 6) at the portals and there was nil wind. The pilot reported that, it looked like there was light coming through the cloud and they tried to pass through the portals. However, they only got part way through before they encountered a ‘wall of cloud’ and had to turn back (Figure 6). The pilot spent over an hour trying to find a different way to enter the area where the emergency locator transmitter signal was detected, however, in each direction they were stopped by low cloud.

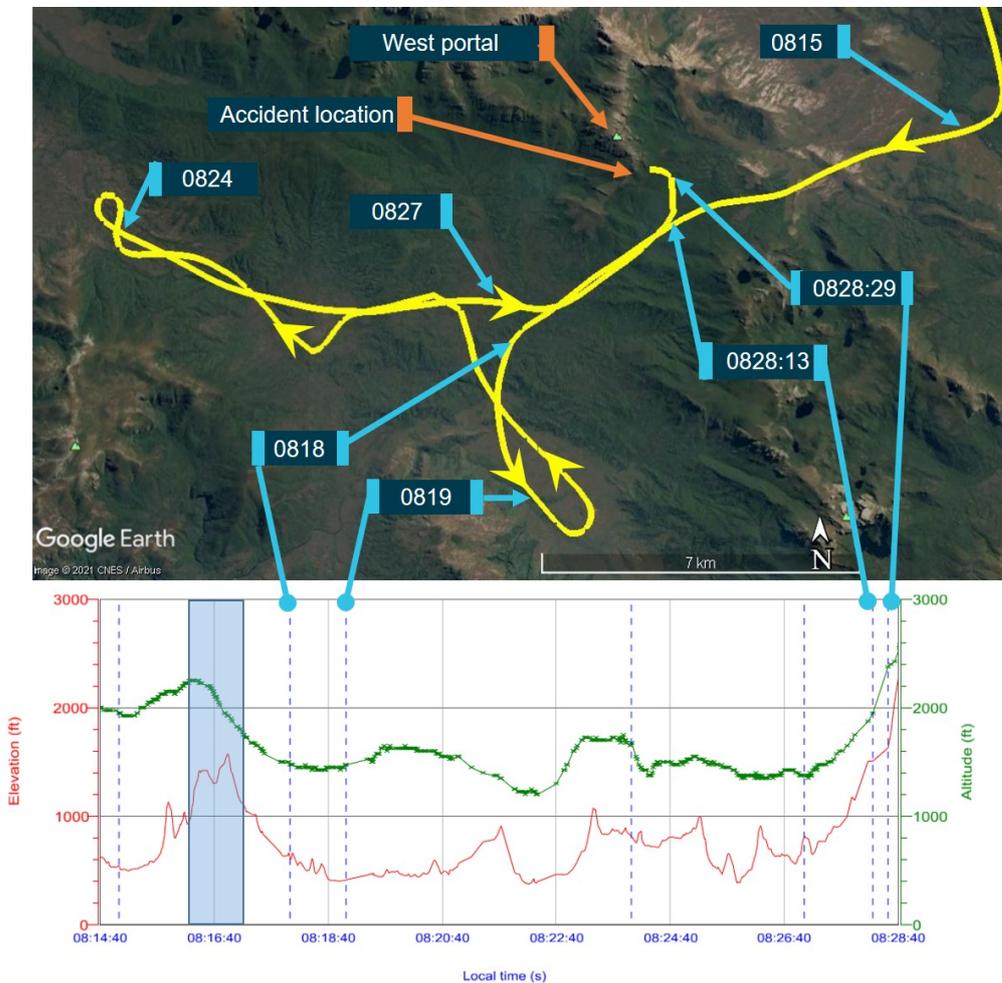
**Figure 8: Aircraft track within the valley (yellow track) and height above ground level (lower graph)**

- At 08:28:29, the aircraft was observed turning toward the ridge of the Western Arthur Range. Over the next 7 seconds, the aircraft climbed about 50 ft at an approximate ground speed of 90 kt.

- In the final 5 seconds of the recording, the aircraft was climbed from 2,425 ft to 2,550 ft AMSL (a climb rate of about 1,500 ft/min) at a ground speed of about 90 kt. The recording stopped at 08:28:41.

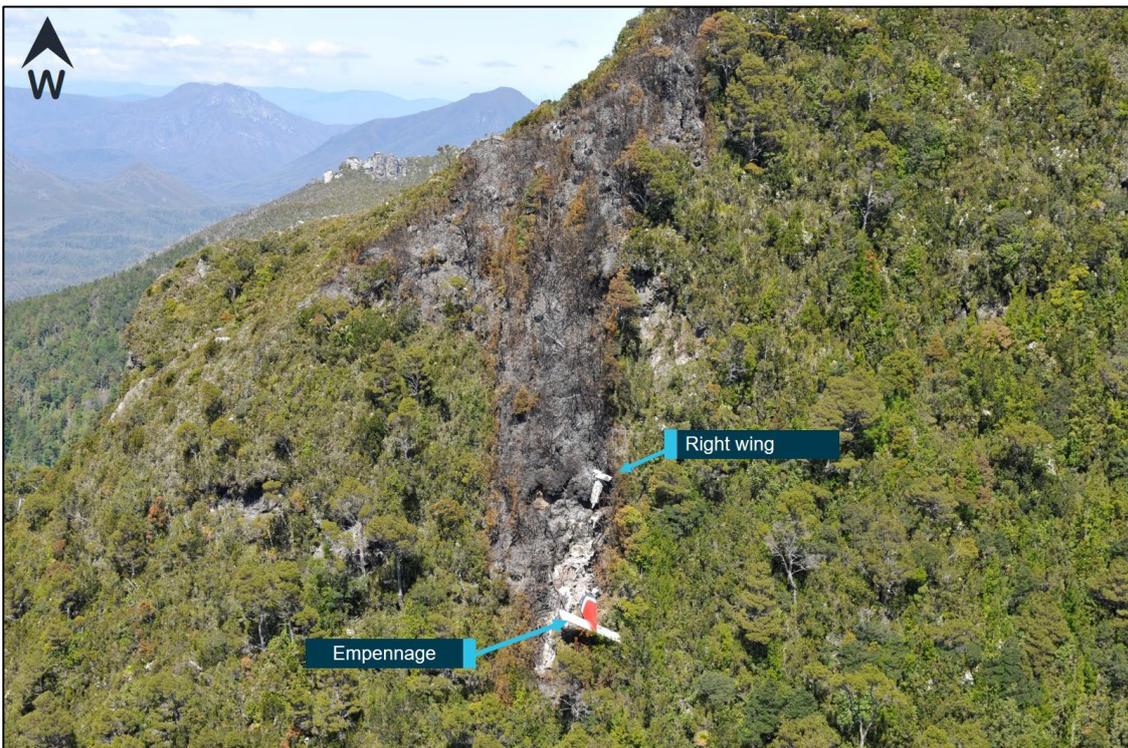
**Figure 9: Accident site**

The ATSB's review of the accident site photographs and statements by Tasmania Police officers, indicated that the aircraft impacted the terrain while heading in a westerly direction. The location of the wings in the photographs and the narrow line of fire damage indicated that the aircraft impacted the terrain in a relatively steep, left angle of bank. The aircraft was destroyed by the impact and a post-impact fuel-fed fire.

The empennage (tail) section of the aircraft was detached from the main wreckage and came to rest inverted, but appeared mostly intact and not affected by the post-impact fire.

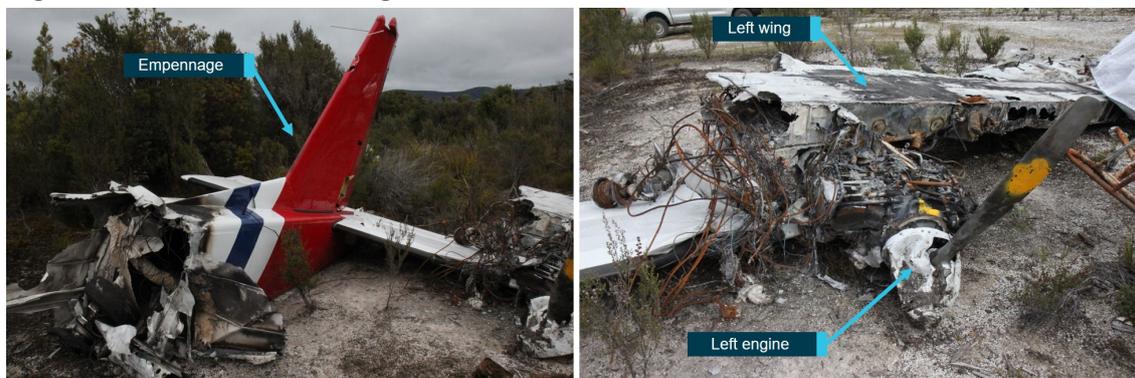
**Figure 10: Recovered wreckage**

post-impact fire, severely degraded the available evidence as fracture surfaces and components were corroded.

Major components recovered from the site included the left and right engines and propellers, the empennage, about two-thirds of the left wing, the forward section of the fuselage, and a large number of small sections of the aircraft and various components (Figure 10).

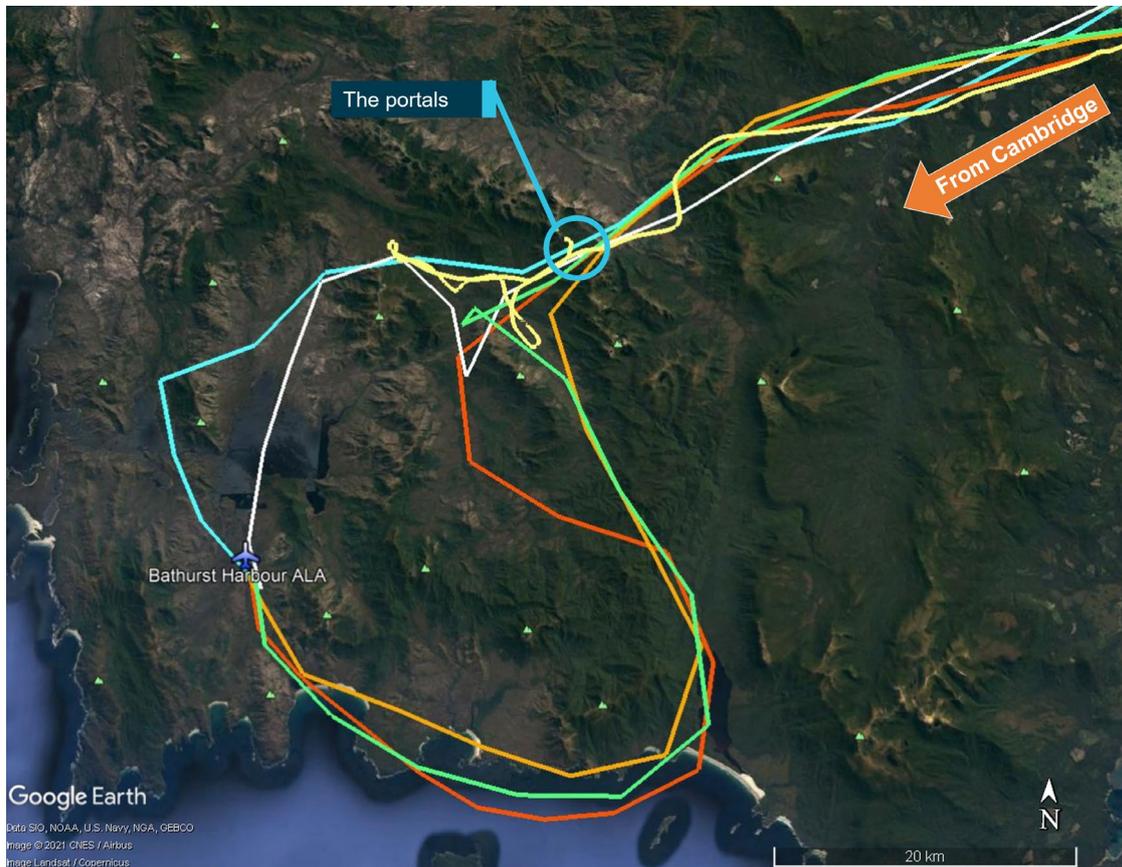
**Figure 12: Comparison of aircraft tracks through the valley, including about 1 month prior to the accident (green – lead aircraft; orange – second aircraft) and the accident track (pale yellow)**

- Five flights in the dataset showed the aircraft taking non-standard routes through the portals area (Figure 12). On one occasion, when two aircraft were in convoy, the aircraft appeared to track on a similar route to the accident flight (shown in green and orange in Figure 12), in that they turned left after passing through the portals. However, they were about 1,000 ft higher when at the same position as the accident flight. In this instance, the aircraft tracked all the way to the coast along a valley. This flight occurred 1 month prior to the accident, and the accident pilot was in the lead aircraft (green).
