FINAL ACCIDENT REPORT

(FALCON 402)

ZU-MDI

FINAL REPORT N° 780/01/2018

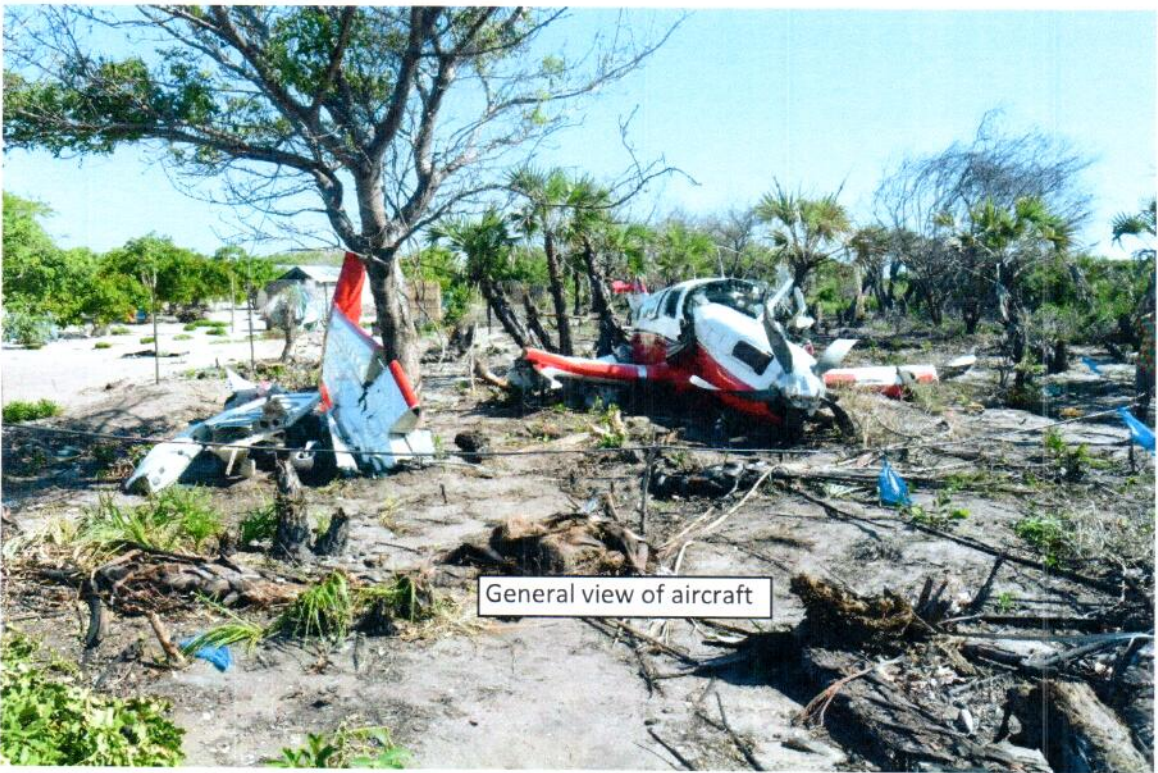
General view of aircraft

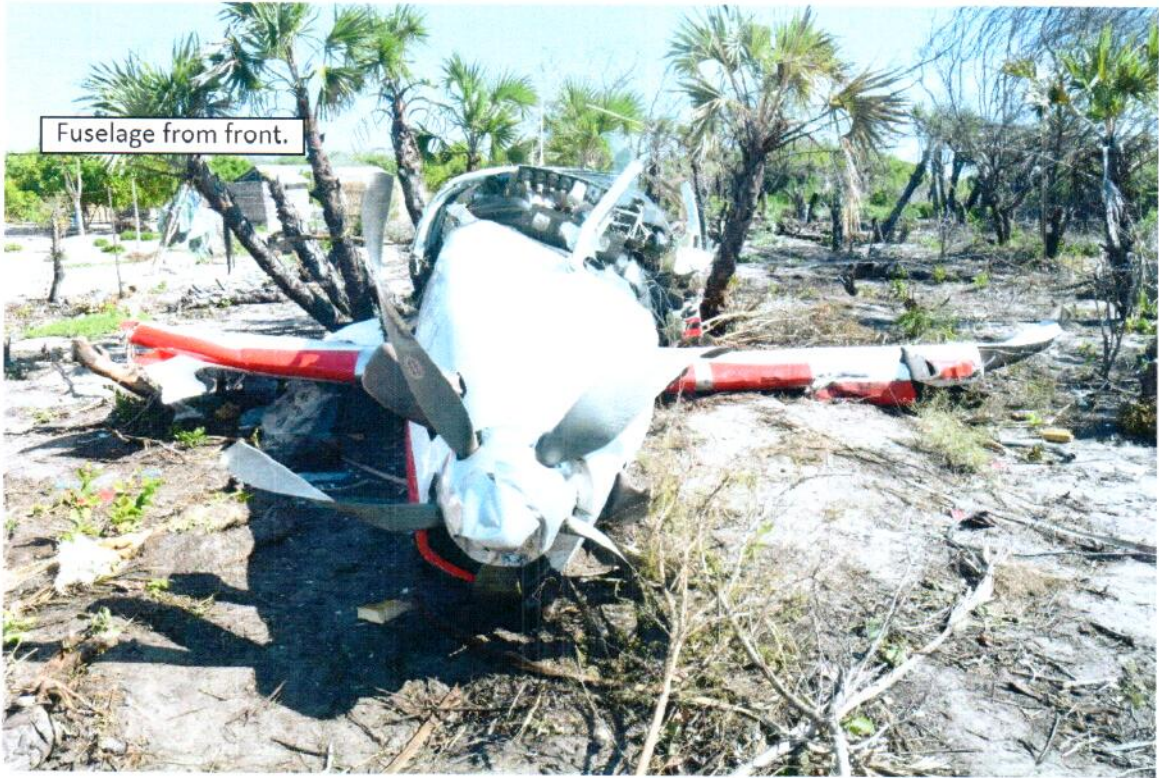
Fuselage from front.

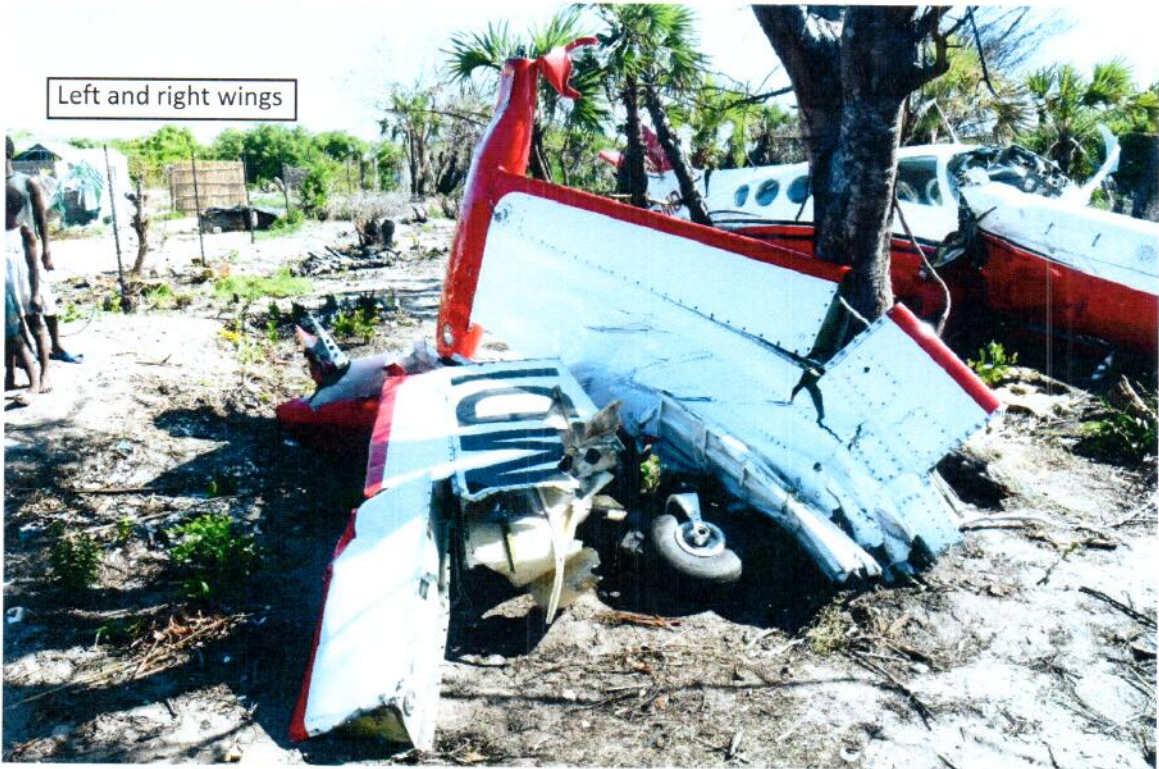
Left and right wings

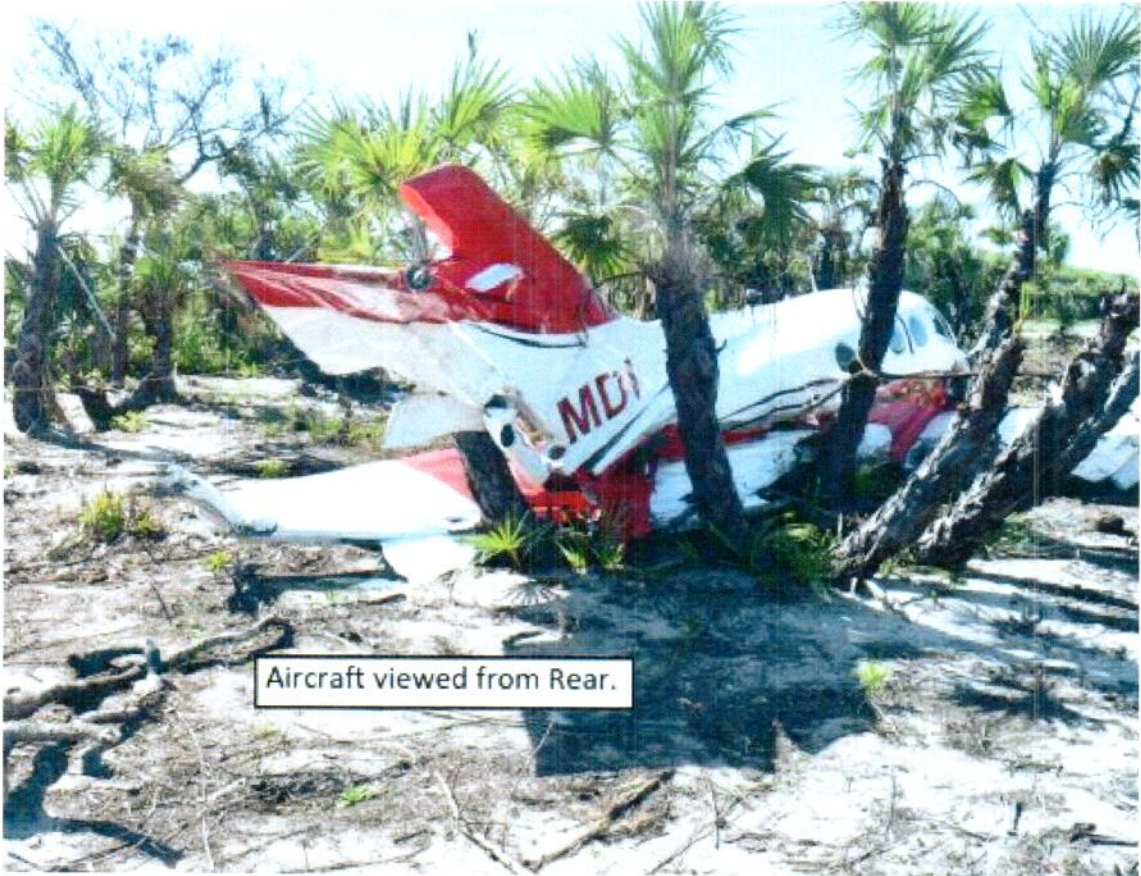
Aircraft viewed from Rear.

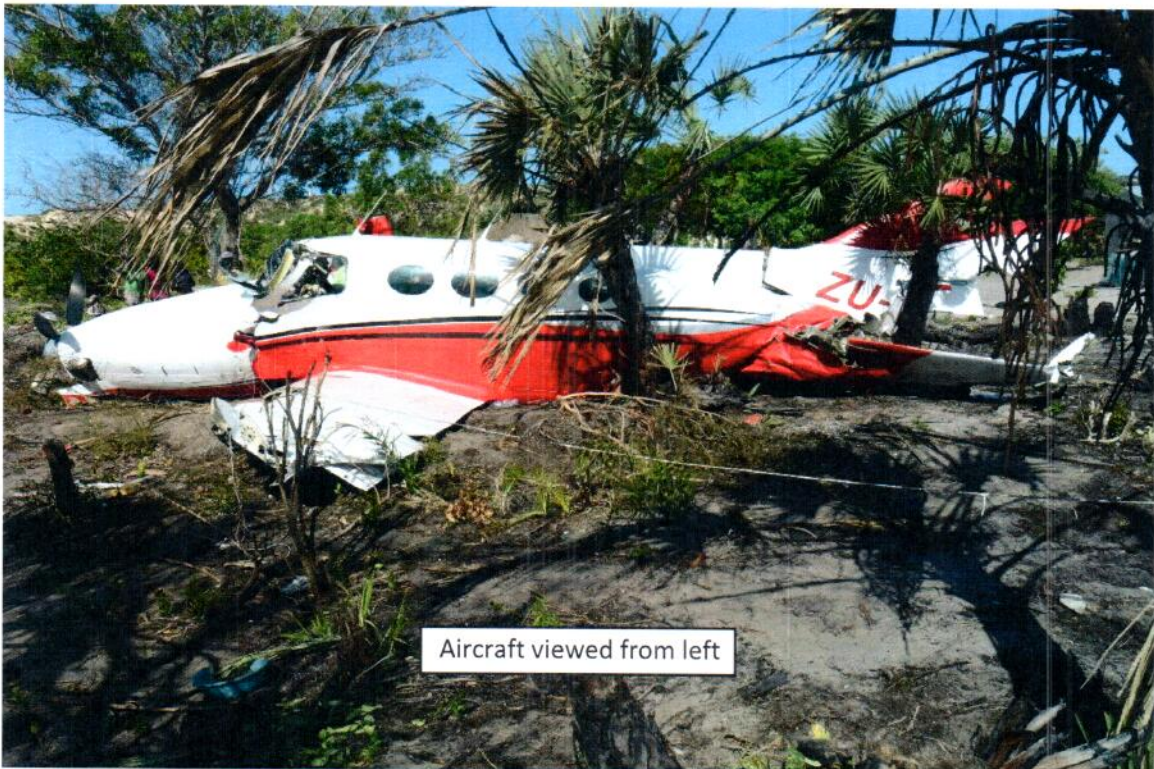
Aircraft viewed from left

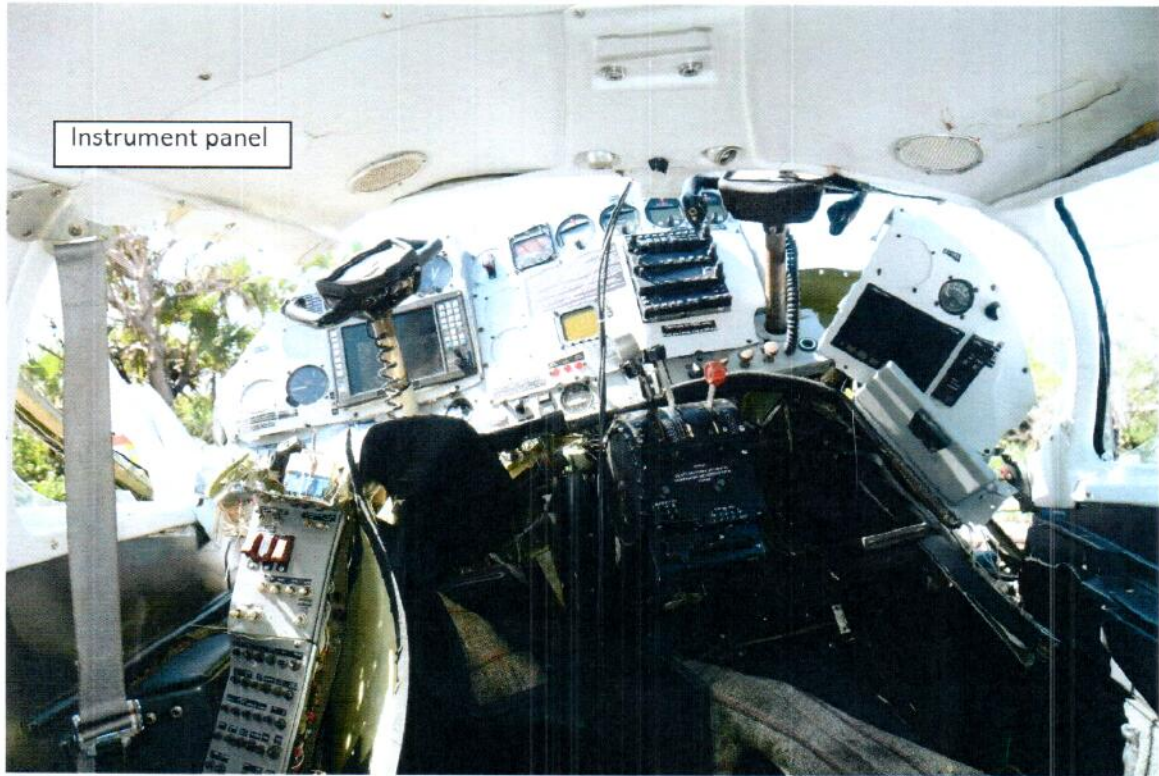
Instrument panel

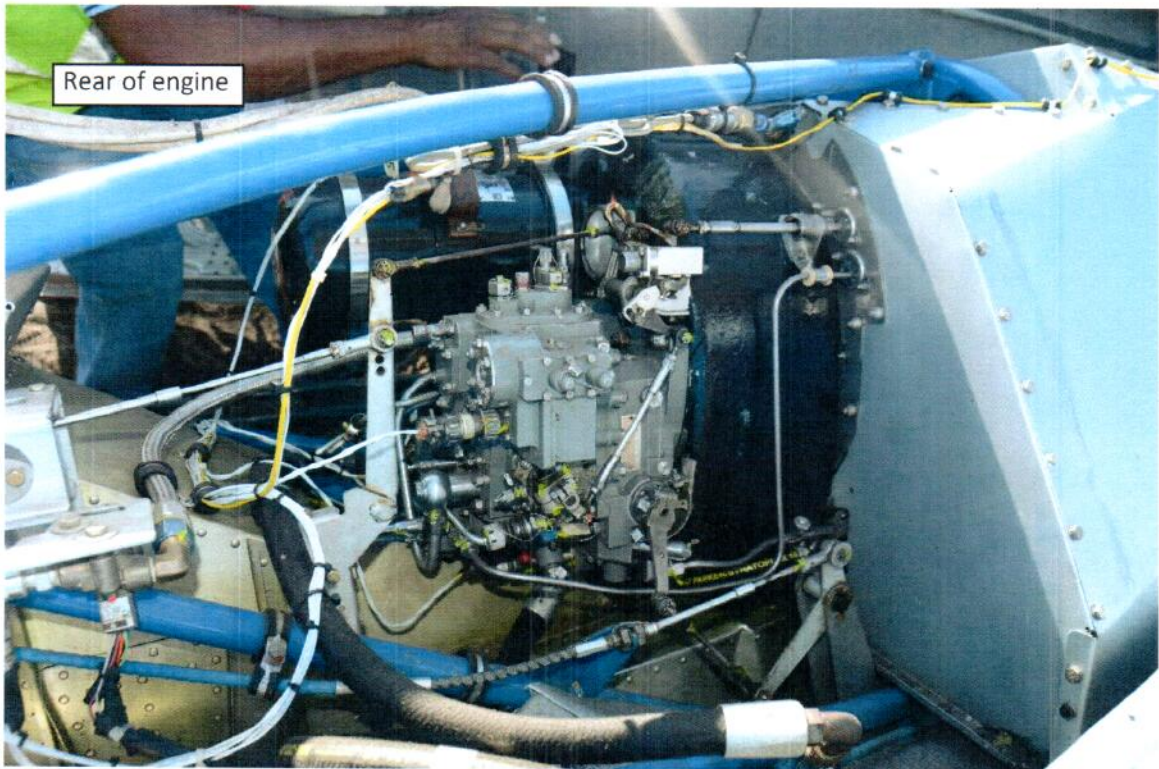
Rear of engine

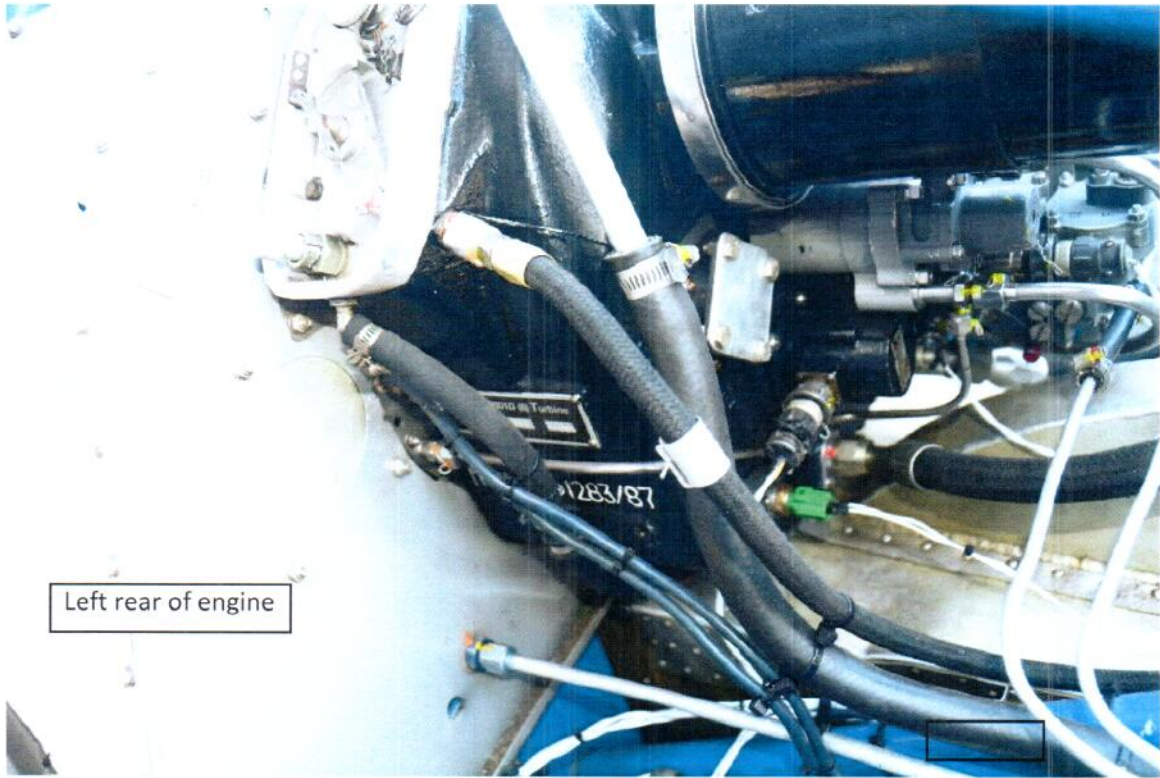
Left rear of engine

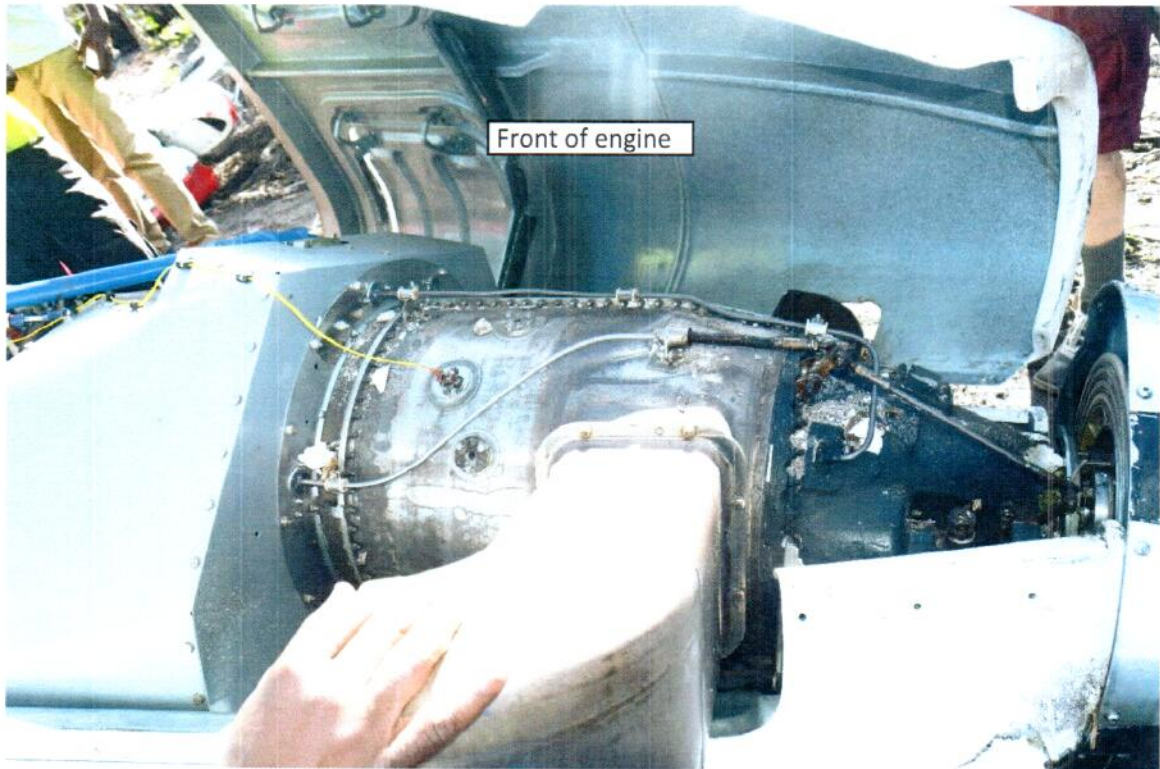
Front of engine
