# National Transportation Safety Board Aviation Accident Final Report

| <b>Location:</b> | New Albany, Mississippi | <b>Accident Number:</b> | CEN19FA119 |
| <b>Date &amp; Time:</b> | April 13, 2019, 15:14 Local | <b>Registration:</b> | N265DS |
| <b>Aircraft:</b> | Rockwell International NA-265-65 | <b>Aircraft Damage:</b> | Destroyed |

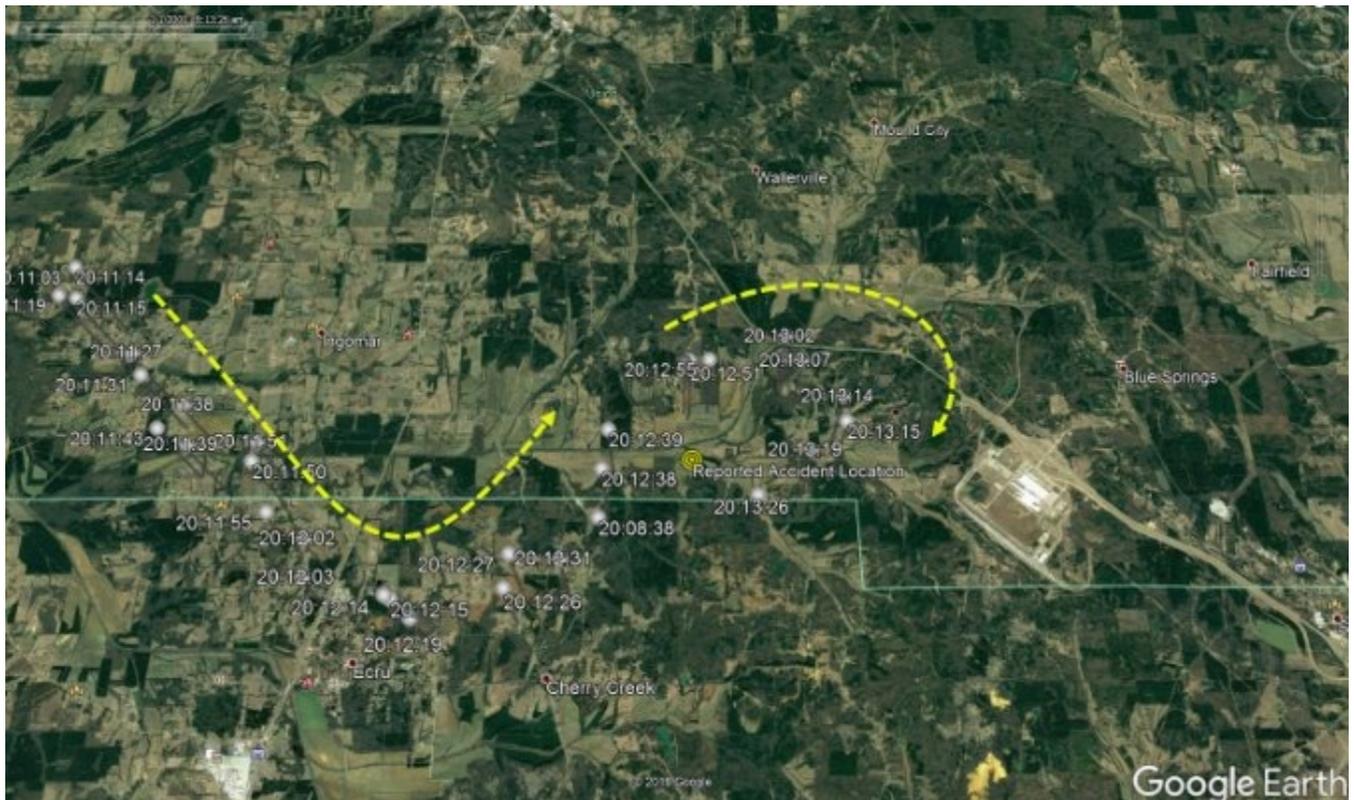
Figure 1 - Radar Track (All times in UTC)

heading assignment to 095° at 1513. The airplane disappeared from radar about 30 seconds later and the controller tried unsuccessfully to raise the flight on the radio at that time. Radar data showed the airplane began a right turn at 1513 that continued to a heading of about 270° until radar contact was lost at 1513:26. The final radar return was about 1/2 mile southeast of the accident location. See figure 1.
