National Transportation Safety Board Aviation Accident Final Report

Location:	Victoria, Texas	Accident Number:	CEN20FA032
Date & Time:	December 9, 2019, 20:17 Local	Registration:	N4602B
Aircraft:	Cessna 208	Aircraft Damage:	Destroyed
Defining Event:	Loss of control in flight	Injuries:	1 Fatal
Flight Conducted Under:	Part 135: Air taxi & commuter - Non-scheduled

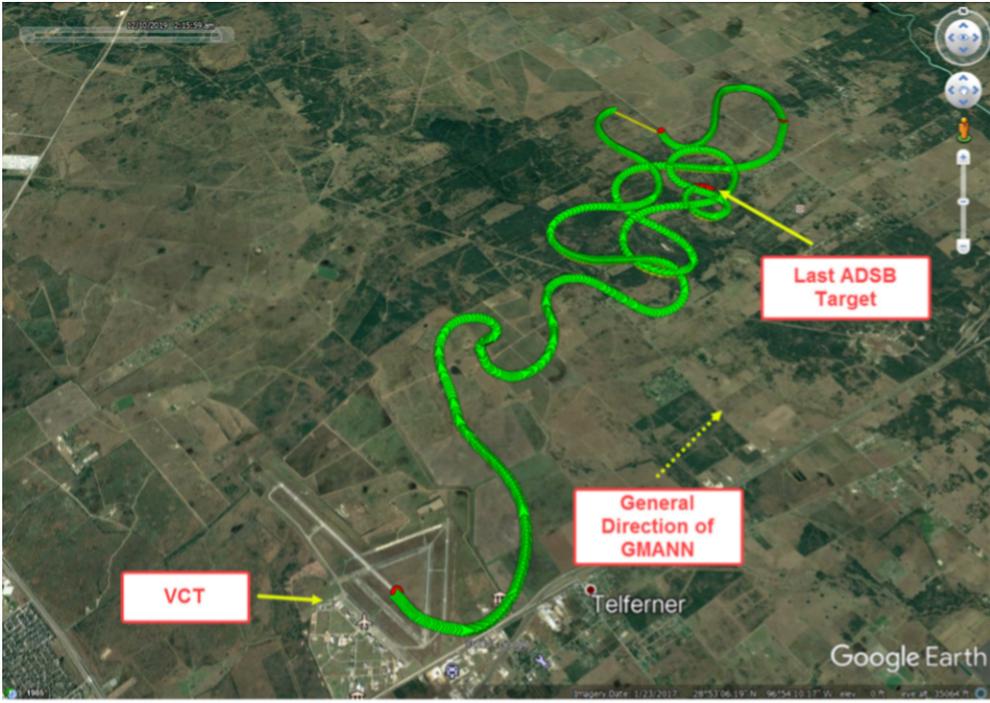
Figure 1. Flight Path of the Airplane

About 2004, the pilot departed VCT and was cleared to 3,000 ft mean sea level (msl). As the airplane climbed through 1,900 ft mean sea level (msl), air traffic control data showed the airplane make a series of fifteen course changes that continued for the remainder of the flight. The course changes alternated between left and right turns, and each involved a heading change of more than 90°. The controller queried the pilot several times concerning the airplane's erratic course changes and assigned the pilot a heading of 035° toward GMANN. The pilot continued to make large turns with erratic altitude and airspeed changes and the pilot often responded to the controller with unintelligible transmissions.

About 2011, the pilot stated that he had "some instrument problems." The controller suggested a return for landing at VCT and the pilot concurred. The pilot was initially cleared for a visual approach to VCT, but when another pilot reported "really hazy" conditions near the airport, the controller notified the pilot he would be given radar vectors and to maintain 3,000 ft msl. The pilot acknowledged these new instructions. The airplane continued to make large turns and subsequently entered a rapid descent, during which radar contact was lost.
