National Transportation Safety Board Aviation Accident Final Report

Location:	Metlakatla, Alaska	Accident Number:	ANC19FA019
Date & Time:	May 20, 2019, 15:56 Local	Registration:	N67667
Aircraft:	De Havilland DHC 2	Aircraft Damage:	Substantial
Defining Event:	Loss of control on ground	Injuries:	2 Fatal
Flight Conducted Under:	Part 135: Air taxi & commuter - Scheduled

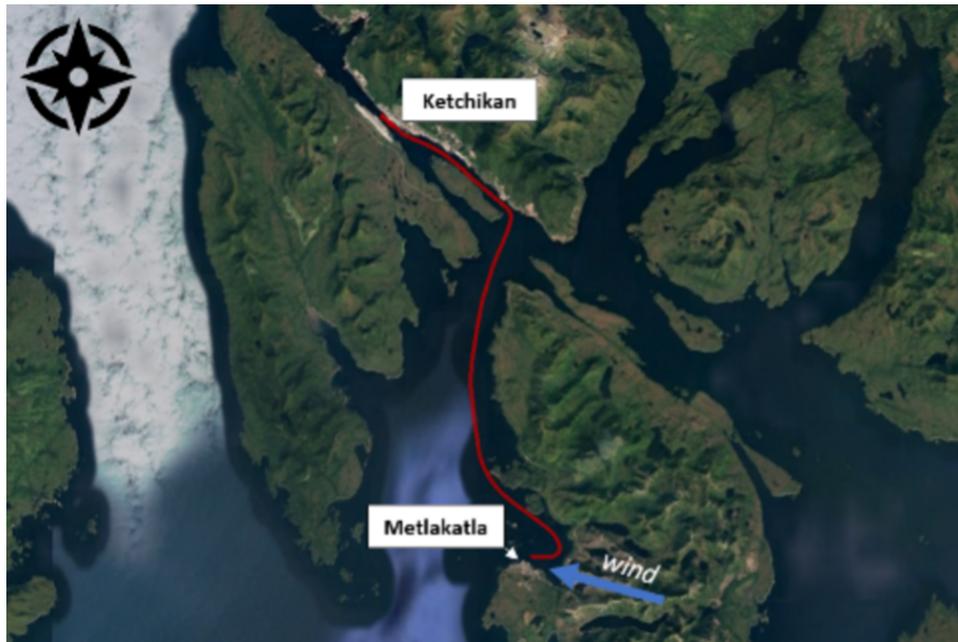
A review of GPS track data revealed that the airplane departed 5KE about 1543 and traveled southeast over an area known as the Tongass Narrows, then south to Metlakatla Harbor at an altitude of about 800 ft. The airplane made a right turn to a 240° (magnetic) heading in the southern portion of the harbor then the data ended. (See figure 1.)

Figure 1. Flight track (red) and wind observation.

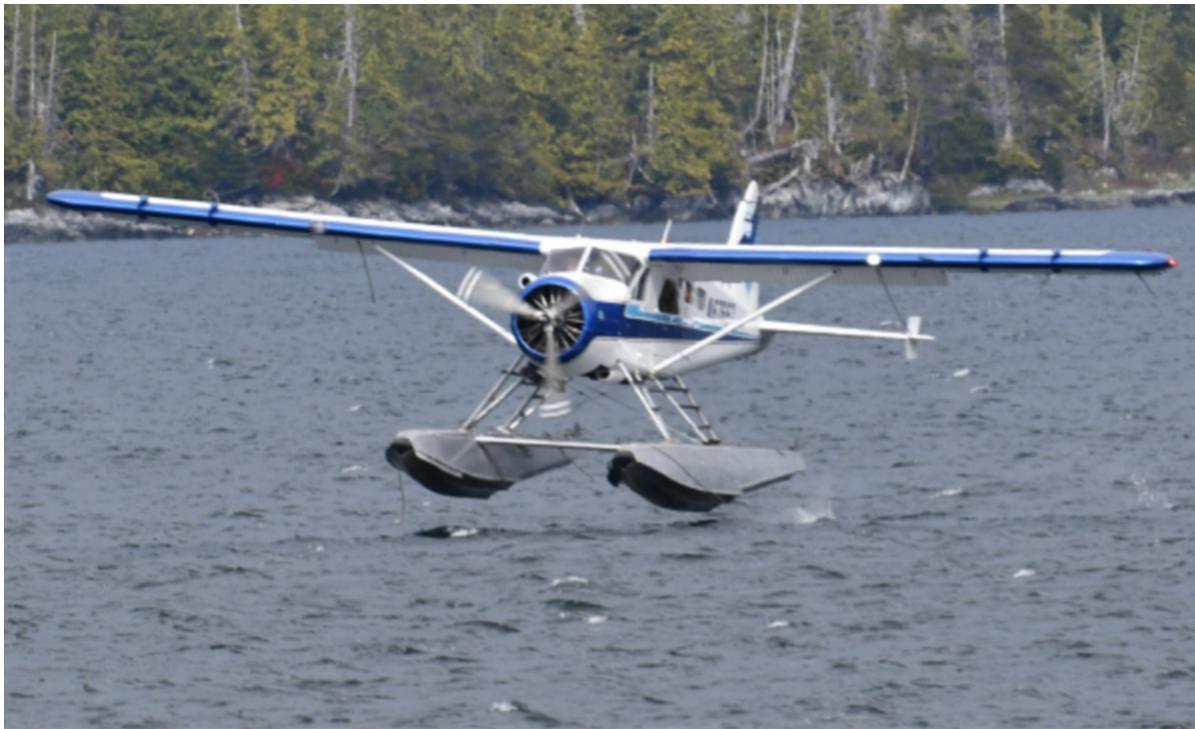
There were three witnesses to the airplane's approach and landing. One of the witnesses, who was taking photographs near the pier, reported that the wind appeared to be pushing the airplane right during touchdown and that the airplane was drifting right as the floats contacted the water. After the airplane skipped once or twice, the left wing "dipped" down, then the right wing "dipped down and dug into the water," which resulted in the airplane nosing over and the right wing separating.

Figure 2. The airplane during the landing sequence after a brief touchdown on the left float. (Source: Nicholas King.)

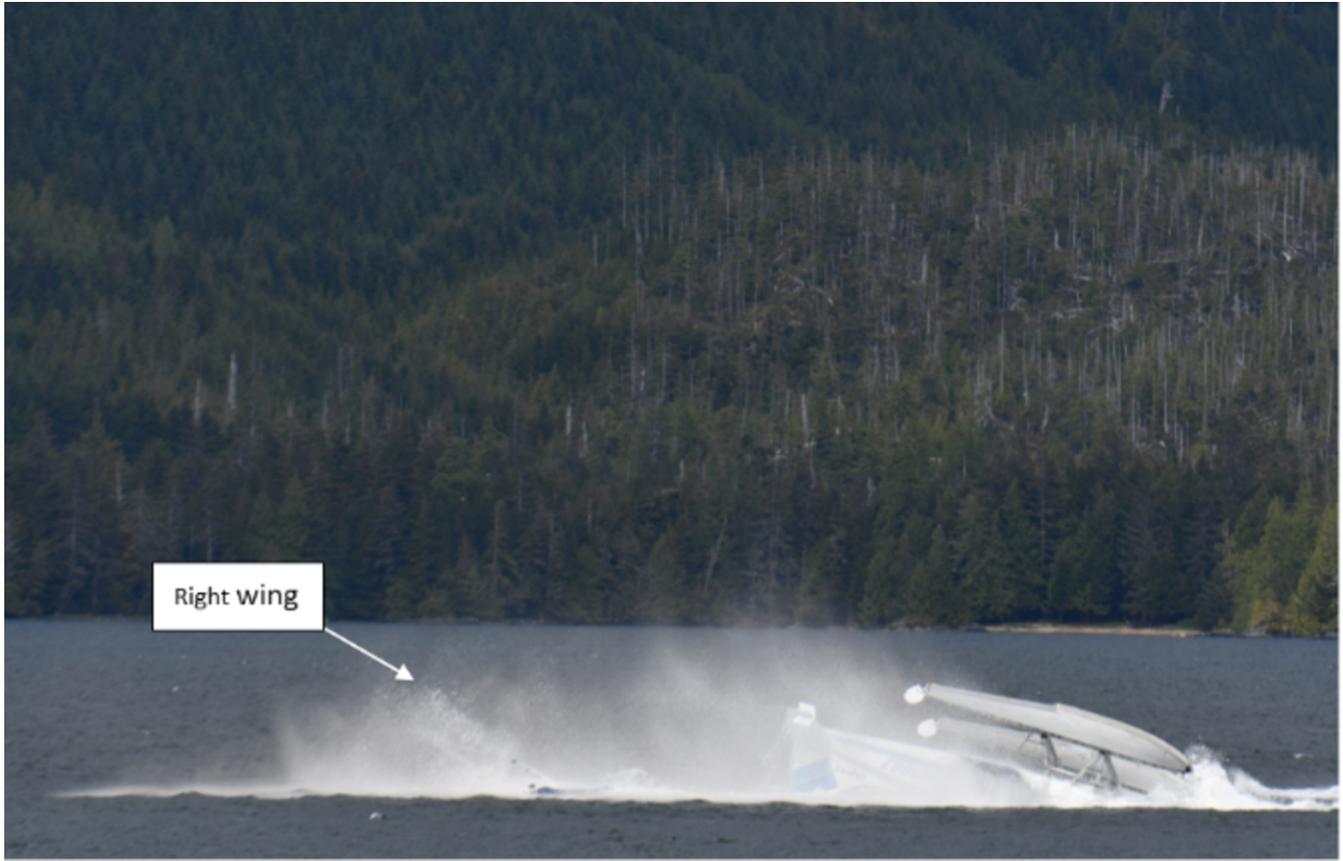
Another witness, who was in a boat, stated that the airplane hit the water hard and he saw the right float "dig into the water" before the airplane turned over as it pivoted around. The third witness stated that the airplane appeared to be "teetering back and forth" and a gust of wind appeared to push the tail upward as the right wing dropped down and the airplane nosed over. She stated that the wind was from the southeast with gusts of 13 mph and the water was less than choppy. The inverted airplane partially sank with the front fuselage and cockpit under water. (See figures 2 and 3.)

Figure 3. The airplane inverted after the accident. (Source: Nicholas King.)

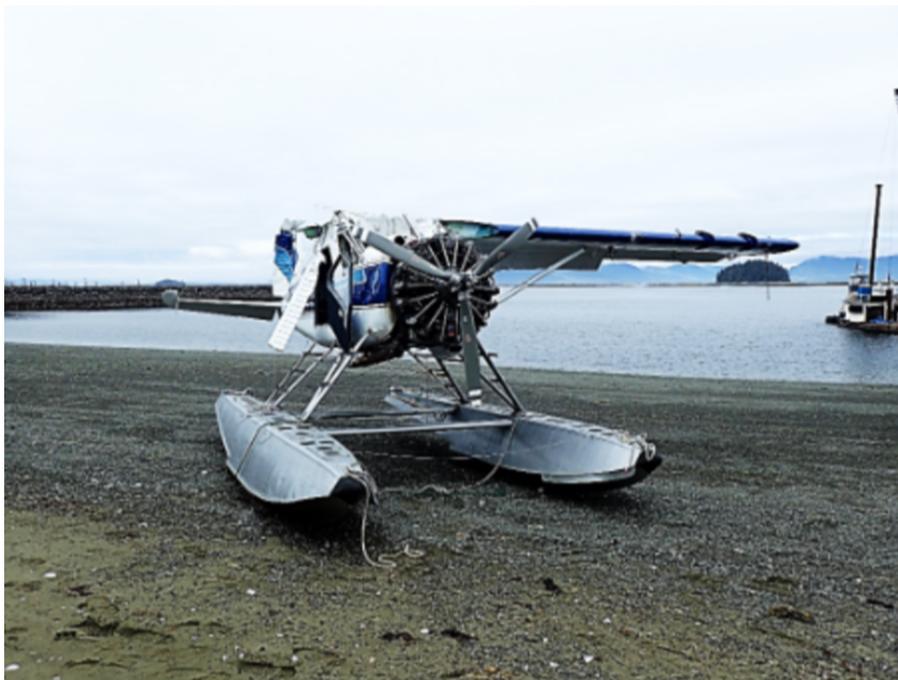
The airplane came to rest inverted on an easterly heading with the right wing separated and floating about 15 ft to the west. First responders stated that the passenger's front right seat was removed to facilitate rescue and subsequently sank in the bay. A postaccident examination of the airframe revealed that all other major components were attached. The floats, float struts, spreader bars, and control cables were intact. The right and left sea rudders were each fractured at the lower welds and exhibited minor bending deformation. (See figure 5.)

Figure 5. The airplane after recovery from the harbor.

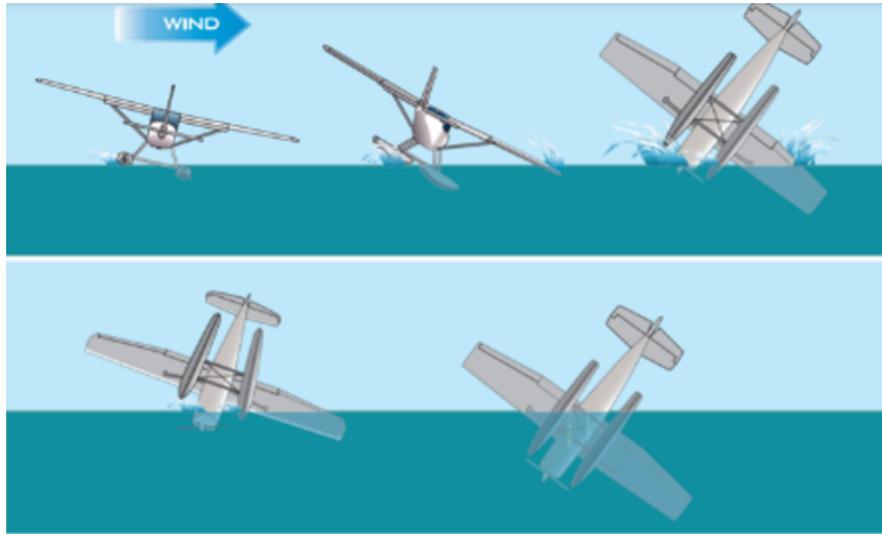
If the seaplane touches down while drifting sideways, the sudden resistance as the floats contact the water creates a skidding force that tends to push the downwind float deeper into the water. The combination of the skidding force, wind, and weathervaning as the seaplane slows down can lead to a

loss of directional control and a waterloop. If the downwind float submerges and the wingtip contacts the water when the seaplane is moving at a significant speed, the seaplane could flip over. See figure 6.3. (Figure 6.)

Figure 6. Figure 6-3 in the FAA Seaplane Handbook illustrating the hazard of landing while drifting sideways in a crosswind at significant speed.
