# Air Transportation Safety Investigation Report A19A0025

## CONTROLLED FLIGHT INTO TERRAIN

Piper PA-46-350P, N757NY

Makkovik Airport, Newfoundland and Labrador, 35 NM SE

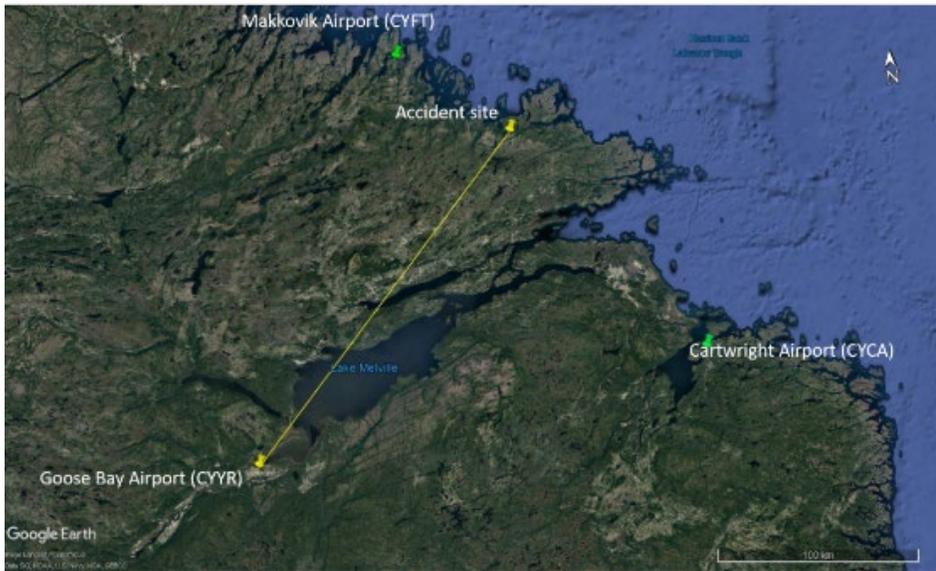
Figure 1. Occurrence flight track (Source: Google Earth, with TSB annotations)

On 01 May 2019 at 0723,<sup>3</sup> the aircraft departed CYR on a VFR flight plan direct to BGBW. The ferry pilot, who was the pilot-in-command, occupied the left seat while the co-owner occupied the right seat. The aircraft climbed to 2000 feet ASL and proceeded on a direct track to destination. The altitude and heading did not change significantly along the route, therefore it is likely that the autopilot was engaged. At 0816, the aircraft collided with a snow-covered hill 2250 feet in elevation, located 35 nautical miles (NM) southeast of Makkovik Airport (CYFT), Newfoundland and Labrador (Figure 1).

The impact happened approximately 200 feet below the top of the hill. The aircraft came to rest in deep snow on steep sloping terrain. The aircraft sustained significant damage to the propeller, nose gear, both wings, and fuselage. Although the cabin was crush-damaged, occupiable space remained. There was no post-impact fire. The ferry pilot was seriously injured and the co-owner was fatally injured.
