# National Transportation Safety Board Aviation Accident Factual Report

<b>Location:</b>	Coleman, Texas	<b>Accident Number:</b>	CEN20FA093
<b>Date &amp; Time:</b>	February 20, 2020, 06:00 Local	<b>Registration:</b>	N860J
<b>Aircraft:</b>	Beech 200	<b>Aircraft Damage:</b>	Destroyed
<b>Defining Event:</b>	Loss of control in flight	<b>Injuries:</b>	3 Fatal
<b>Flight Conducted Under:</b>	Part 91: General aviation - Personal

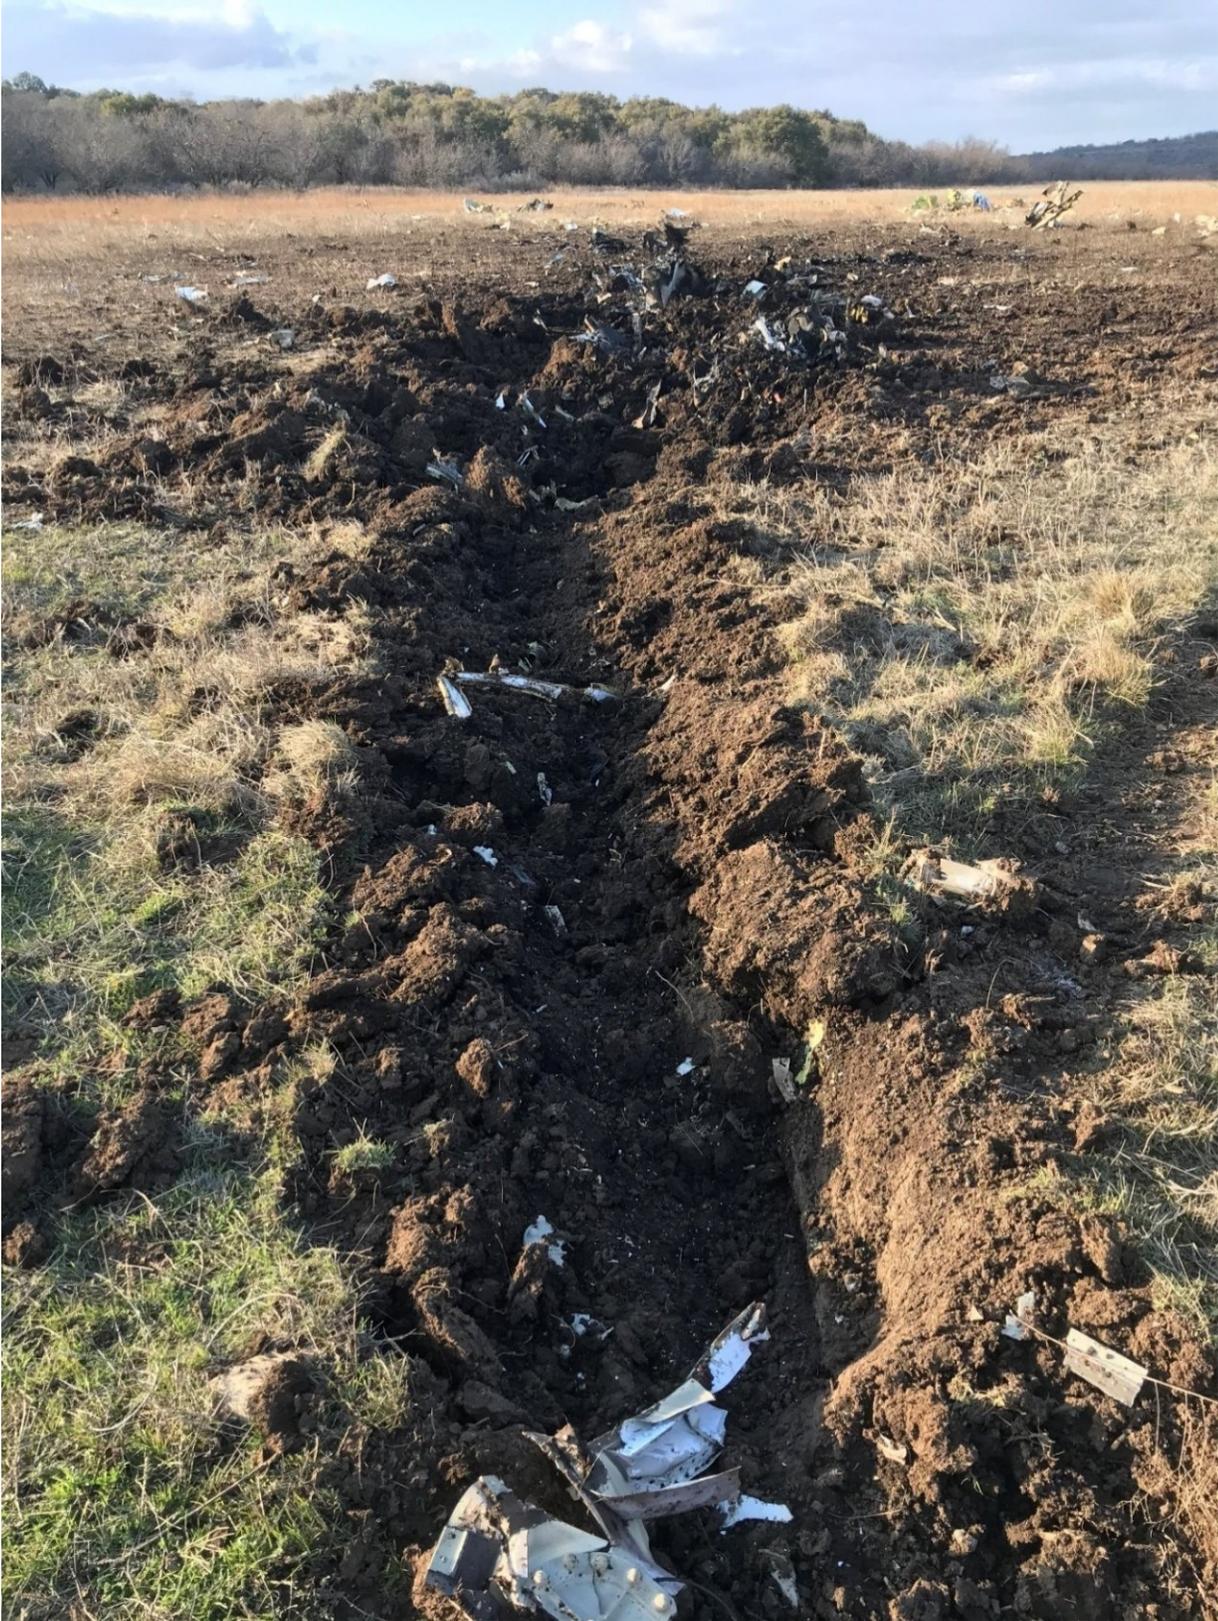
The airplane impacted terrain in a right-wing-low attitude. The wreckage path was oriented on a magnetic heading of 320° and continued for about 570 ft. The wreckage was highly fragmented along the wreckage path. There was a strong fuel odor at the site.

Figure 1: Wreckage path with fragmented wreckage

Various parts of the flight controls were located along the wreckage path. A section of the empennage wreckage contained the rudder, which remained attached; the left and right elevators which also remained attached. The counterweighed tips had impact separated and were located in the debris path. Various pieces of the flight control cables were found in the wreckage path, and continuity could not be established due to the fragmentation of the wreckage. Multiple pieces of both the left and right ailerons were located among the wreckage.

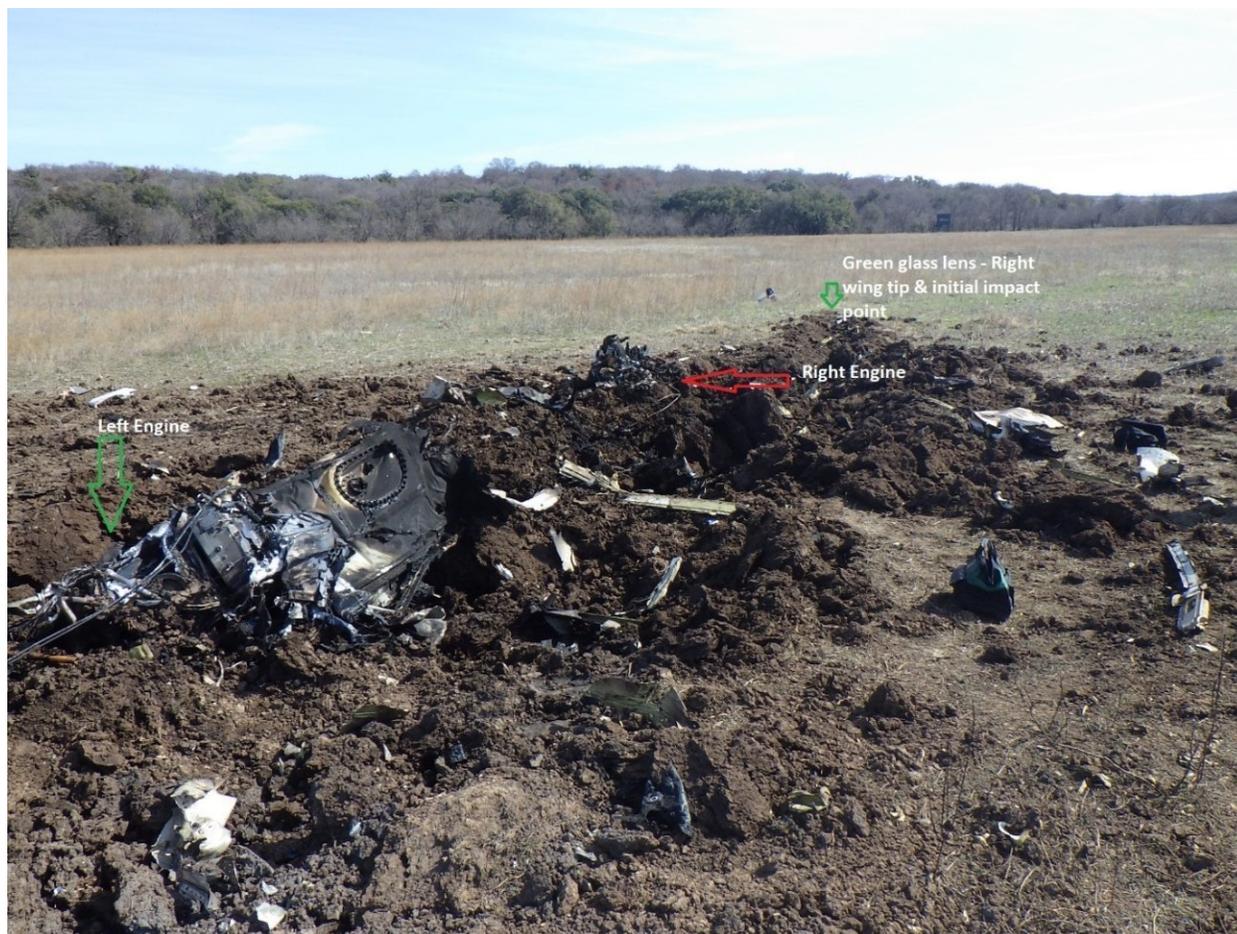
Both engines were either buried or partially buried in the ground, just beyond the initial wing impact point. The right-side engine sustained heavy impact damage: the engine case, accessory gear box, exhaust ducts were crushed, deformed, or fragmented. Disassembly of the engine was conducted in the field; examination of the compressor turbine showed circumferential rubbing wear at the disc and blade firtree serration area from contact with the pressure turbine (1<sup>st</sup> stage) vane ring. The compressor turbine disc downstream side center bore, and lugs showed rubbing wear from contact with the interstage baffle. The compressor turbine shroud segments showed circumferential rubbing wear and corresponding rubbing wear was observed on the compressor turbine blade tips. A visual examination of the 1<sup>st</sup> stage compressor rotor showed several airfoils were bent in the opposite direction of rotation with material observed on the blade tips. The 1<sup>st</sup> stage compressor rotor airfoils showed impact marks on the leading edge.

The left engine was located slightly further along the debris path. The exhaust ducts were still attached to the engine and were crushed, deformed, and folded over the engine exhaust case. The engine also displayed heavy impact damage. Disassembly of the left engine was conducted in the field; examination of the compressor turbine disc found it was fractured at the compressor rear air seal area and released from the compressor. Circumferential rubbing wear was observed on the compressor disc upstream side from contact with the compressor turbine vane ring. The downstream side of the compressor turbine disc showed circumferential rubbing wear across the entire disc face from contact with the 1<sup>st</sup> stage power turbine vane ring and interstage baffle. The compressor turbine blades were fractured and showed secondary impact damage. The fracture surfaces showed evidence of tensile overload. The compressor turbine shroud segments showed circumferential scoring. The corresponding portion of the fracture compressor turbine disc remained inside the engine. The compressor turbine vane ring airfoils showed debris, otherwise no pre-impact distress was observed.

The left and right engine examinations did not identify any pre-impact abnormalities.

Figure 2: Initial impact point and Engines

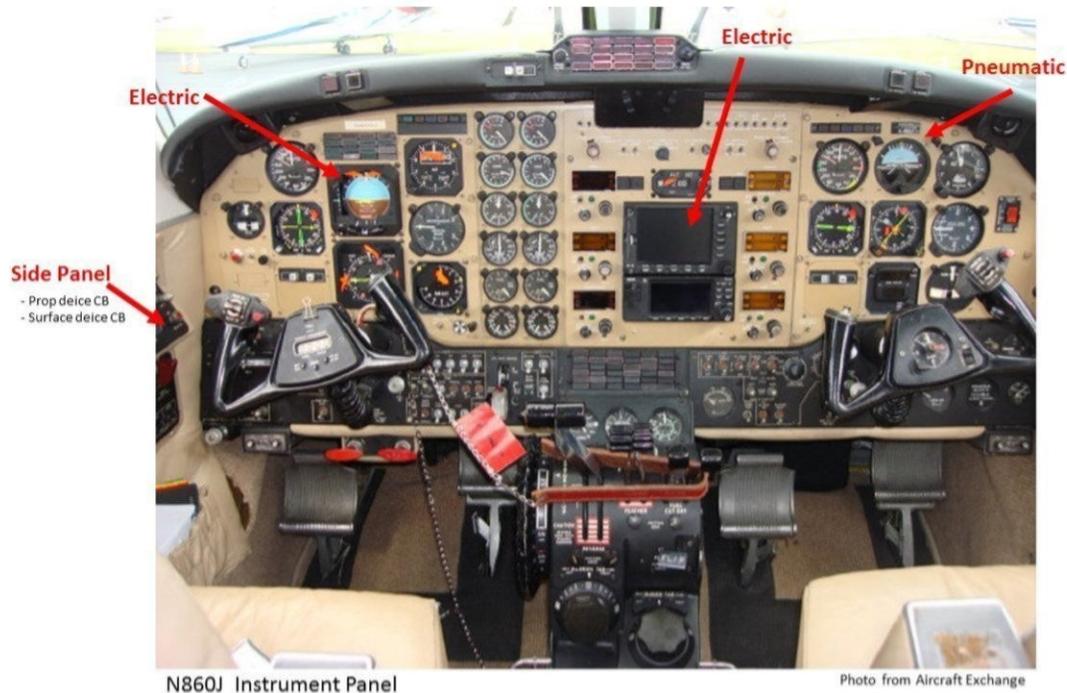
The instrument panel was highly fragmented, with pieces of instruments scattered along the wreckage path. Due to the impact damage, instrument readings and the position of switches and levers in the cockpit were not considered reliable. The right-side pneumatic attitude indicator was located; the instrument had impact separated from the panel and displayed heavy impact damage. The rotor/gyro was outside of the case; light circumferential scoring/rubbing was noted. A remote gyro unit was in the debris path. The unit also had heavy impact damage with circumferential scoring/rubbing on the rotor/gyro system.

Figure 3: N860J panel
