National Transportation Safety Board Aviation Accident Final Report

Location:	Elizabethton, Tennessee	Accident Number:	ERA19FA248
Date & Time:	August 15, 2019, 15:37 Local	Registration:	N8JR
Aircraft:	Textron Aviation Inc 680A	Aircraft Damage:	Destroyed
Defining Event:	Runway excursion	Injuries:	3 Minor, 2 None
Flight Conducted Under:	Part 91: General aviation

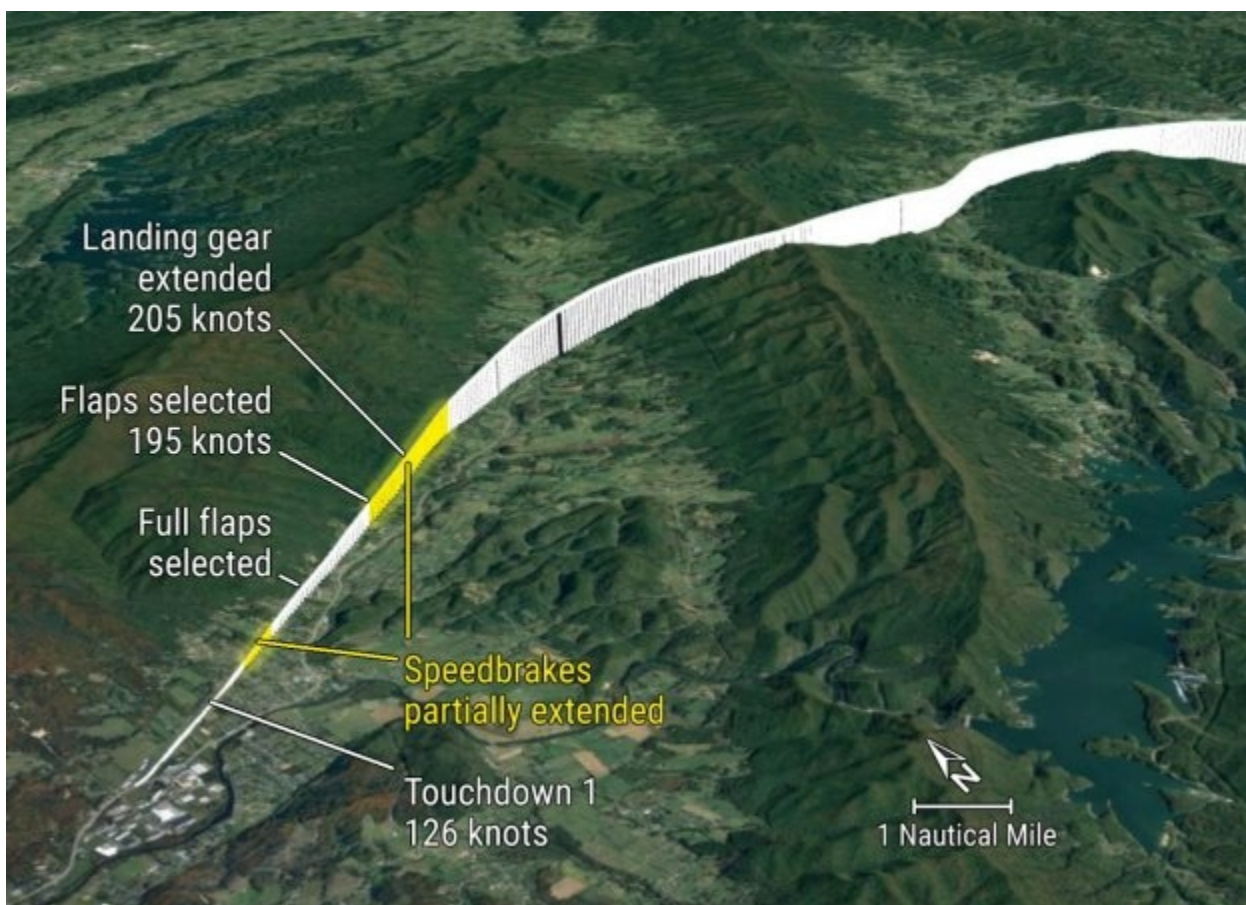
Figure

: N8JR's approach, including speed and use of

speedbrakes

(in

yellow

), landing gear,

and flaps.

As the flaps were extending, the TAWS forward looking terrain alert rate of terrain closure caution alert sounded twice (at 1536:59 and at 1537:09), then a warning alert sounded (at 1537:11). The airplane was at an altitude of 2,159 ft msl (471 ft agl). Following these alerts, the copilot selected full flaps and the descent rate and airspeed decreased. At 1537:26, the copilot stated, "and I don't need to tell ya, we're really fast," and the pilot responded, "I'm at idle." Six seconds later, the pilot asked, "do I need to go around?" and the copilot responded, "no." At 1537:31, about 270 ft agl, the speedbrakes were partially extended for 5 seconds (to 140 ft agl). The pilot then stated, "I got the speed brakes out," to which the copilot responded, "well you should get rid of those because we don't wanna get a CAS [Crew Alerting System] m- or a thing sent to ya." Eight seconds before touchdown, at 1537:41, the pilot stated, "alright, I'll be on the T-Rs [thrust reversers] quickly." For the computed airplane weight, the reference speed (V_{ref}) for the final approach was 108 knots; the airplane's airspeed at the runway's displaced threshold was 126 knots. Five seconds before touchdown, the airplane's descent rate was over 1,500 ft per minute (fpm).

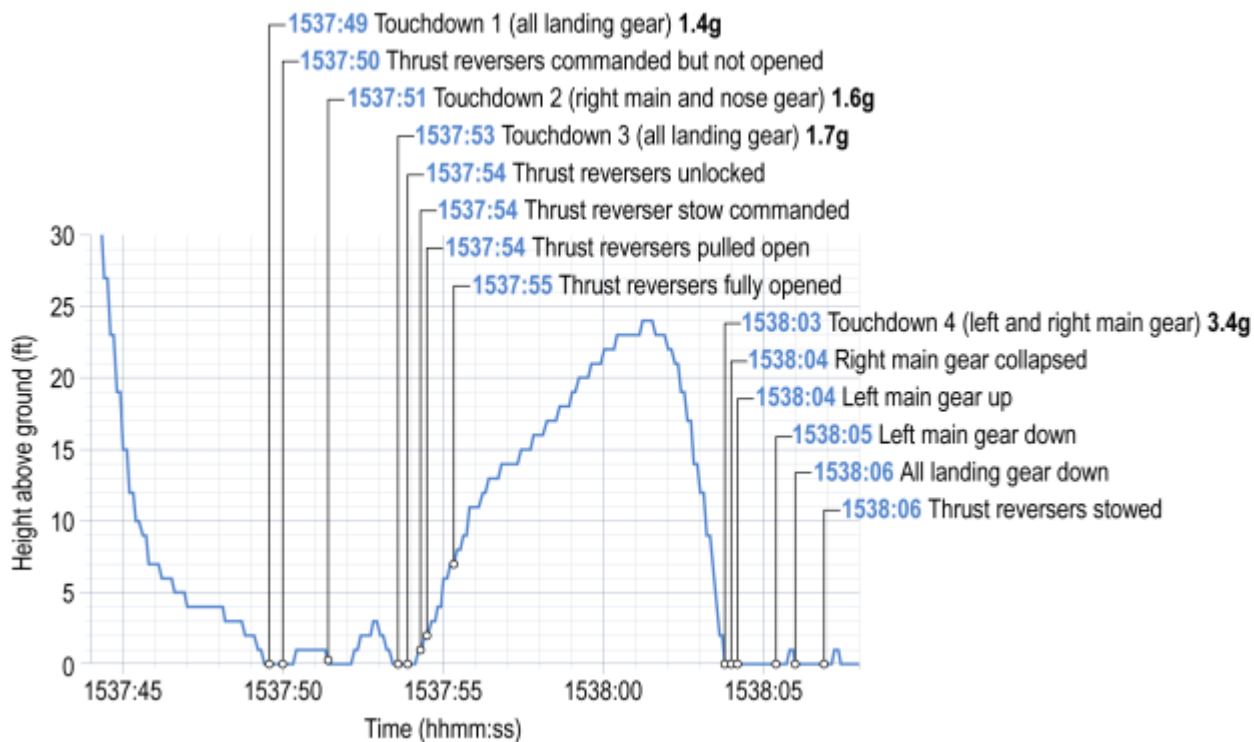
Figure 2. Graph depicting the airplane's thrust reverser actions, landing gear touchdowns, and vertical acceleration (bold) during its bounced landing.

When the airplane touched down initially at 1537:49, it was travelling 126 knots (18 knots above V_{ref}) and had a descent rate of 600 fpm (the maximum allowed per the airplane flight manual [AFM]). All three landing gear registered "on-ground" simultaneously with a vertical acceleration of 1.4 gravitational acceleration (g), and thrust reverser deployment was commanded 0.4 second after the landing gear first touched the ground as the throttles were moved to the reverse idle position; however, the airplane bounced after touching down for 0.6 second and was airborne again before the thrust reverser command could be executed.

When the airplane touched down a second time, 1.2 seconds later at 1.6 g, the nose landing gear touched down first, followed immediately by the right main landing gear. The left main landing gear never registered on-ground during the touchdown, and the airplane bounced and became airborne again after 0.4 second.

The airplane touched down a third time, 1.8 seconds later at 1.7 g and about 1,000 ft down the runway with about 3,100 ft of paved surface remaining. The thrust reversers unlocked 0.4 second after all three landing gear registered on-ground because the reverser deployment command from the first touchdown was still active. Almost immediately after the thrust reversers unlocked, the pilot advanced the throttles to idle, sending a thrust reverser stow command at 1537:54; however, the landing gear status changed to "in-air" almost simultaneously when the command was executed.

The airplane bounced after 0.6 second and became airborne a third time, and the in-air landing gear status triggered a cut in hydraulic power to the thrust reverser actuators, which is intended to prevent the

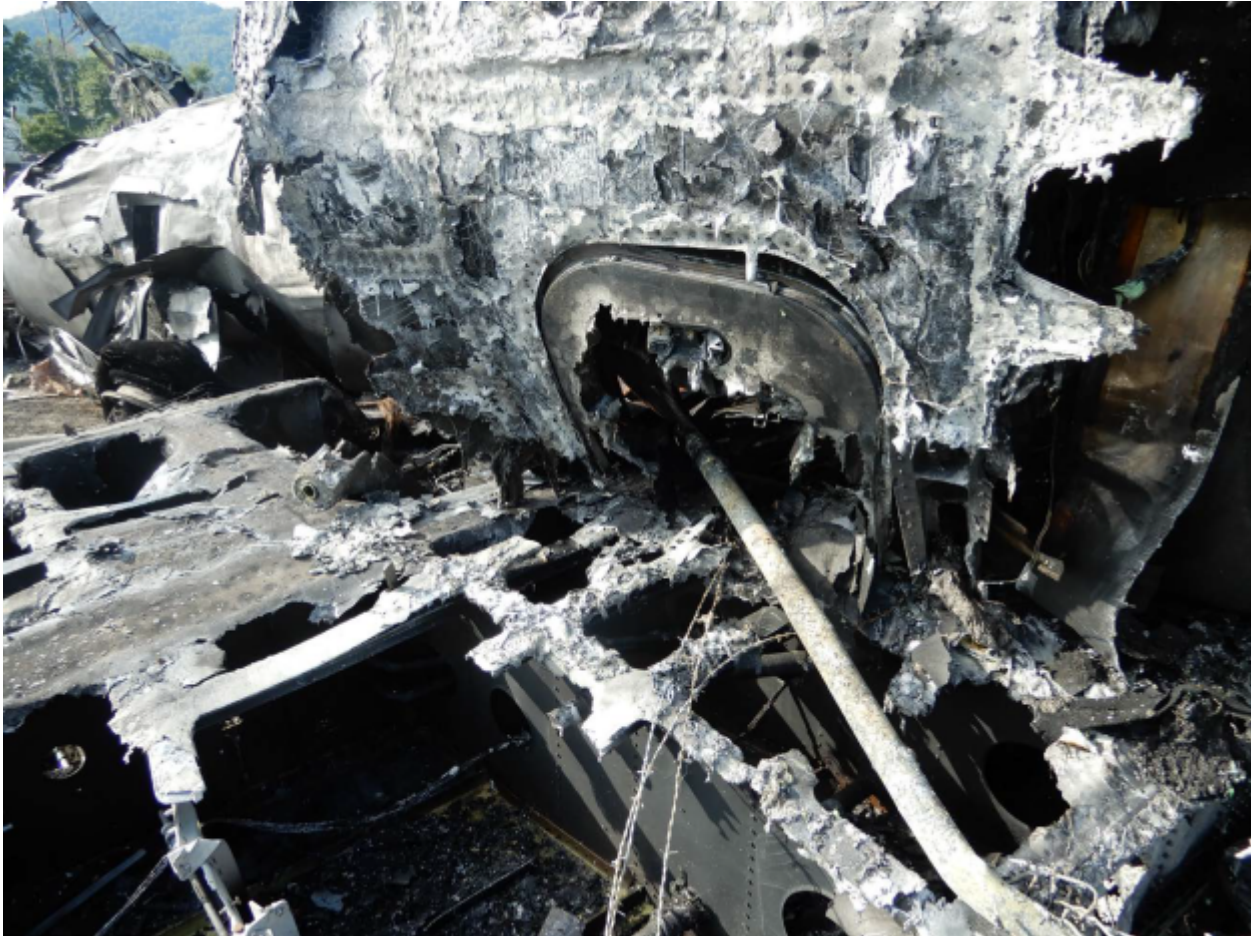
The pilots and passenger continued to struggle with the emergency escape hatch and observed heavy smoke coming from the lavatory, followed by flames. The copilot attempted to open the cabin entry door a second time, and he was able to push the door partially open with enough clearance to get all the occupants out. In a postaccident interview, the copilot reported that the exterior handle was likely pushing against the ground at the time, preventing it from opening fully.

Figure 3: Emergency escape hatch impaled by a metal fence post.
