# National Transportation Safety Board Aviation Accident Factual Report

<b>Location:</b>	Aniak, Alaska	<b>Accident Number:</b>	ANC20LA050
<b>Date &amp; Time:</b>	May 28, 2020, 16:00 Local	<b>Registration:</b>	N909AK
<b>Aircraft:</b>	Rockwell 500	<b>Aircraft Damage:</b>	Substantial
<b>Defining Event:</b>	Wrong fuel	<b>Injuries:</b>	4 Serious
<b>Flight Conducted Under:</b>	Public aircraft

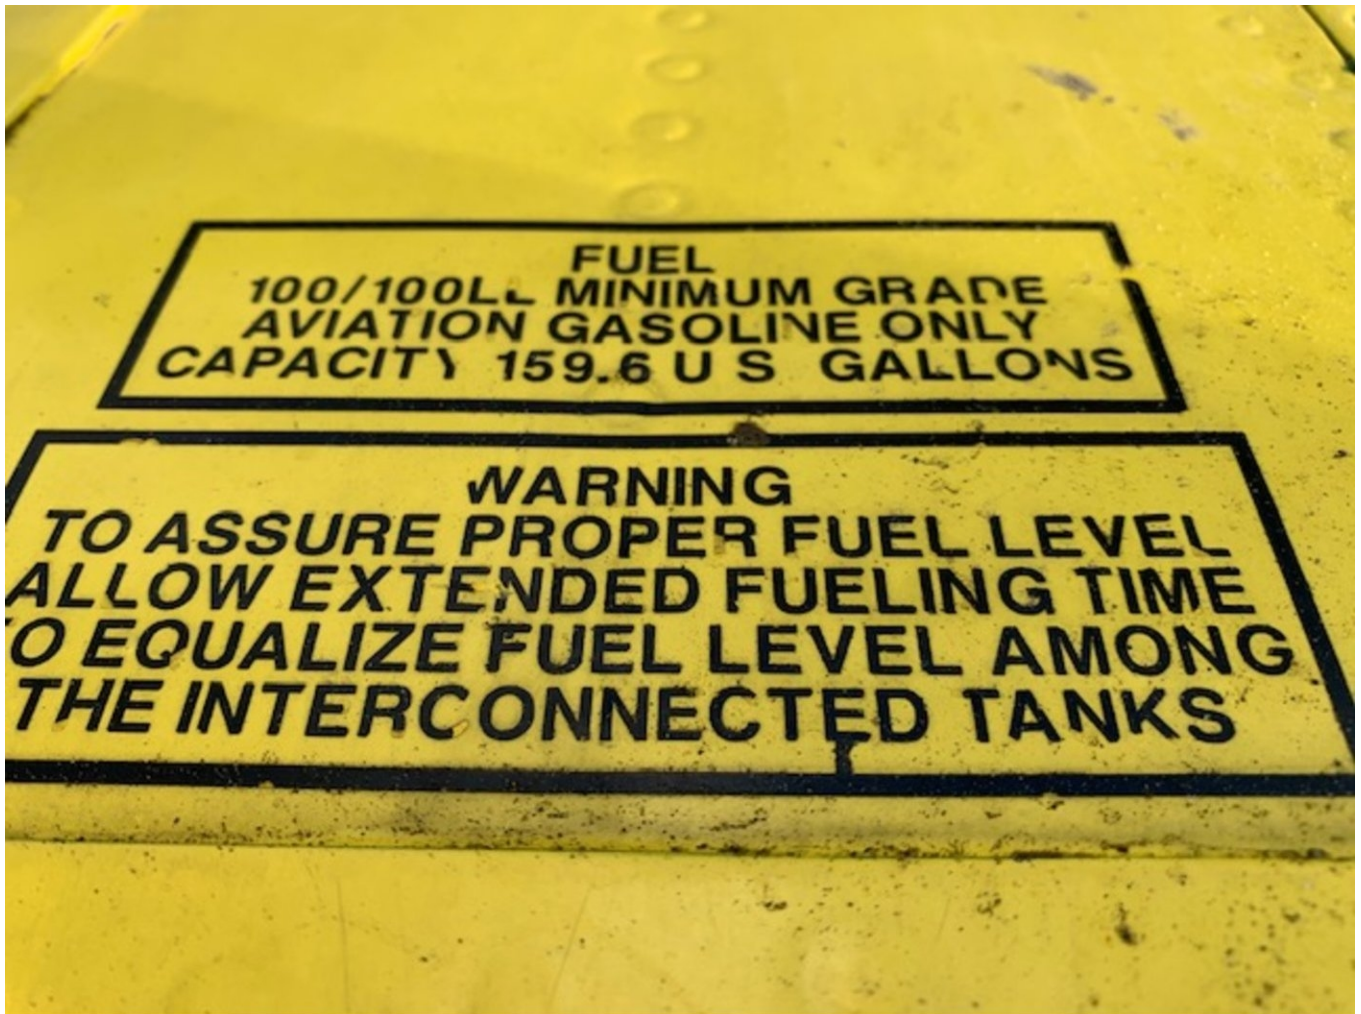
The fueler reported that he was unfamiliar with the airplane, so he queried the pilot as to where he should attach the grounding strap and the location of the fuel filler port. Before starting to refuel the airplane, he asked the pilot "do you want Prist with your Jet" to which the pilot responded that he did not. After completing the refueling process, he returned to his truck, wrote "Jet A" in the meter readings section of the prepared receipt, and presented it to the pilot for his signature. The pilot signed the receipt and was provided a copy. The fueler stated that he later added "no Prist" to his copy of the receipt, and that he did not see a fuel placard near the fueling port.

A postaccident examination revealed that the reciprocating engine airplane had been inadvertently serviced with Jet A fuel. A slightly degraded placard near the fuel port on the top of the wing stated, in part: "FUEL 100/100LL MINIMUM GRADE AVIATION GASOLINE ONLY CAPACITY 159.6 US GALLONS." (see Figure 1.)

Figure 1 - Fuel placard on accident airplane located near fueling port.
