FINAL REPORT ON ACCIDENT TO
M/s ACSPL CESSNA CITATION 560XL
AIRCRAFT VT-AVV ON 27TH AUG 2019
AT ALIGARH AIRFIELD, UTTAR PRADESH

FINAL INVESTIGATION REPORT ON ACCIDENT TO M/s AIR CHARTER SERVICES CESSNA CITATION 560XL AIRCRAFT VT-AVV AT ALIGARH ON 27/08/2019

On 27.08.2019, Cessna Citation 560XL aircraft VT-AVV of M/s Air Charter Services Pvt Ltd (ACSPL) while operating a non-scheduled flight from Delhi to Aligarh met with an accident during landing at Dhanipur Airstrip, Aligarh. There were 4 passengers and 02 crew members on board the aircraft. There was no injury reported to any person on board aircraft.

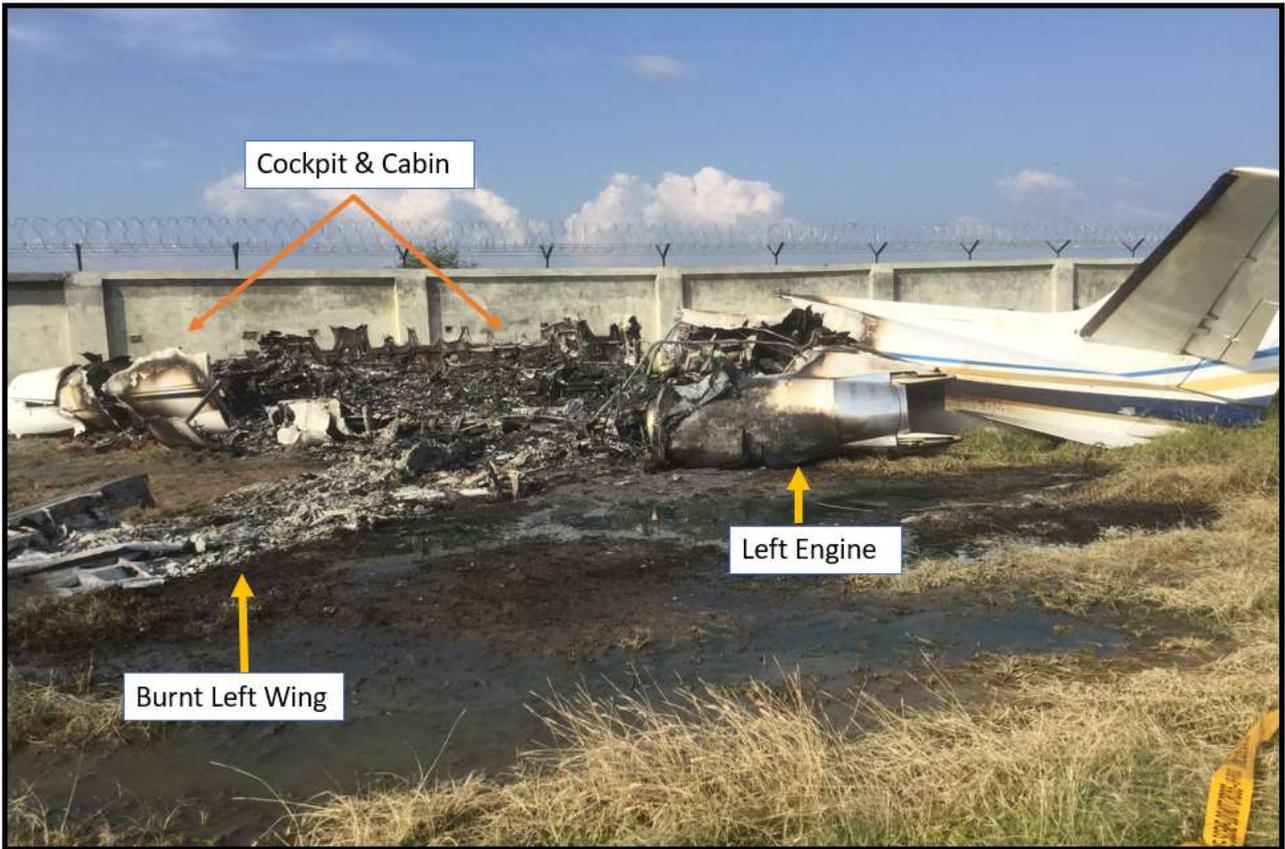
The aircraft wing and fuselage impacted the ground on extended portion of runway ahead of the threshold of RWY 11. Various aircraft parts (landing gears, wing high lift devices and components of the lower fuselage) were damaged after touchdown and were found scattered throughout the aircraft track.

The cockpit, LH wing and aircraft cabin were destroyed due to the post crash fire.

Fig-1: Port Side View of VT-AVV

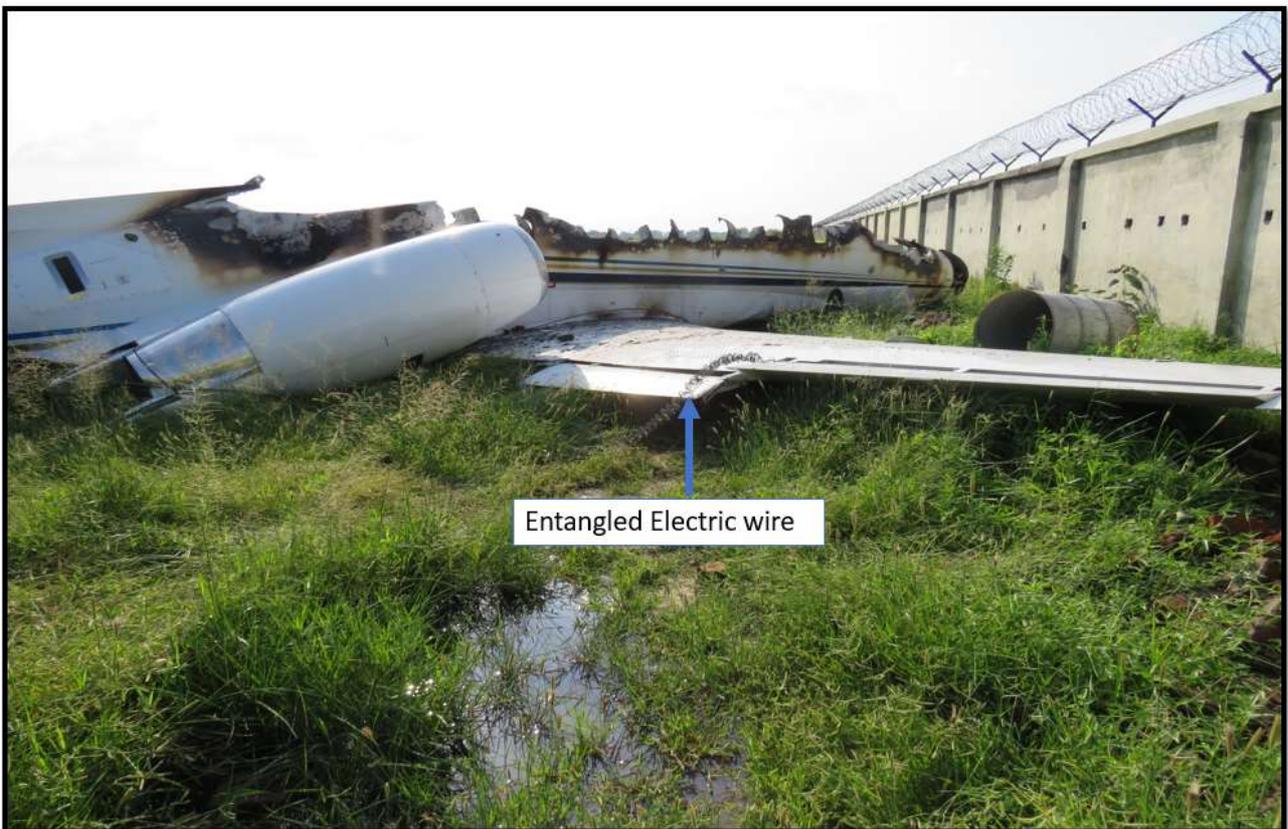
Fig-2 : Starboard View of VT-AVV

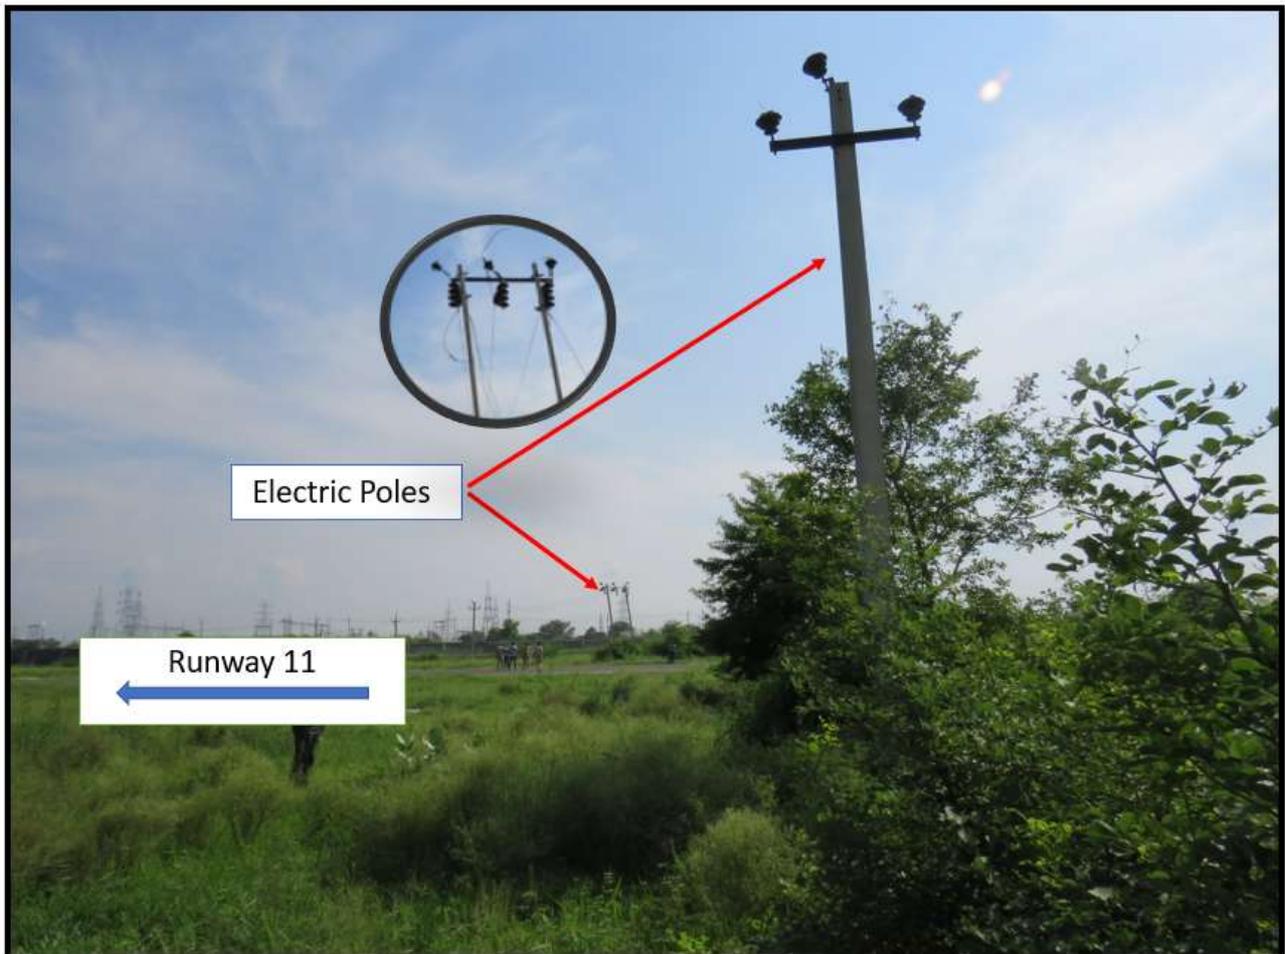
Before touchdown, the aircraft MLG got entangled with overhead powerlines which were crossing the under construction extended runway. Following damages were observed:

- (a) High tension powerlines crossing the extended portion of the runway 11 were damaged.
- (b) The insulators fitted on electrical poles were found bent in the direction of involved flight.

Note: The powerlines were not carrying power at the time of impact.

Fig-3: Electrical Cable Installations on Runway Strip 11

4.2 DGCA shall issue instructions to all airports to remove all the hazardous installations before carrying out any civil work on runway.

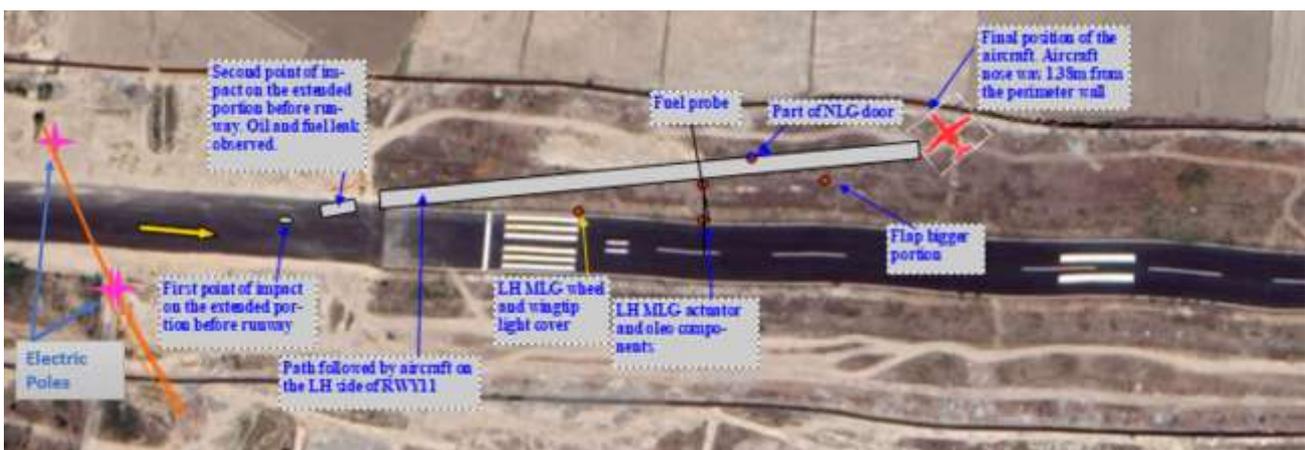
- (a) The first point of impact was located at a distance of 104m ahead of the transverse marking at threshold of RWY11.
- (b) The second point of impact was located at a distance of 91m ahead of the transverse marking of threshold RWY11. From this point onwards, fuel / oil stains were observed on the paved surface.
- (c) Pieces of broken powerlines were found throughout the track followed by the aircraft.
- (d) Lower wing access panel and portion of antenna were found at a distance 43m on the track followed by the aircraft.

Fig-6: Wreckage distribution diagram

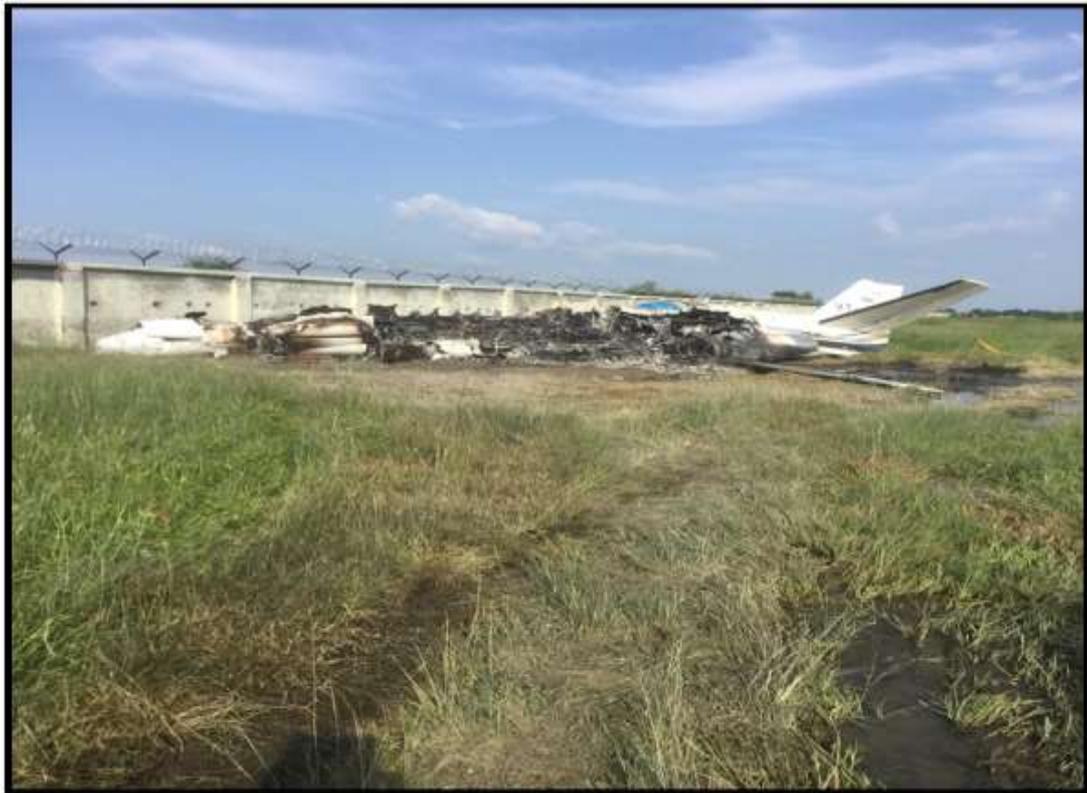
Fig-7: Final Rest Position of the Aircraft

(h) At the final rest position, the aircraft nose was at distance of 1.38m from the perimeter wall and orientation had changed approximately 120° w.r.t. approach direction.

(j) Landing gears were found collapsed and the aircraft fuselage and wing were in contact with the ground. The RH MLG actuator link was found to have broken. One powerline was found entangled on RH wing and passing below the fuselage and entangled with the LH wing. The final location of the aircraft was approximately 260 m from the first point of contact.

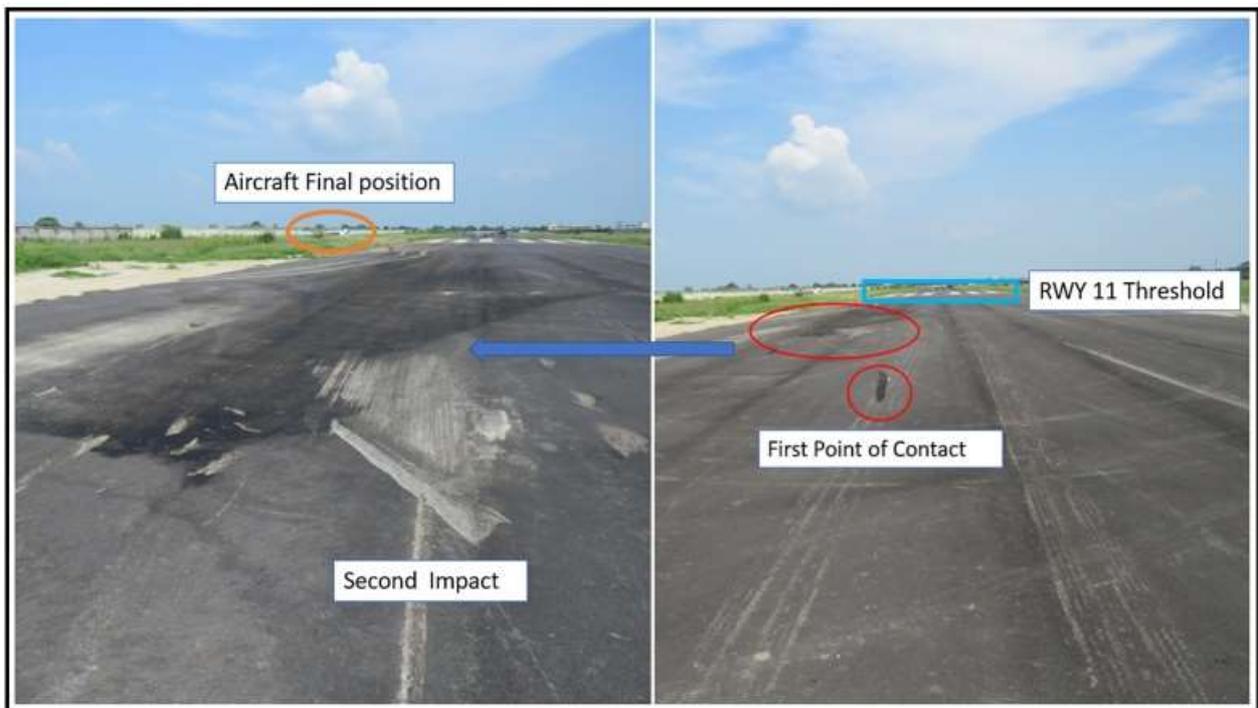
Fig-8: Landing Gear Tyre Markings on Runway

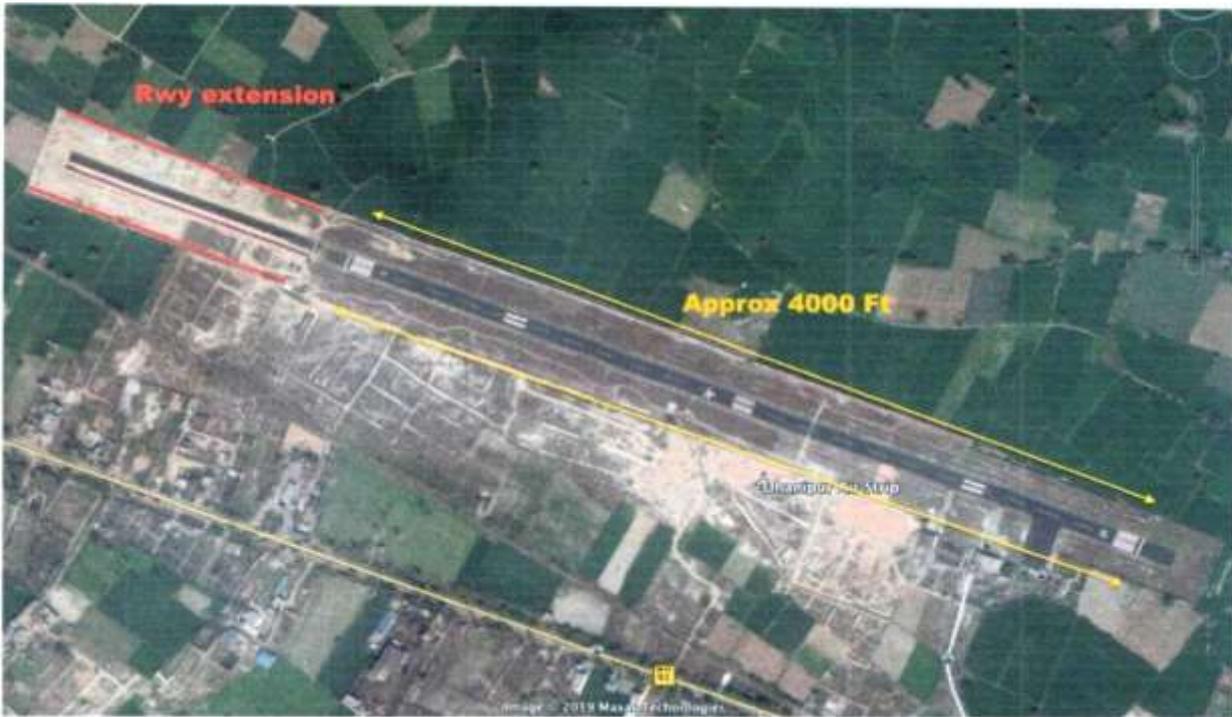
Presently, the runway length is being extended. The total length of runway under extension ahead of transverse line marking from threshold is 415 m. However, the estimated date of completion of runway extension is not available. Further, there are no markings/signs available to indicate status of extended portion of runway. There is no ATC available at the airport.

- (a) Since this is a 'DAY VFR OPS ONLY' airport, anytime visibility is less than 5 km, delay arrival
- (b) Look out for local Flying by Training Aircraft Fairly intense mostly on Cessna -172.
- (c) Look out for Power cable on Rwy 11 approach/ Extension. Also, caution for men and material on undershoot of Rwy 11. It's preferable to use Rwy 29, winds permitting.
- (d) **Extended portion of the runway is not to be used.**

Fig-10: Extension Work of Runway
