# **FINAL INVESTIGATION REPORT**

***ACCIDENT INVOLVING  
M/S AIR INDIA EXPRESS LIMITED  
B737-800 AIRCRAFT VT-AXH  
ON 07 AUGUST 2020 AT KOZHIKODE***

**AIRCRAFT ACCIDENT INVESTIGATION BUREAU  
MINISTRY OF CIVIL AVIATION  
GOVERNMENT OF INDIA**

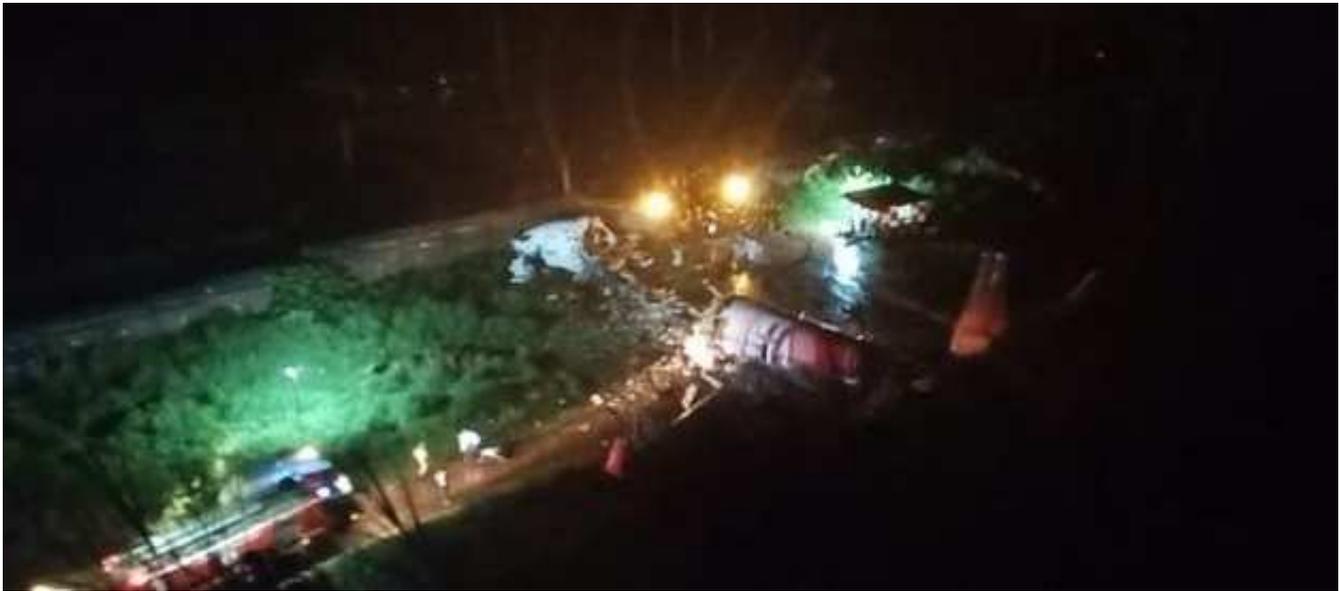
*Figure 1: One of the first images of accident site before commencement of ARFFS Operations.*

plummeting down the tabletop runway. The aircraft fell to a depth of approximately 110 ft below the runway elevation and impacted the perimeter road that runs just below the tabletop runway, at a ground speed of 42 Kt. Aircraft came to an abrupt halt on the airport perimeter road, close to the perimeter wall. There was no post accident fire. The impact caused the aircraft to separate into three sections and resulted in 21 fatalities including both pilots.

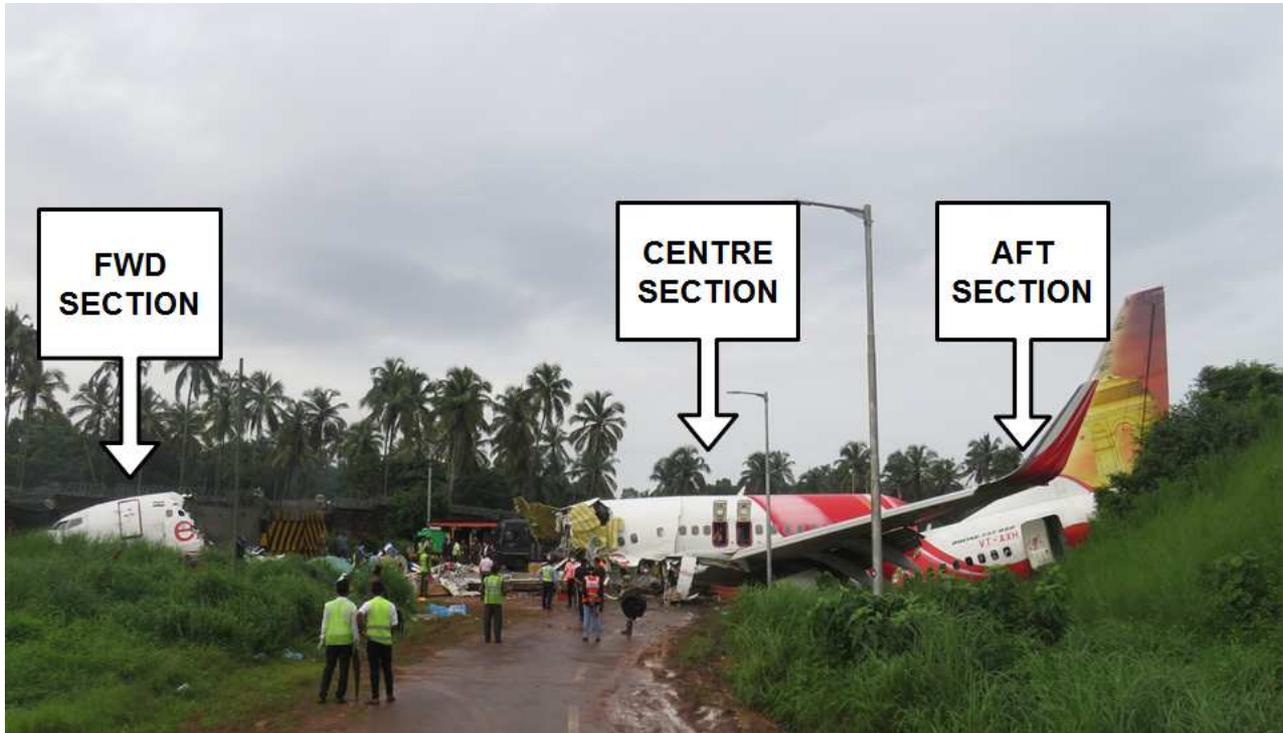
Figure 2: Aircraft broken into three sections.

Aircraft was completely destroyed in the accident and the fuselage split into three sections. Detailed information is given in 1.12 – Wreckage and Impact information.

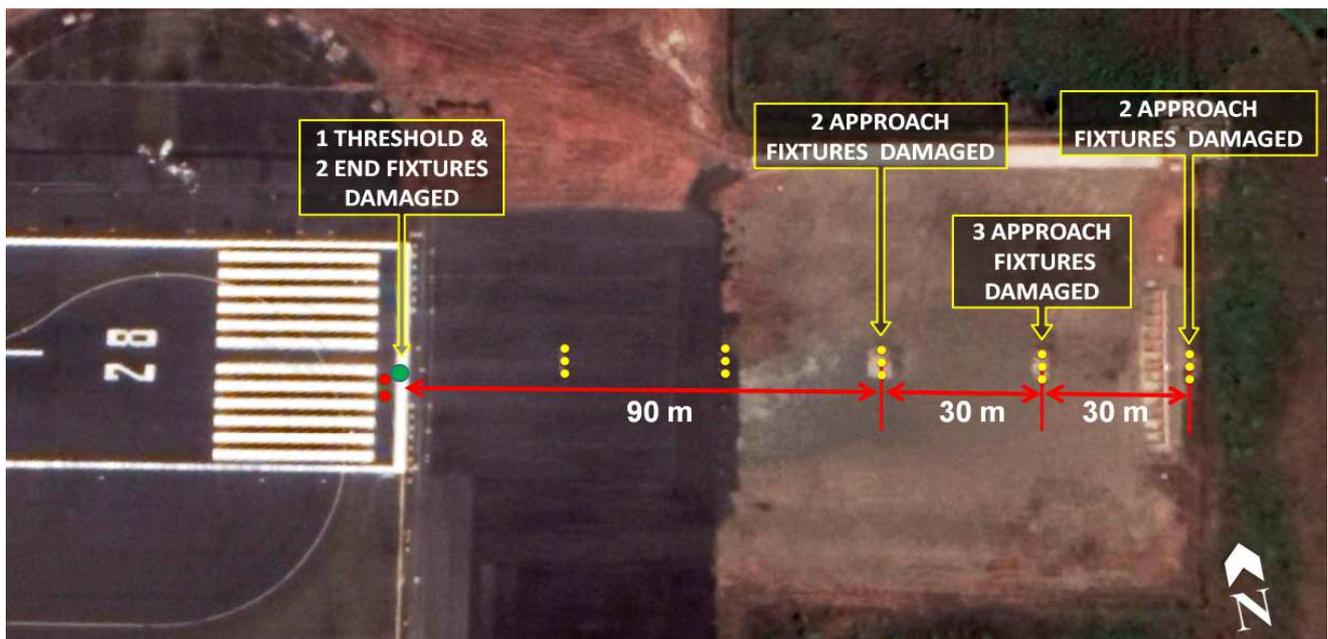
Figure 3: The location of the damaged lights in RESA.

- (a) 02 Runway End Lights and 01 Threshold Light was damaged by the aircraft wheels.
- (b) 03 units of SALS were partially damaged by the aircraft wheels.

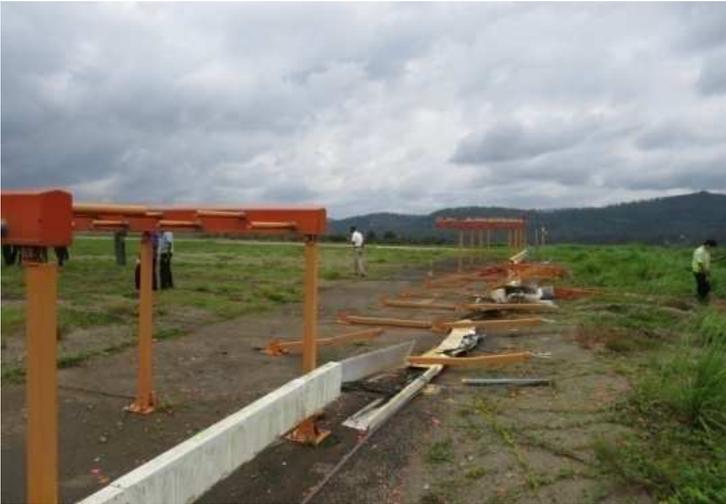
*Figure 4: Damage to ILS Localiser Antenna*

- (c) Localiser Antenna Array was damaged when the aircraft went through the array.
- (d) Runway Area Perimeter Fence was damaged due to impact with aircraft as it slid down the slope after overshooting the runway and RESA.

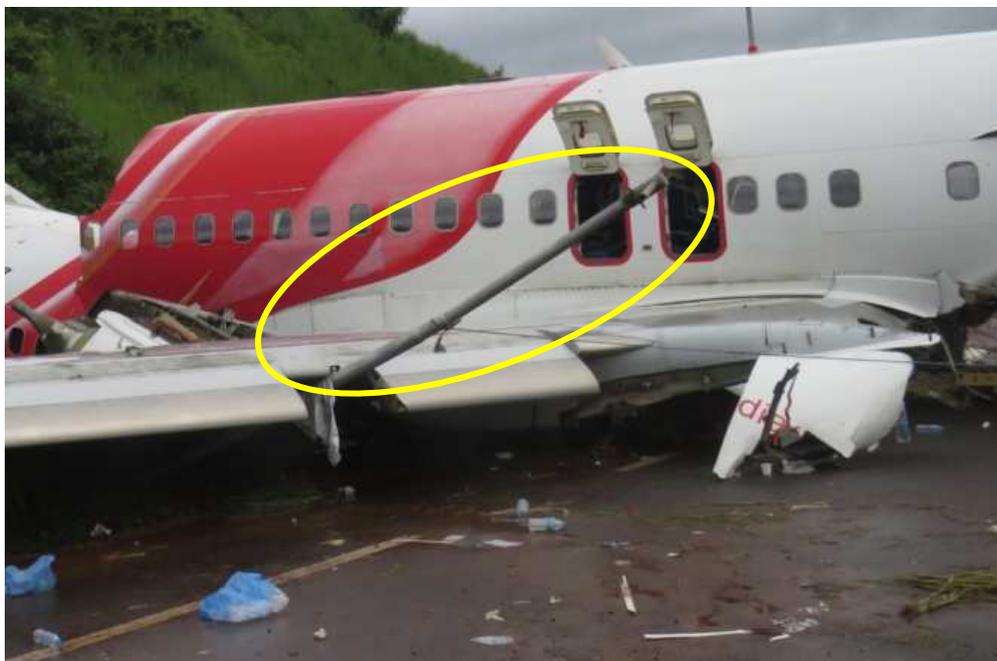
*Figure 6: Lamp post broken by impact with right wing*

- (e) A lamp post on the perimeter road was also broken due to impact with the right wing of the aircraft.

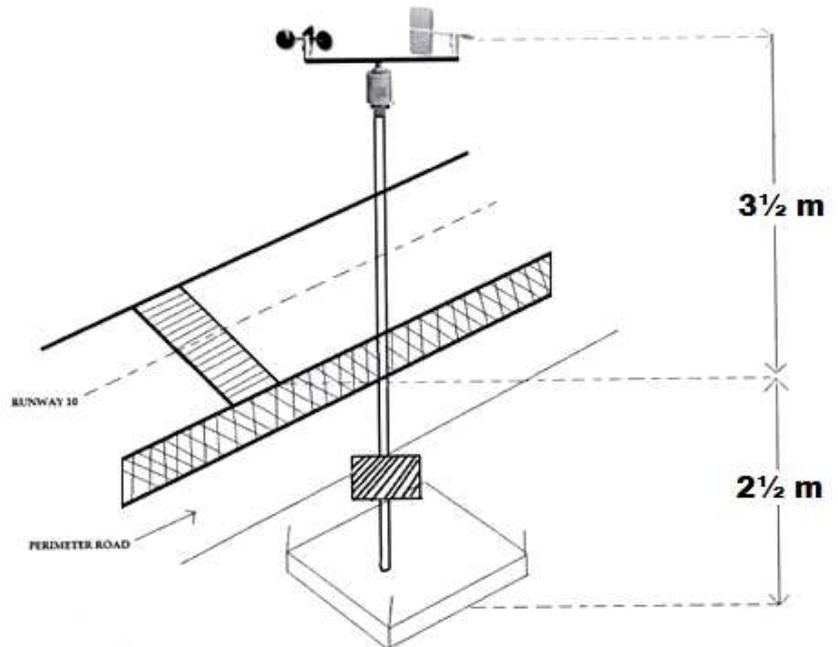
Figure 13: Anemometer installation for Runway 10

As per CAR issued by DGCA (CAR Section 9 - Air Space and Air Traffic Management, Series M, Part I, Issue II, 24 March, 2017, Rev. 2, 08 November, 2018) and ICAO Annex 3, the height of the Anemometer for reporting surface wind and directions shall be 10 m (+/- 1 m). However, the height of anemometer for Runway 10 is 6 m and it is installed on a platform 2.5 m below the runway surface. Hence, the effective height of the Anemometer above the runway surface for runway 10 is just 3.5 m. The same is depicted in the figure 13.

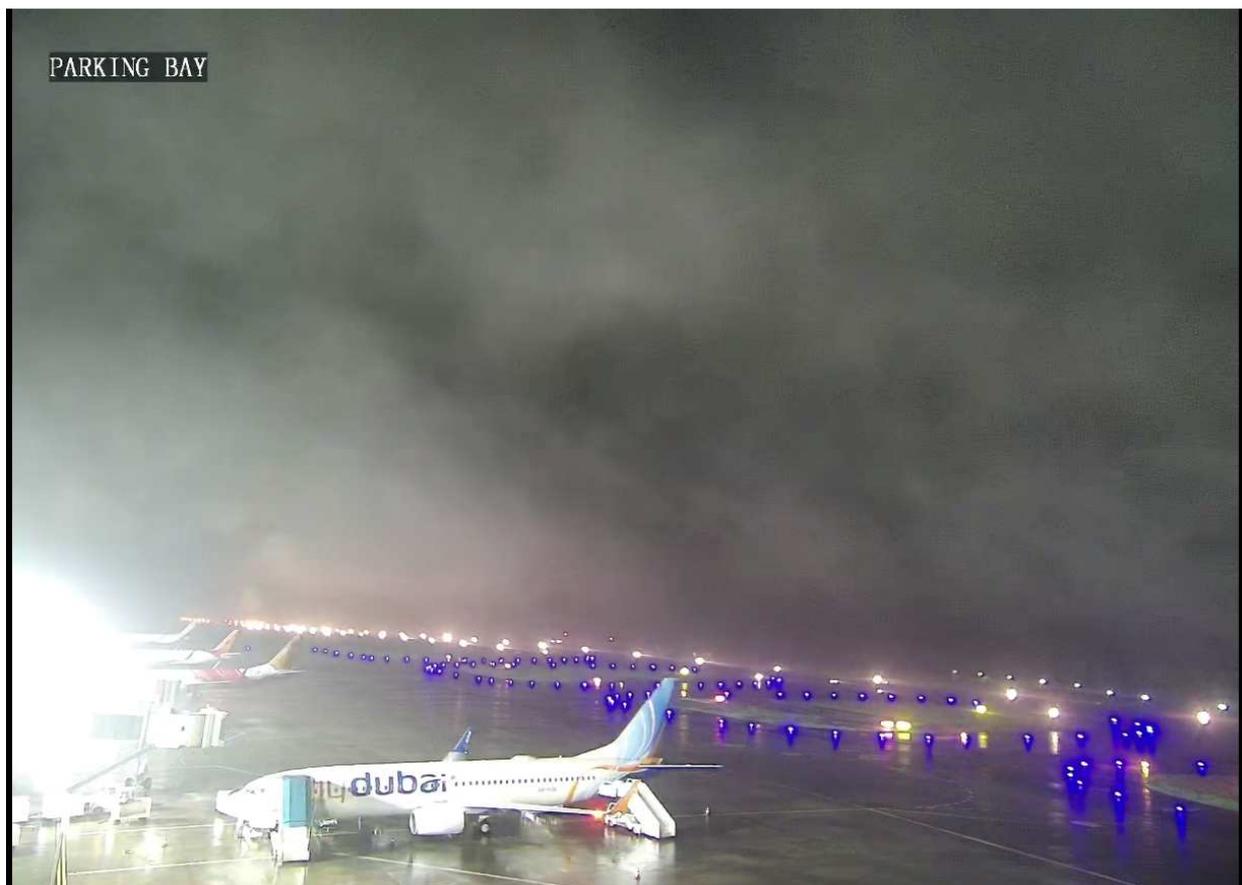
*Figure 20: Screenshot from CCTV footage at 19:22 IST*

The above figure shows low clouds in the direction of Runway 28 approach. The aircraft had made a missed approach on Runway 28 at around this time.

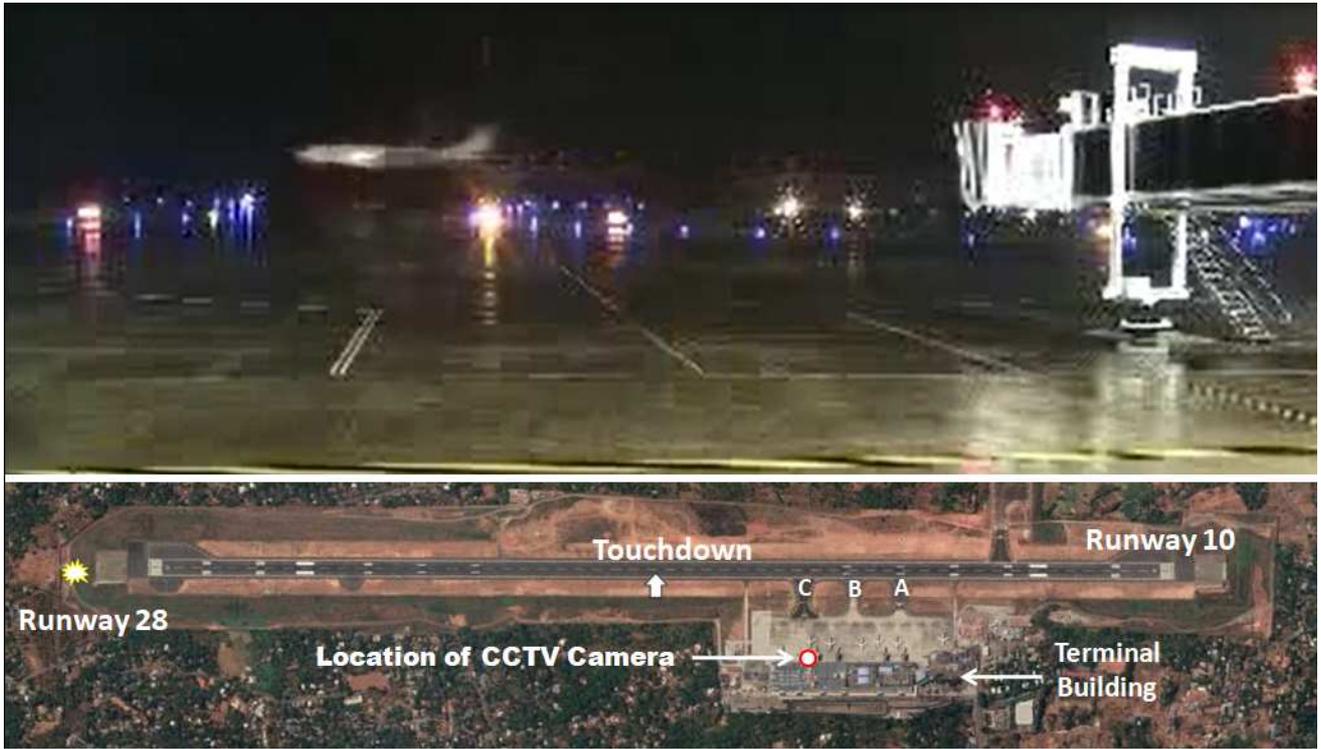
*Figure 21: The Screen Shot from CCTV Installed in Front of Taxiway 'C'*

The above figure shows the aircraft while crossing Taxiway 'C', and still floating. The location of camera and final touchdown point is also shown.

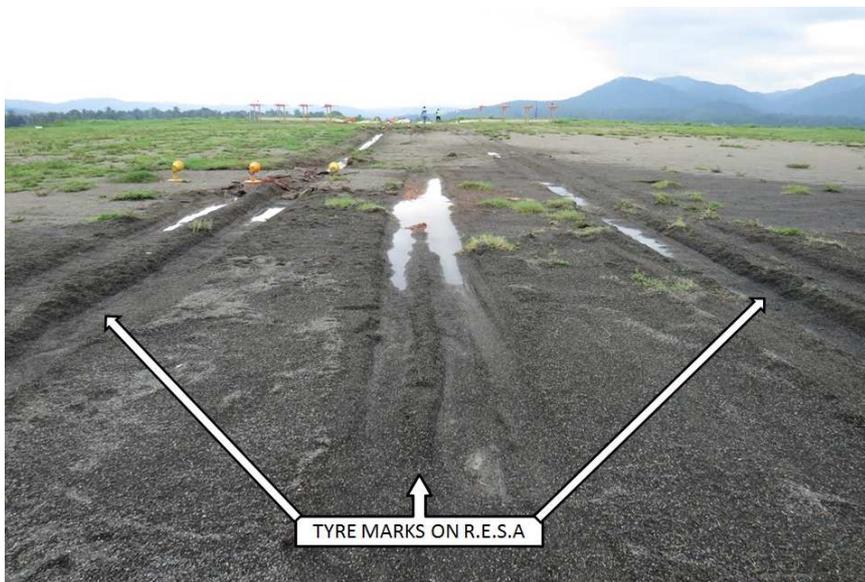
Figure 26: Tyre Marks on RESA.

The aircraft touched down at 4438 ft from the threshold of runway 10. Airport Safety Investigation Co-ordinator and the AAIB investigators did not observe any distinct tyre marks on the Runway during runway inspection as Aerodrome was experiencing continuous rains during the accident and later throughout the night.

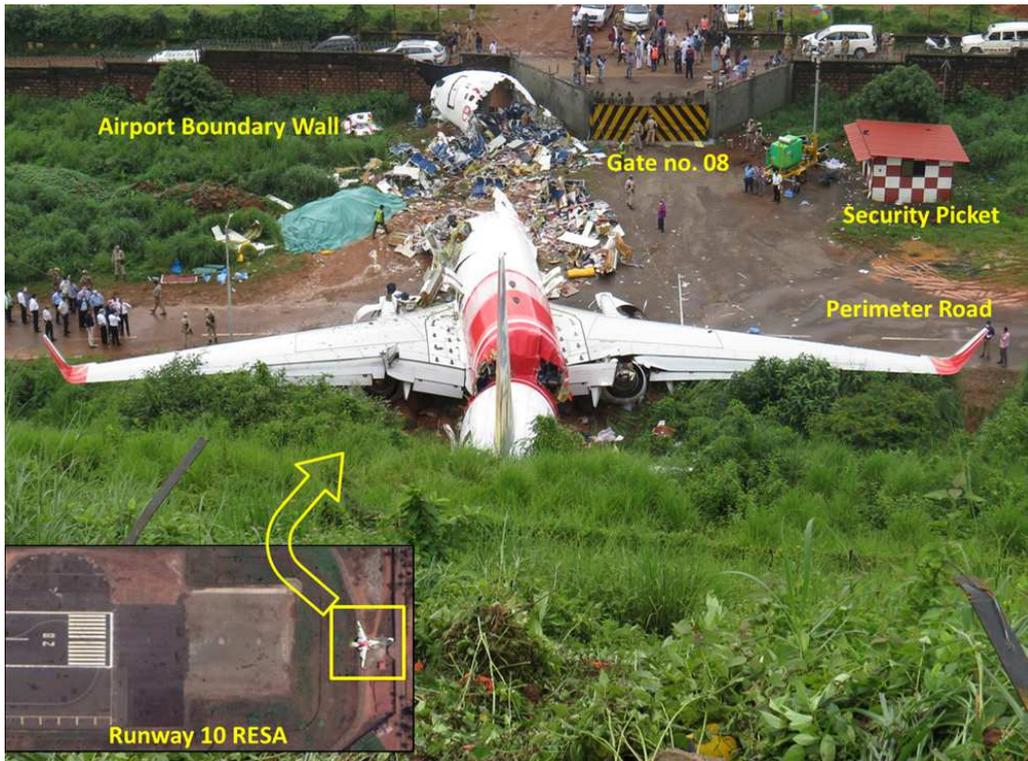
Figure 27: Layout of Wreckage.

section was on a heading of 110 degrees magnetic and the aft section on a heading of 120 degrees magnetic.

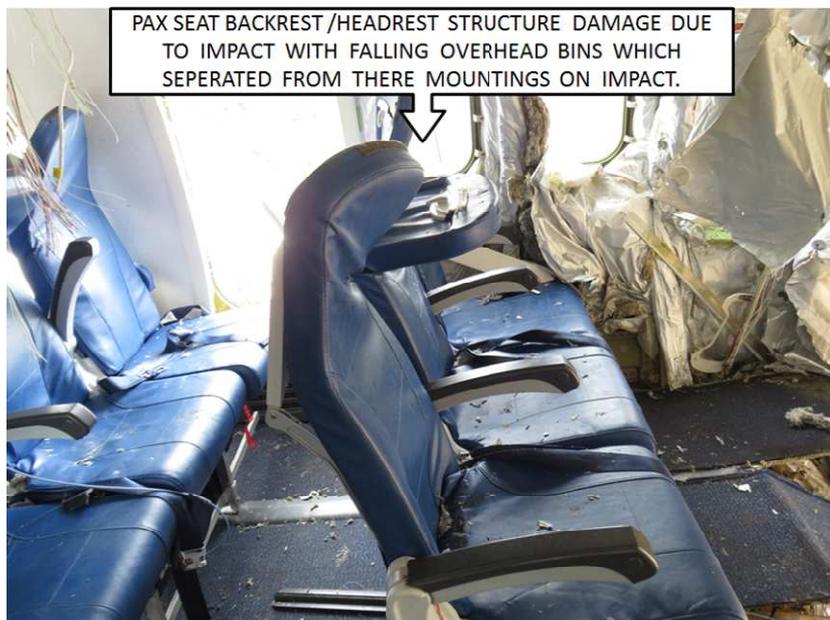
The centre section after separating from the forward section continued plunging into the road at an approximate angle of 30° (as confirmed by the observed impact line). The structural members in section 44 bore the brunt of impact with the ground, the floor beams were shattered, the lower lobe skin, cargo and cabin

floor crumpled and separated. Attached cabin equipment including seats, overhead bins, passenger service units and side wall panels fragmented and were scattered over an area of approximately 300 square yards forward of the centre section. The passenger seat headrests were bent forward due to impact with the loaded overhead bins that separated and fell down with a forward momentum.

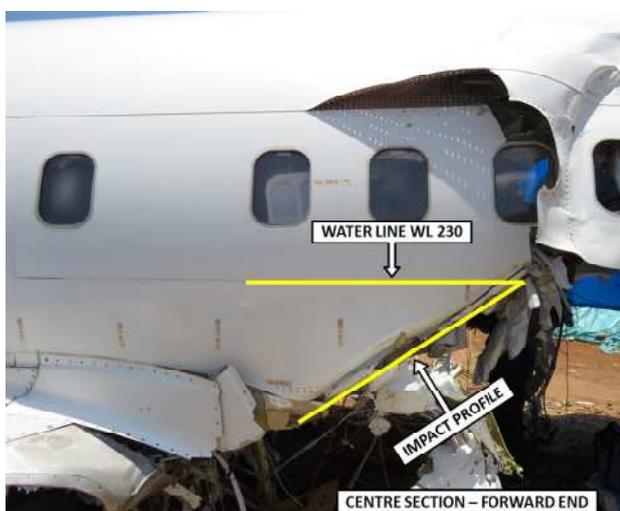
Figure 31: Centre section impact profile

The centre wing box including the centre tank structure was exposed and severely damaged. The air conditioning system components were crushed and damaged. Section of the fuselage skin, cargo floor panel, generator cables and system tubing showed signs of a rippled pattern resembling corrugated sheet.

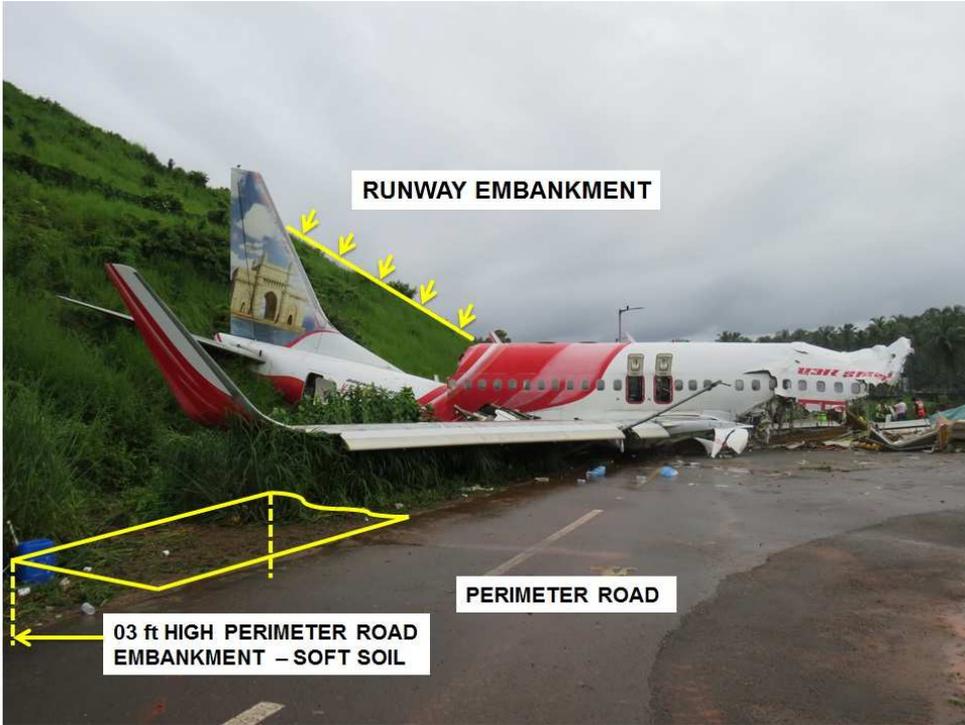
Figure 33: Layout of Centre & Aft Section Wreckage

The aft section separated from the centre section between STA 727D and STA 727J during the fall and impact. The centre section was supported on the belly by the edge of the perimeter road embankment. Due to momentum the aft section continued moving down and separated from the centre section. It was supported at the forward end by the base of a storm drain and at the aft end by the runway embankment. Due to this orientation it was at a relative angle of 10-12 degrees with the centre section.

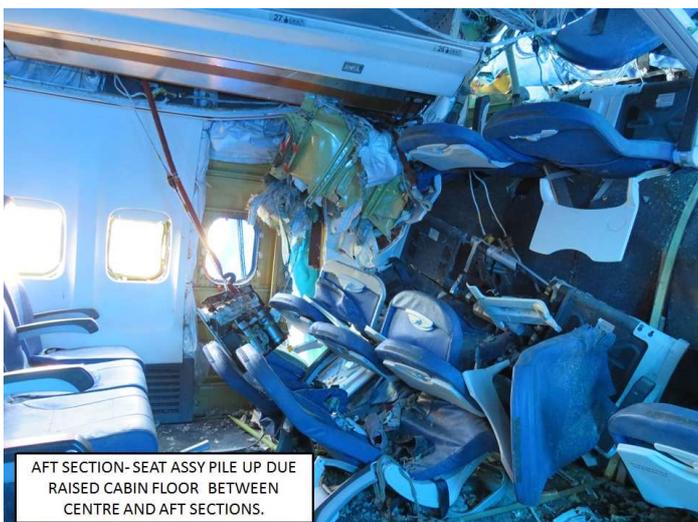
Figure 34: Aft Section Seat Pile up

The cabin floor structure was damaged but did not separate cleanly. Due to the height difference between the cabin floor levels of the two sections, the cabin floor rotated from horizontal to near vertical position between seat rows 23 to 26 with the seats still attached causing the passenger seats to pile up at this location. The empennage was relatively intact other than a few post impact damages.

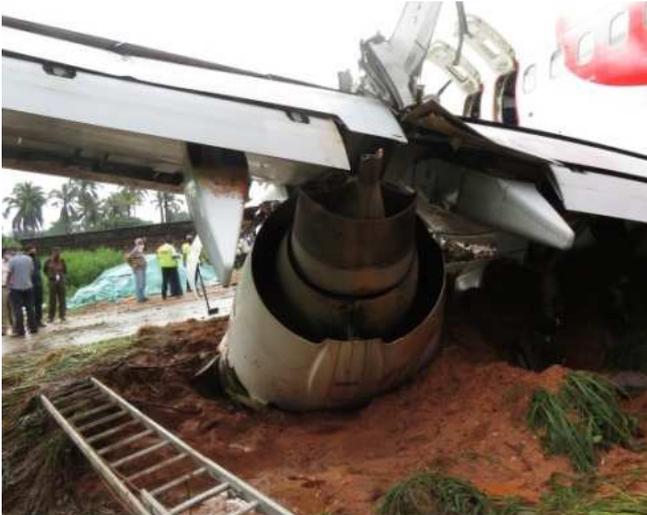
Figure 36: Left Engine

The engines were embedded in the soft ground at an approximate angle of 30°. The left engine came to rest at a distance of 10 ft behind the strut and the right engine was at a distance of 17 ft behind the strut. Both engines suffered extensive impact damage.

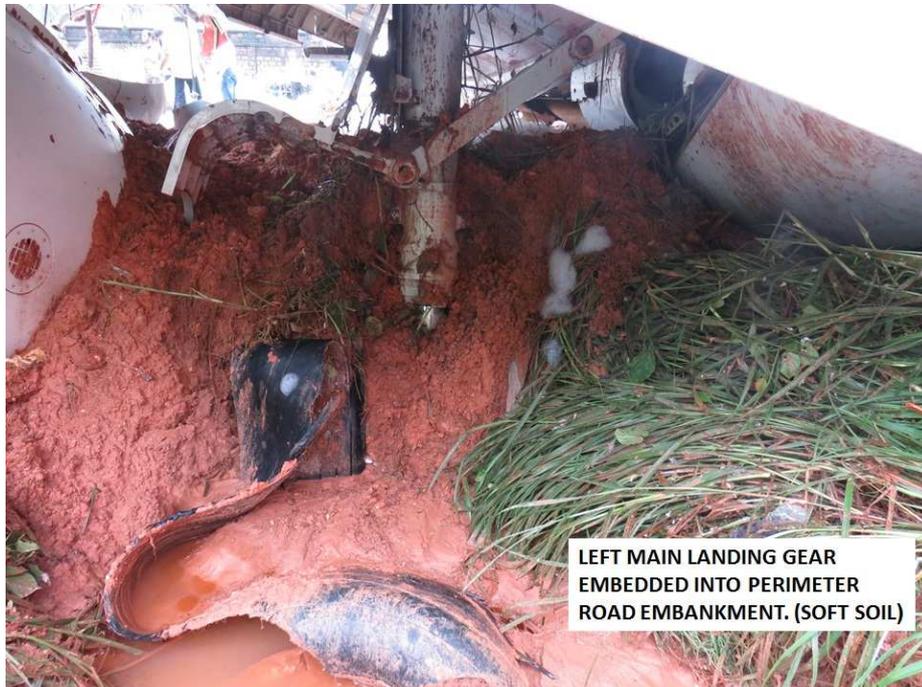
The left main landing gear was embedded in the road embankment soft soil with the gear strut fully extended. The DFDR indicated that it was down and locked

before impact. The wear on the tyres was typical of in-service tyres and showed signs of abrasions on the side wall sustained during its contact with concrete base structures in RESA. The outboard tyre tread was ripped apart probably due to touching down on a boulder in the storm drain. The inboard tyre was intact and the tyre pressure recorded was 202 psi.

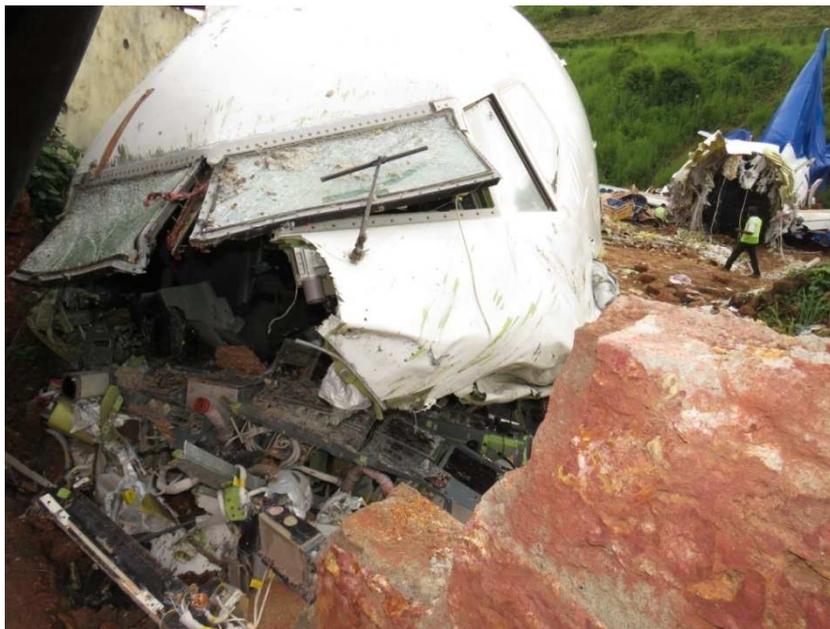
The flight deck door buckled between the floor and the ceiling and separated from the door hinge. The upper and the lower blow out panels were open and supported on the hinges.

Both the forward windshield glass shattered. The window frame and its support structure was damaged. LH windshield wiper motor converter was retrieved from the wreckage with superficial damage. RH windshield wiper motor converter and arm assembly separated from its location and were retrieved from the debris. Both wiper arm assemblies were found slightly deformed.

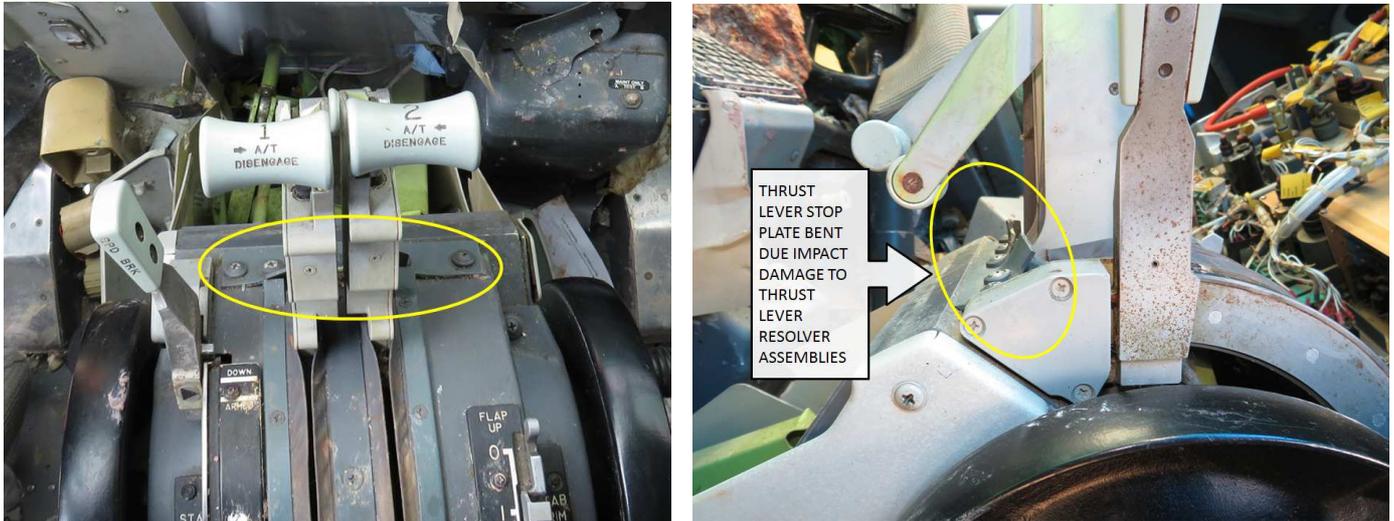
Figure 45: Engine Thrust Lever

The throttle lever position did not correspond to the last recorded position in the DFDR data before impact. The Engine Throttle Levers were found jammed at the full forward position with the stop plate bent forward. This was attributed to impact damage sustained by the Thrust Lever Resolver Assemblies and Control Rods causing it to move back thereby forcing the throttle lever forward with such a force that it resulted in bending the stop plate. Both the throttle levers were jammed and could not be moved.

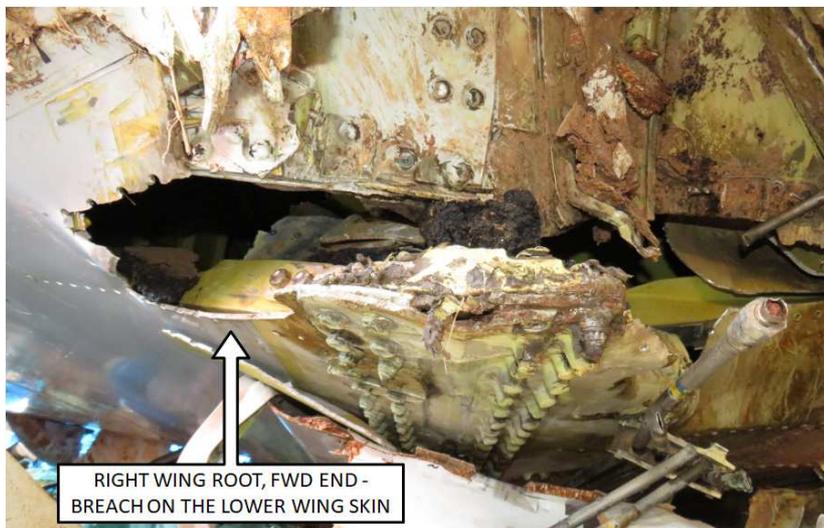
wing main tank. The fuel leaked through the opening created on the lower wing skin. On the left wing the fuel leaked from the separated fuel supply line on the pylon and it continued to leak until the fuel level inside the tank decreased below the level of the separated line. Approximately 650 litres of fuel was later drained from the left wing main tank.
