# Investigation Report

Type of Occurrence: Accident

Location: Gransee

Type: C 208 Caravan

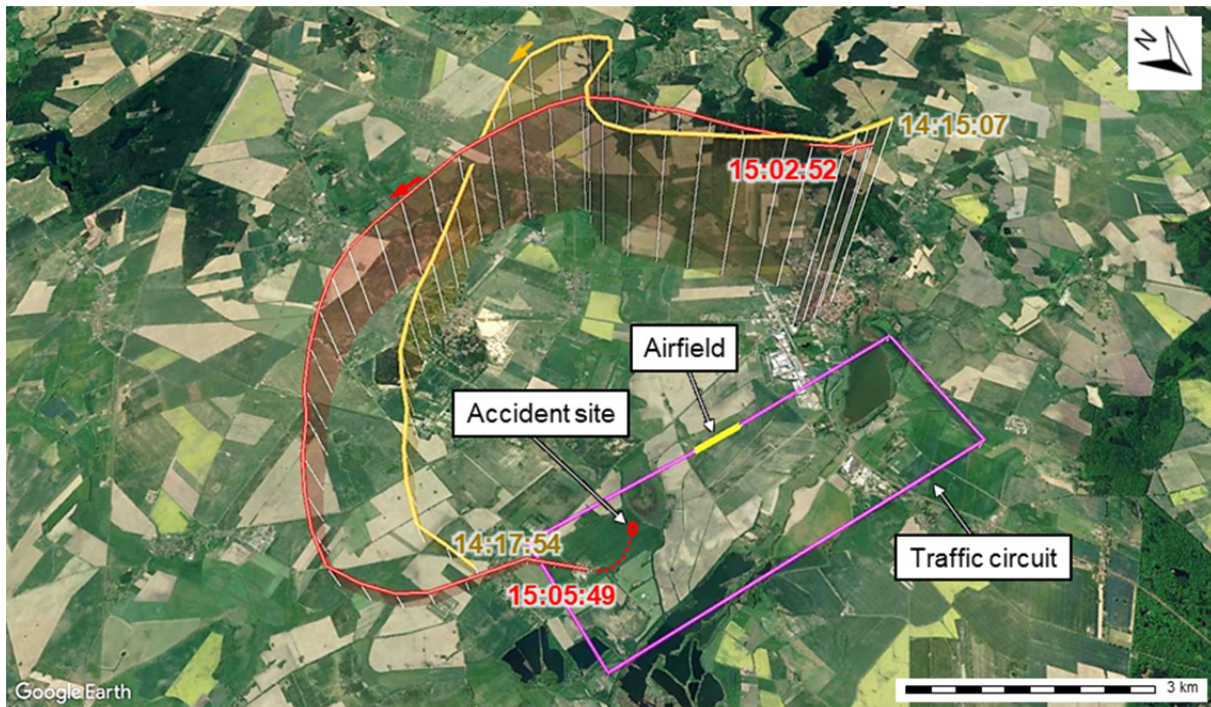
During both flights the skydivers had been dropped at flight level 130 at a heading of about 300° south of the airfield. After dropping the skydivers, at 1415:07 hrs and at 1502:52 hrs, respectively, the airplane entered a descent with a very high rate of descent and flew in a wide left-hand turn back to the airfield. During the third flight a right-left-hand turn with bank angles of about 50° to 60° (Fig. 1) occurred during descent.

Fig. 1: Accident flight (red) third flight (yellow)

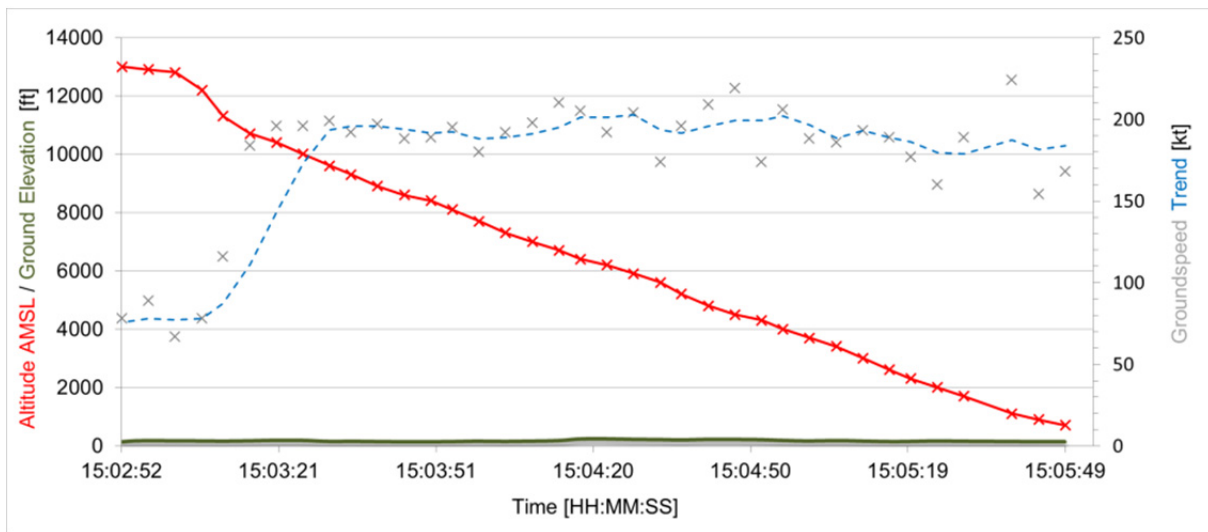
Fig. 4: Depiction of the descent and the speed between 1502:52 hrs and 1505:49 hrs

Below 10,000 ft AMSL, the airplane reached ground speeds between 180 and 200 kt. The mean rate of descent was 4,000 ft/min.

The analysis of the flight path determined that the descent was conducted as a wide turn with a relative constant speed of 180 to 200 kt and a rate of descent of about 4,000 ft/min. Even in the flight phase close to the ground - below 1,000 ft AMSL - speed was still in the area of the maximum allowable value. Up until the end of the radar recording (last recorded altitude: 550 ft AMSL) no significant reduction in rate of descent could be determined.

Up until the end, the determined speed was beyond the operating limitations stipulated in the POH and the OM Part C.

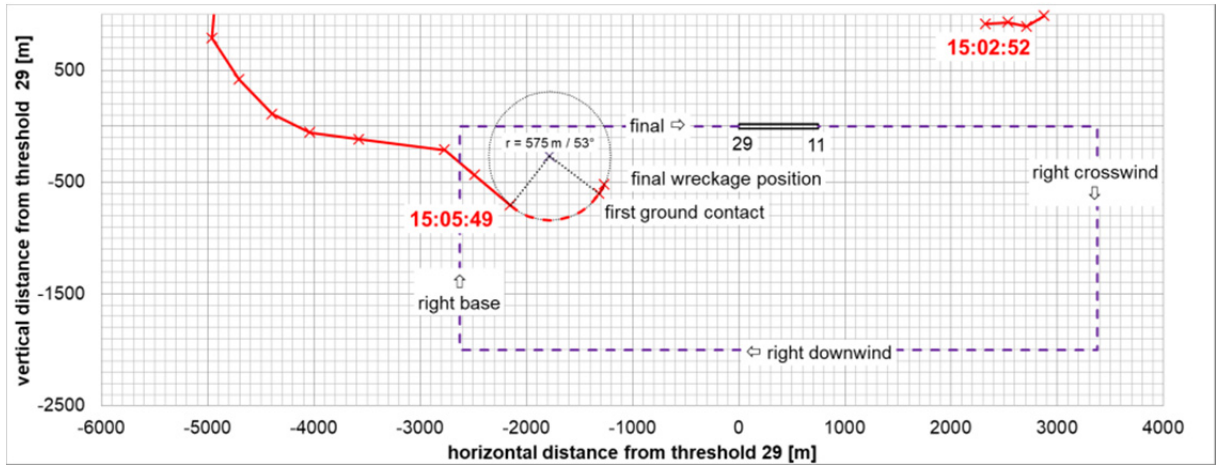
Based on the radar points and the direction of the impact traces, the flight had a circular arc with a radius of about 575 m prior to impact. Assuming a speed of about 168 kt (310 km/h or 86 m/s) the required mean bank angle was about 53° (Fig. 5).

Fig. 5: Analysis of the accident scenario

It is highly likely that the minimally possible steep turn to the left, which witnesses had described and been proven by calculation, was the attempt to return to the extended centre line of runway 29. During this manoeuvre speed exceeded  $V_A$  considerably.

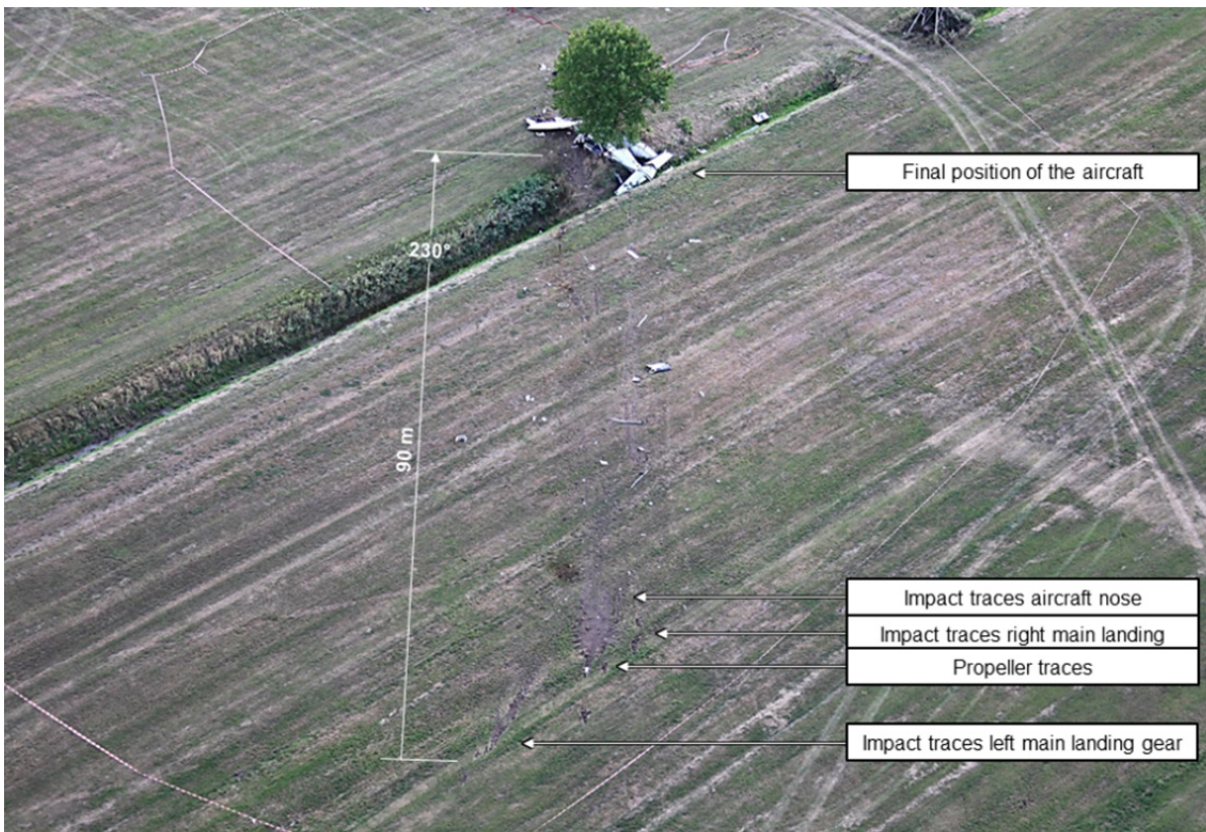
The ground traces<sup>13</sup> proceeded over a distance of 90 m in 230° (Fig. 7).

The first impact trace could be correlated with the main landing gear. At the beginning of the extended earth deposit, which could be correlated with the impact of the nose, five propeller impacts with a distance of about 50 cm and a depth of 10 cm were determined.

The final impact occurred at the counter slope of a drainage ditch at a single tree.

Fig. 7: Ground traces at the accident site

According to the traces at the accident site, the impact with the ground occurred from the left-hand turn. The bank angle during impact was low; it is likely that it was approximately  $20^\circ$ . The rate of descent was relatively low and the impact angle very small. This allows the conclusion that a flare had been initiated from the steep turn and with a high rate of descent and the crash had occurred in the middle of this manoeuvre.
