Aviation Investigation Final Report

Location:	Warm Springs, Oregon	Accident Number:	WPR21LA082
Date & Time:	January 9, 2021, 13:37 Local	Registration:	N3RB
Aircraft:	Cessna 560	Aircraft Damage:	Destroyed
Defining Event:	Medical event	Injuries:	1 Fatal
Flight Conducted Under:	Part 91: General aviation - Personal

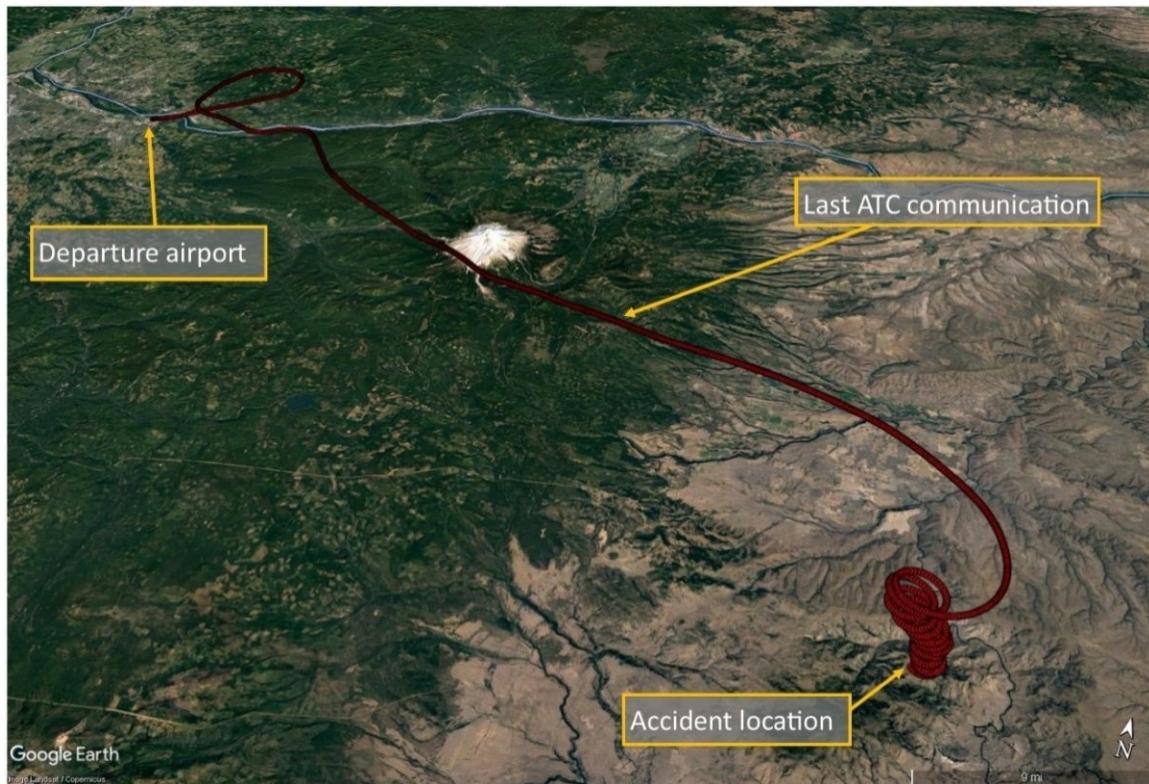
Figure 1 – Flight track

At 1327, the airplane had reached an altitude of 27,000 ft when it began to deviate to the right while continuing to climb. The controller alerted the pilot that he was about 30° right of course, but the pilot did not respond. The airplane continued to climb until 1328:45, when it reached its highest altitude of 31,000 ft. The airplane began to descend and remained for the next eight minutes in a spiraling and descending 1-mile radius right turn. (see Figure 1.) The last ADS-B

target was recorded at 1336:27, with the airplane on a northwest heading at an altitude of 3,800 ft.

Interpolation of the ADS-B data during the spiraling descent indicated a right bank angle of between 60° and 70° and a descent rate of between -2,500 to -5,000 ft/min to impact.

The data also revealed 50- to 100-knot oscillations in groundspeed during the descent. The data was compared to flight test data for the Citation 560 series airplane, specifically the data used to simulate the longitudinal, open-loop, long period (or phugoid) response of the airplane after a pitch disturbance.

The data for the accident airplane displayed longitudinal dynamic characteristics that were similar to the flight test data for over a period of oscillation, or approximately 90 seconds.
