# Aviation Investigation Final Report

<b>Location:</b>	Lansing, Michigan	<b>Accident Number:</b>	CEN20FA001
<b>Date &amp; Time:</b>	October 3, 2019, 08:58 Local	<b>Registration:</b>	N700AQ
<b>Aircraft:</b>	Socata TBM 700	<b>Aircraft Damage:</b>	Substantial
<b>Defining Event:</b>	Loss of control in flight	<b>Injuries:</b>	5 Fatal, 1 Serious
<b>Flight Conducted Under:</b>	Part 91: General aviation - Business

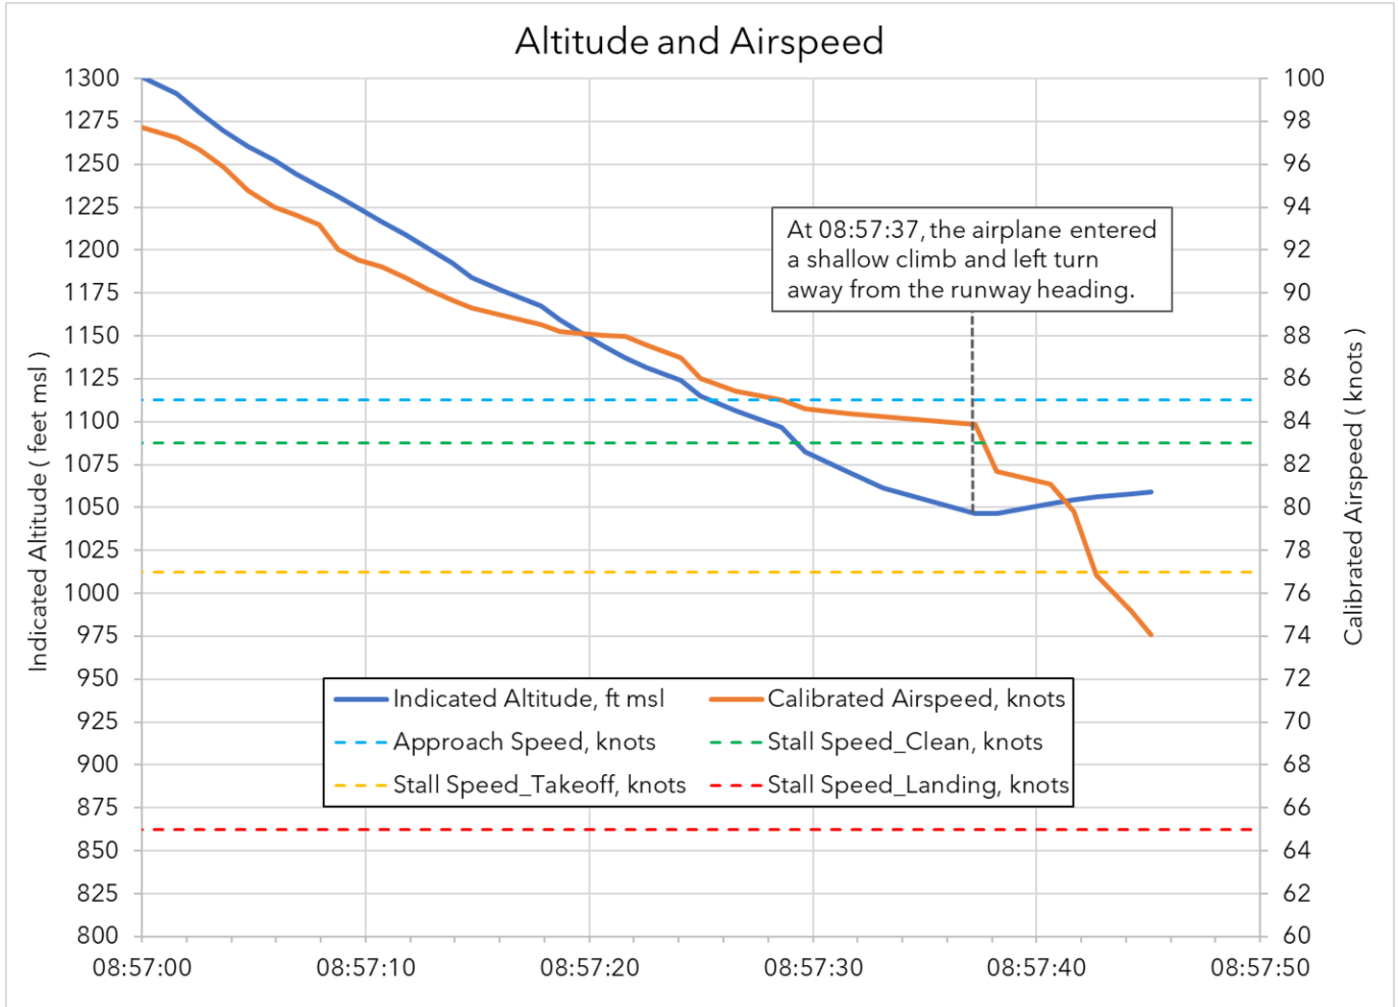
The ADS-B data indicated that at 0857:06 the airplane was about 1.3 miles from the runway threshold at 1,250 ft msl (about 400 ft above the runway elevation) and established on the localizer inbound to the runway. At 0857:37, the airplane was 0.5 miles from the runway threshold at 1,047 ft msl (about 180 ft above the runway elevation) and 84 knots when it entered a shallow climb and left turn away from the runway heading. Between 0857:37 and 0857:45, the airplane climbed to 1,059 ft msl and decelerated to 74 knots, as shown in figure 2. At 0857:45, the final ADS-B datapoint was located about 315 ft north of the localizer centerline and 0.35 miles west of the runway 10R threshold. The final ADS-B datapoint was about 475 ft southwest of the initial impact point with terrain. Figure 3 shows ADS-B position data during the airplane's final approach.

**Figure 2.** Altitude and airspeed during final approach.

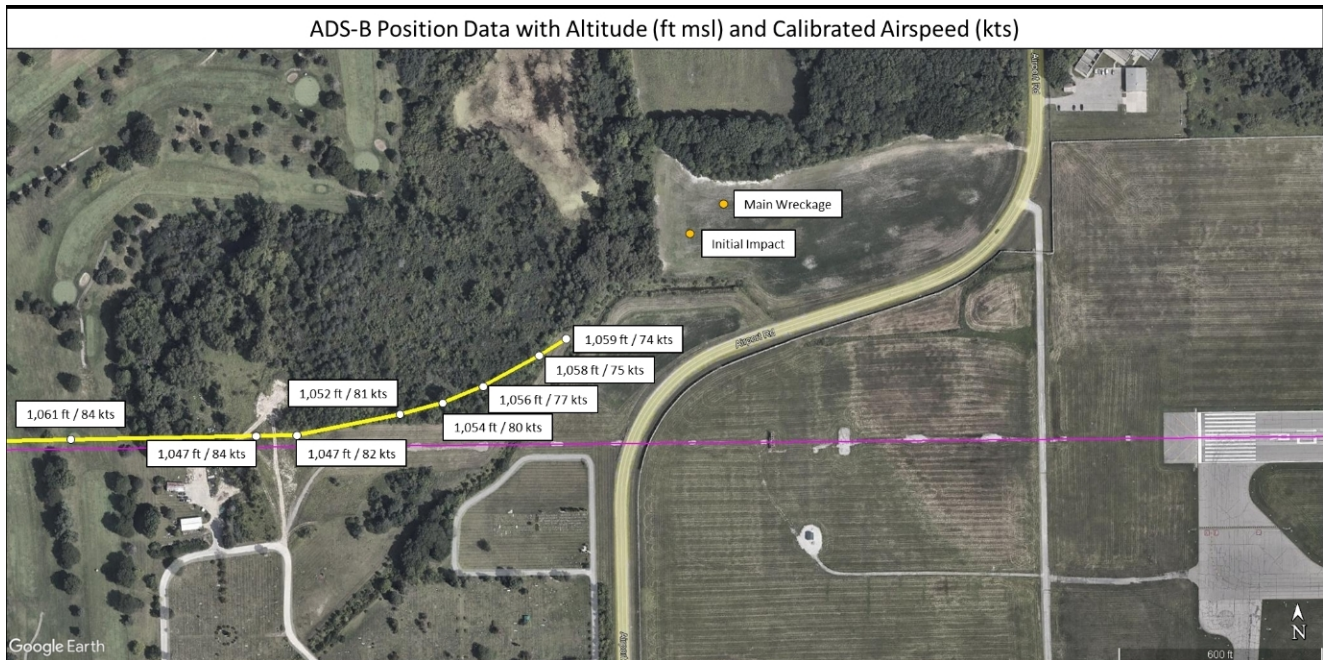
**Figure 3.** ADS-B position data during final approach.

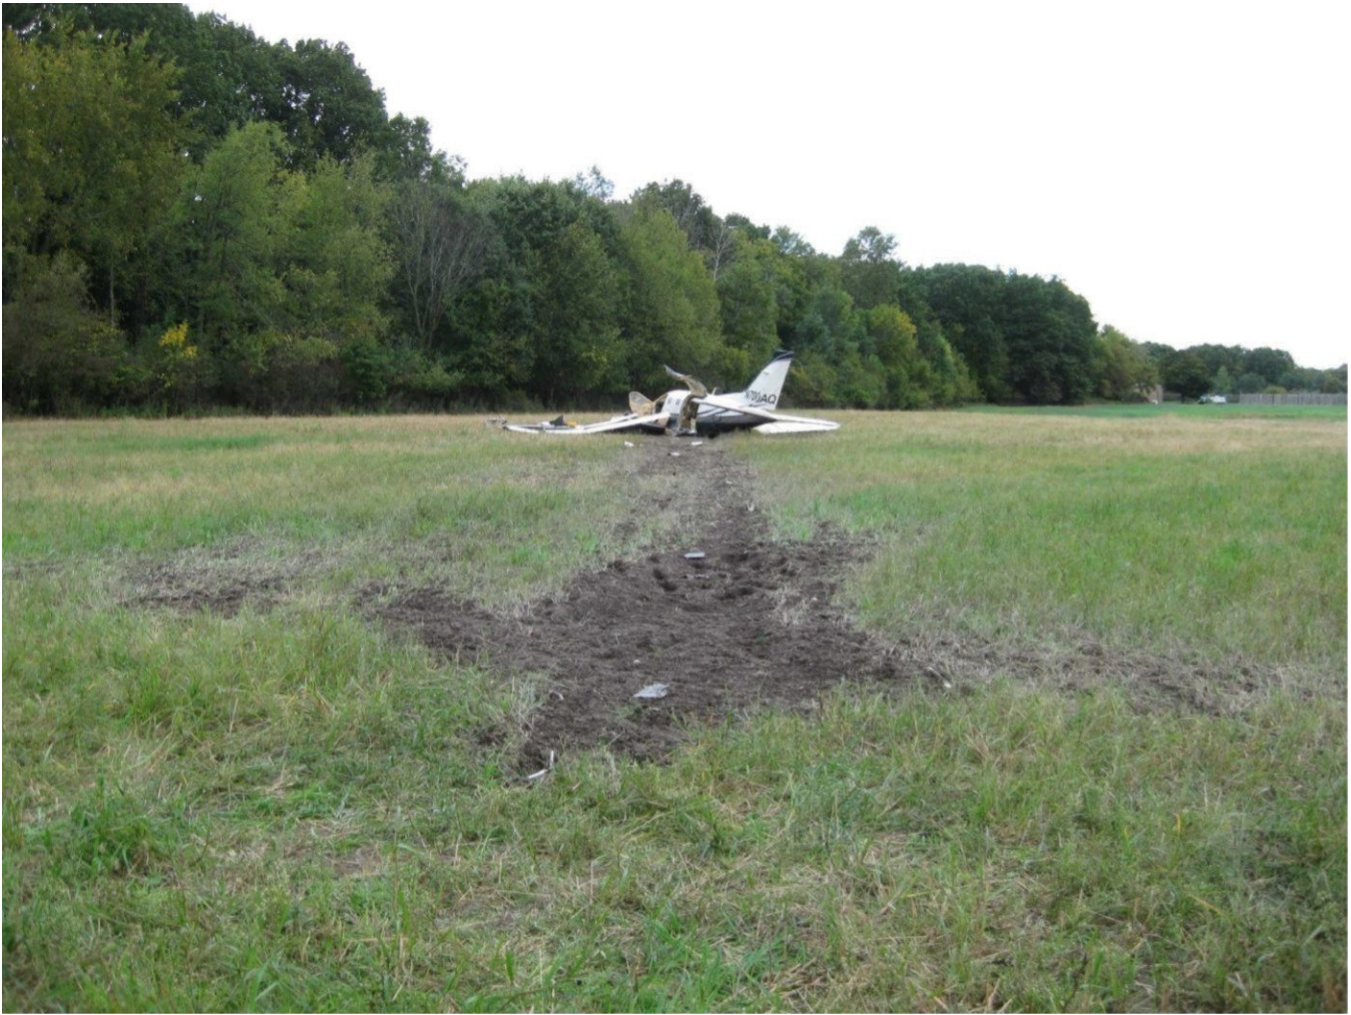
The accident site was in an open grass field located about 0.3 miles west-northwest of the runway 10R threshold. The initial impact point was in a large, depressed grass area that preceded a 135-ft-long ground scar oriented on a 060° bearing. The initial impact area measured 42 ft wide, consistent with the wingspan of the airplane (figure 5). The lower VHF antenna, the left main landing gear door, and several flap track fairings were located along the wreckage debris path.

**Figure 5.** Initial impact point and ground scar.
