# Aviation Investigation Final Report

<b>Location:</b>	Myrtle Beach, South Carolina	<b>Accident Number:</b>	ERA19LA043
<b>Date &amp; Time:</b>	November 12, 2018, 14:15 Local	<b>Registration:</b>	N840JC
<b>Aircraft:</b>	Aero Commander 690	<b>Aircraft Damage:</b>	Substantial
<b>Defining Event:</b>	Turbulence encounter	<b>Injuries:</b>	1 Serious
<b>Flight Conducted Under:</b>	Part 91: General aviation - Personal

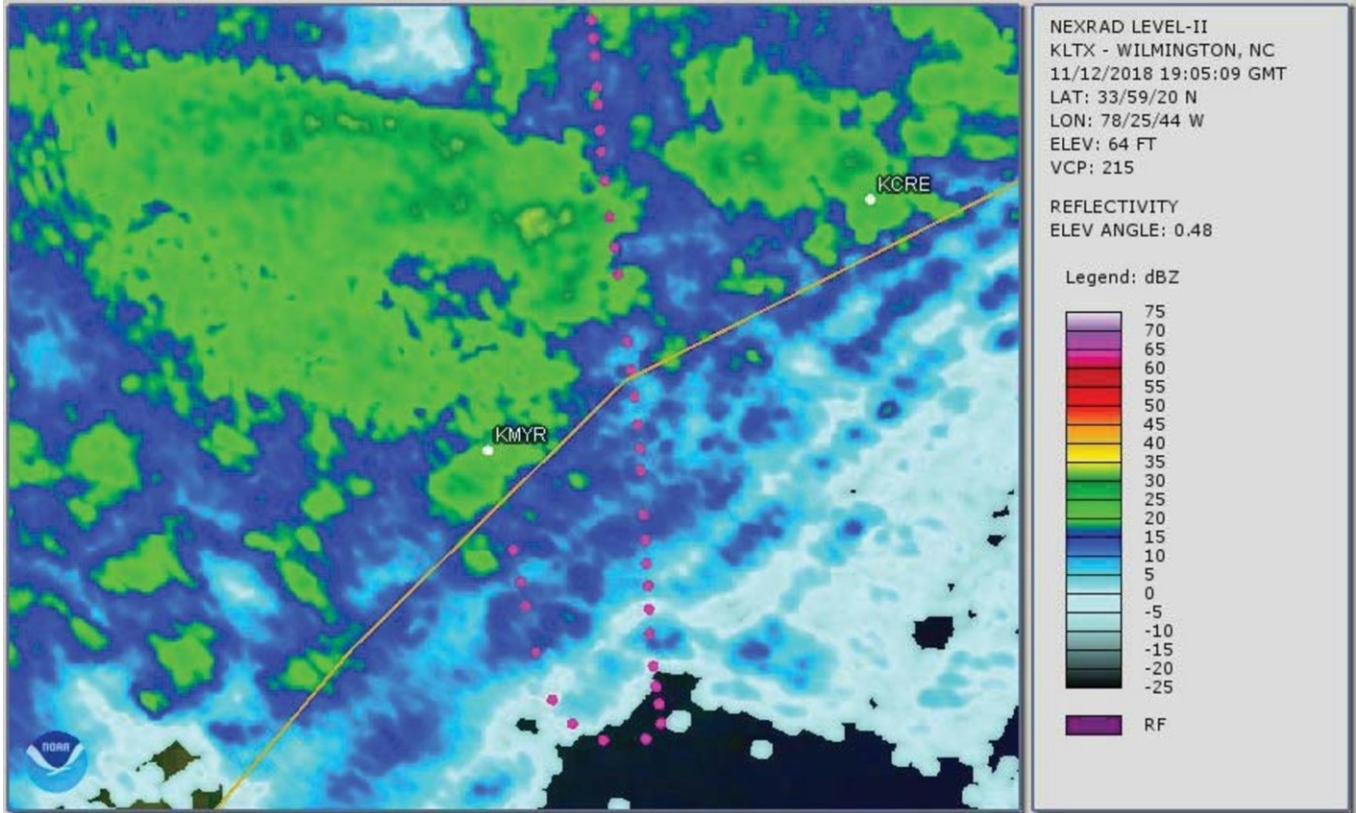
Figure -Base reflectivity image with flight track overlay

The following figure shows the accident airplane's flight track overlaid on base reflectivity radar imagery. The flight track showed the last radar target at 650 ft mean sea level near the accident site. Echoes of 5 to 15 dBZ extended over the flight track and accident site. No strong reflectivity echoes or gradients were noted over or in the vicinity of the accident site to indicate any thunderstorms and the radial velocity data did not detect any divergent couplets typically associated with microbursts.
