COMANDO DA AERONÁUTICA
CENTRO DE INVESTIGAÇÃO E PREVENÇÃO DE
ACIDENTES AERONÁUTICOS

FINAL REPORT
A - 153/CENIPA/2019

OCCURRENCE:	ACCIDENT
AIRCRAFT:	PP-BSS
MODEL:	C90GT
DATE:	02DEC2019

This is the Final Report of the 02DEC2019 accident with the C90GT aircraft model, registration PP-BSS. The accident was classified as “[CFIT] Controlled Flight Into Terrain”.

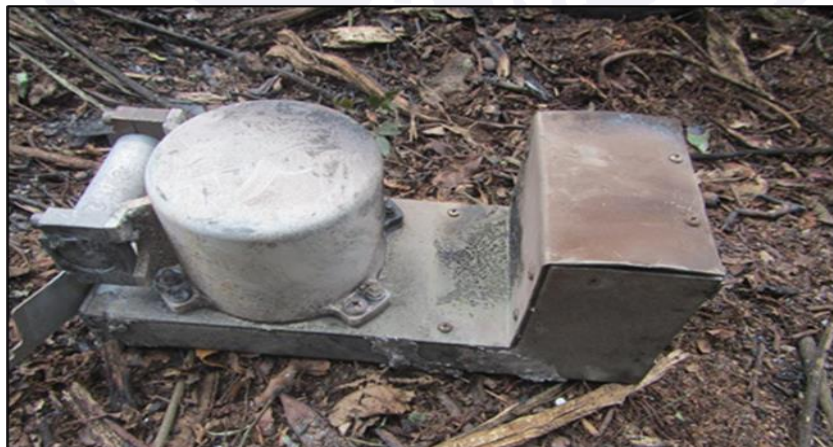
Figure 3 – The CVR image recorded at the accident site.

The equipment worked normally and contained data relating to the flight of the event. The information found allowed performing a spectral analysis of the engine noise and identifying the alarms emitted by the aircraft.

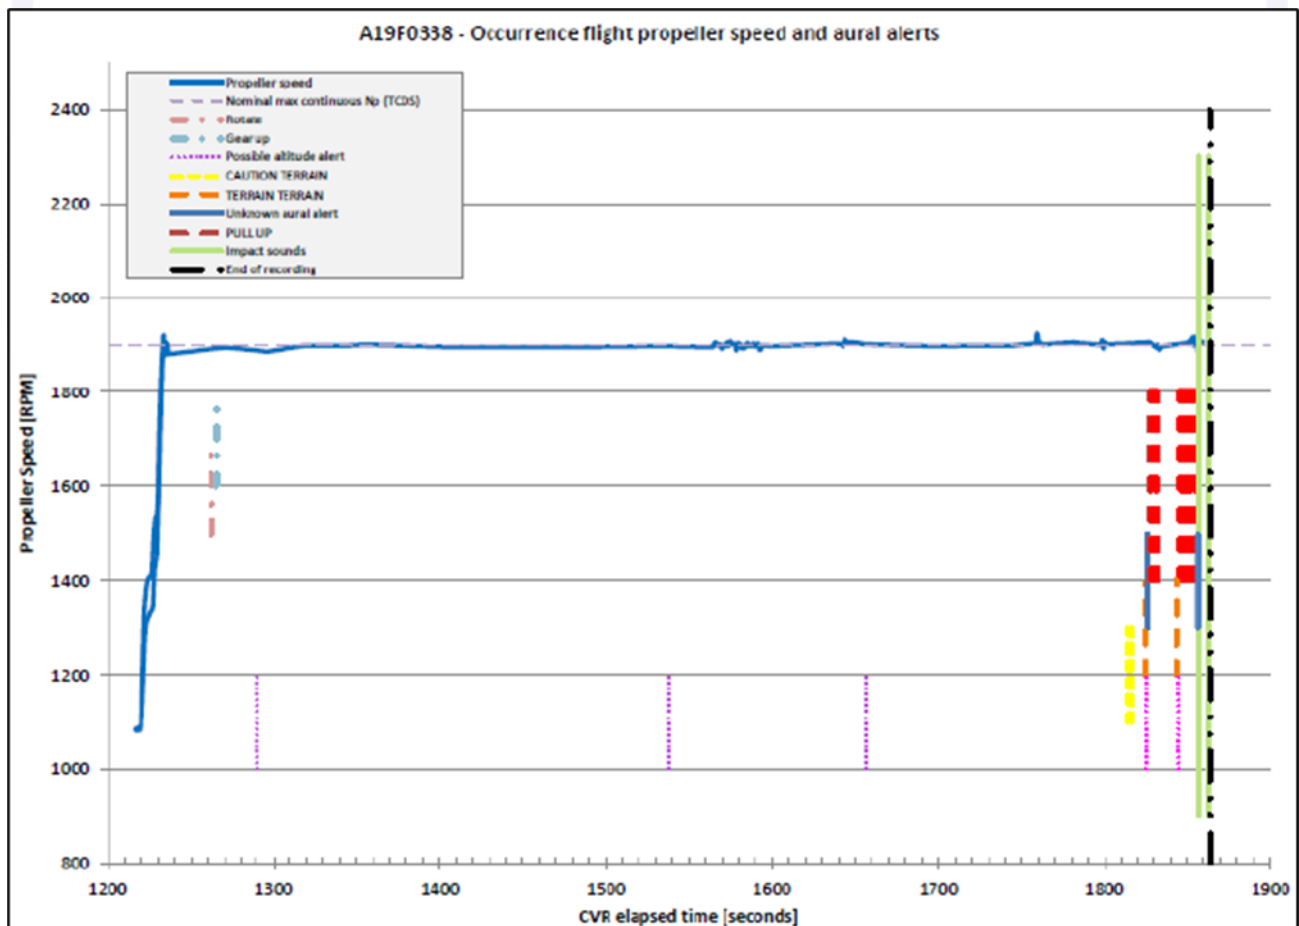
Figure 4 - Propeller rotation graph and the alerts recorded by the CVR.

The information extracted from the CVR allowed us to observe that, from the take-off of SBJD, the rotation of both propellers increased and stabilized at approximately 1,900 RPM, remaining in this regime until the moment of impact.

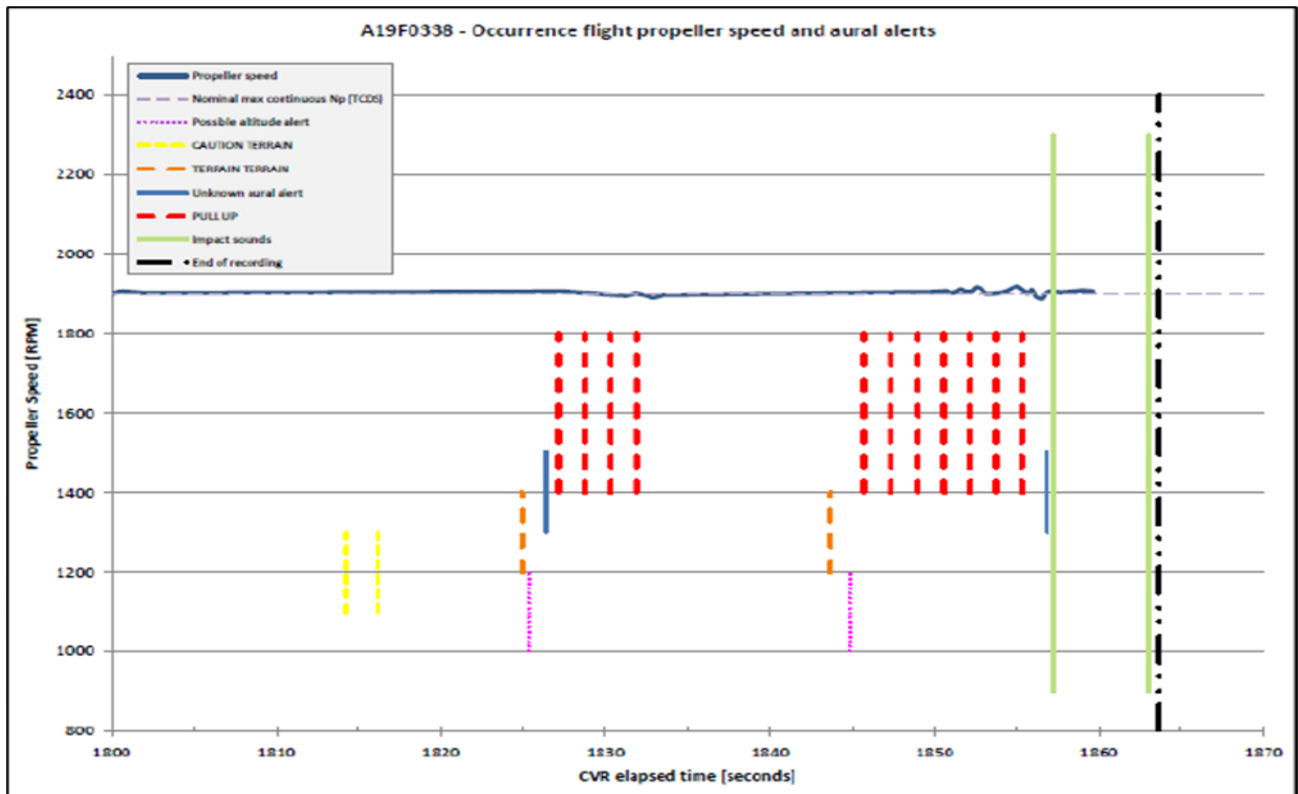
The analysis of the recorded data showed that the EGPWS issued several alerts related to the proximity to the ground, such as “Caution Terrain”, “Terrain, Terrain” and “Pull Up”. In the last moments of the recording, the CVR recorded sounds that were identified as being from impacts (Figure 5).

Figure 5 - Graph of propeller rotation and sounds recorded by the CVR in the final moments of the flight.

From the data obtained through the CVR, it was found that, in the last moments of the flight, the EGPWS issued several alerts of proximity to the ground (Caution Terrain) and evasive action to avoid collision (Pull Up).

Based on this information, it was concluded that the pilot did not react to such alerts, a fact that revealed difficulties in thinking and acting in the face of an imminent collision condition, in which the aircraft was.

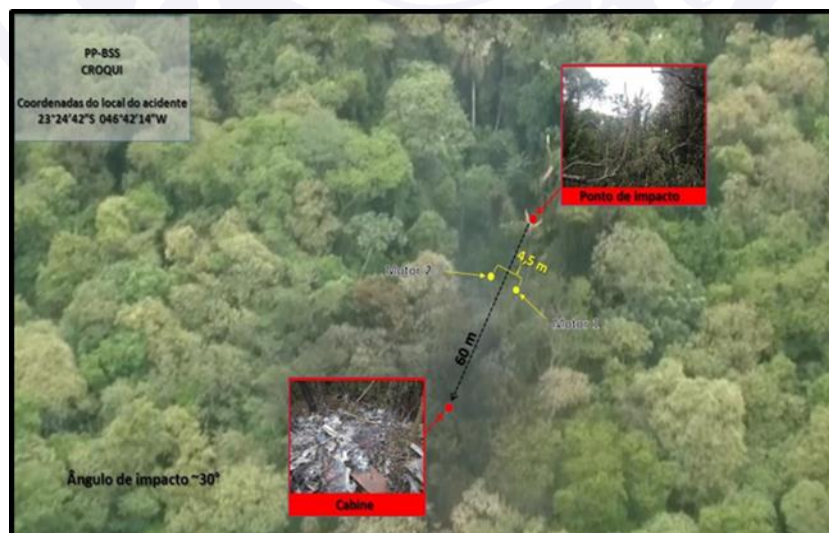
The distribution of the wreckage was linear (Figure 6).

Figure 6 - Top view of the crash site.

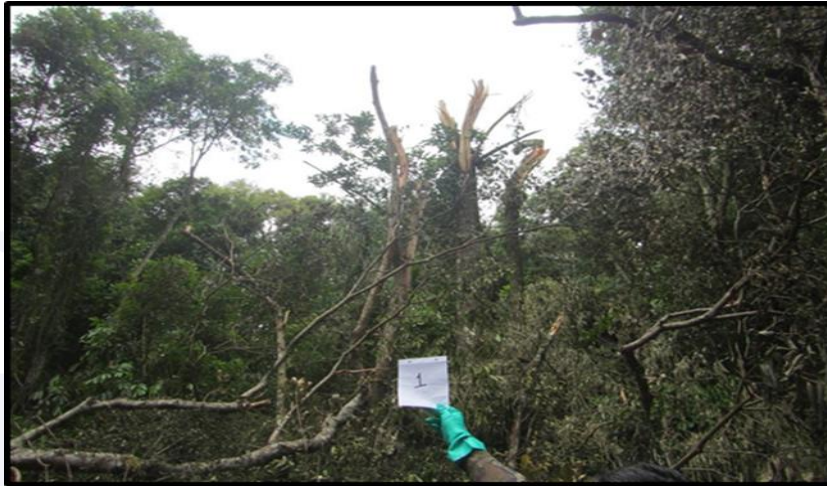
The first impact occurred against the top of some trees (Figure 7).

Figure 7 - Image of the point of the first impact against the top of the trees.

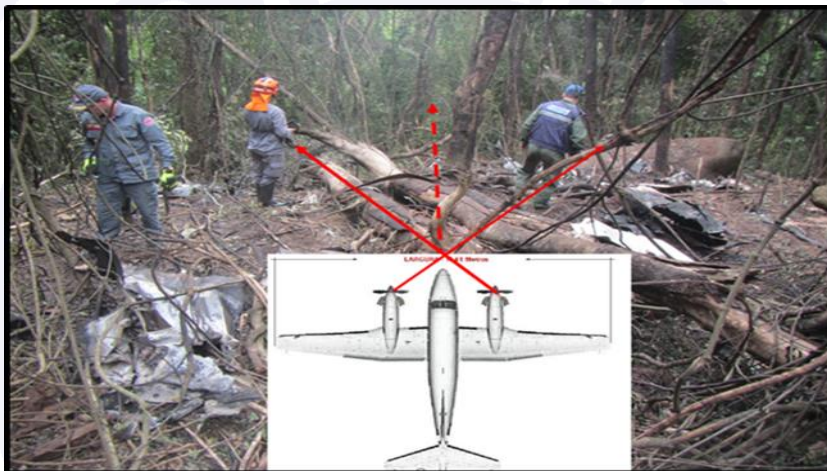
The engines were found opposite the side corresponding to their installation in the aircraft and the direction of flight, indicating that the aircraft rotated on its longitudinal axis during the impact against the trees (Figure 8).

Figure 8 - Impacted tree, aircraft trajectory and final position of the engines.

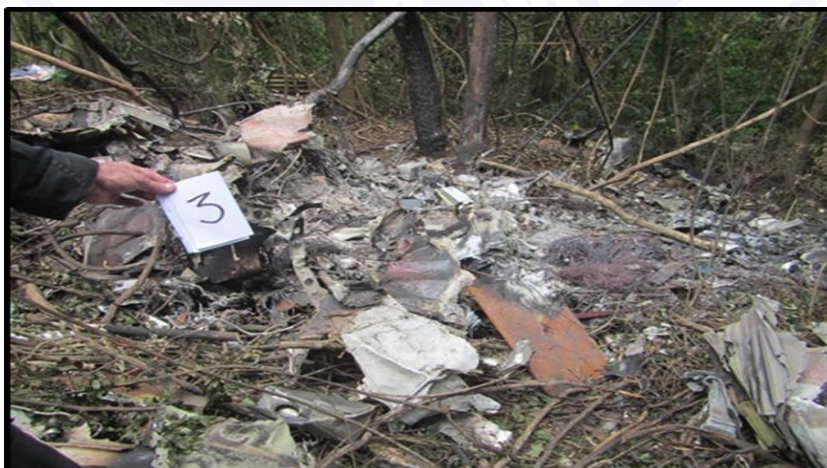
The cabin wreckage was found approximately 60 meters from the site of the first impact.

Figure 9 - Image of the cockpit wreckage.

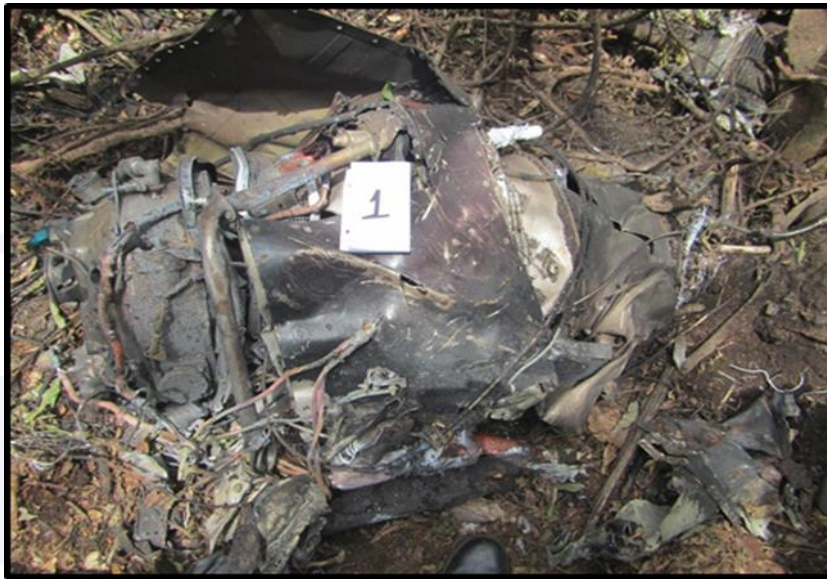
The engines were about 30 meters from the point of first impact and 4.5 meters apart.

Figure 10 - Image of the left engine.

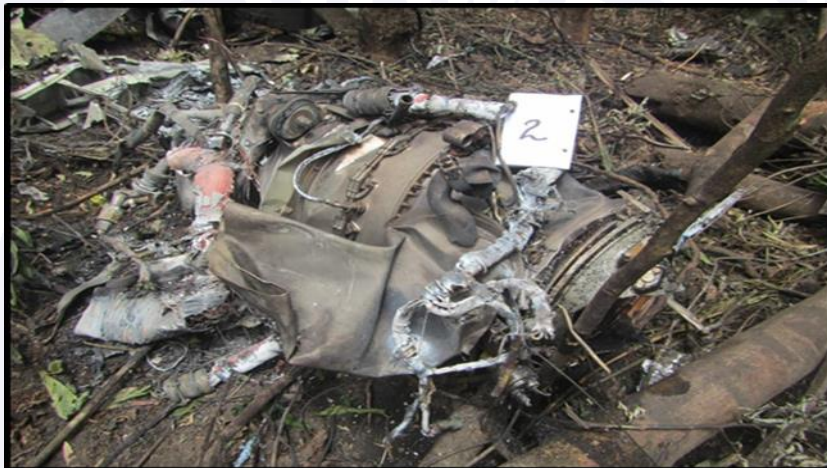
Figure 11 - Image of the right engine.

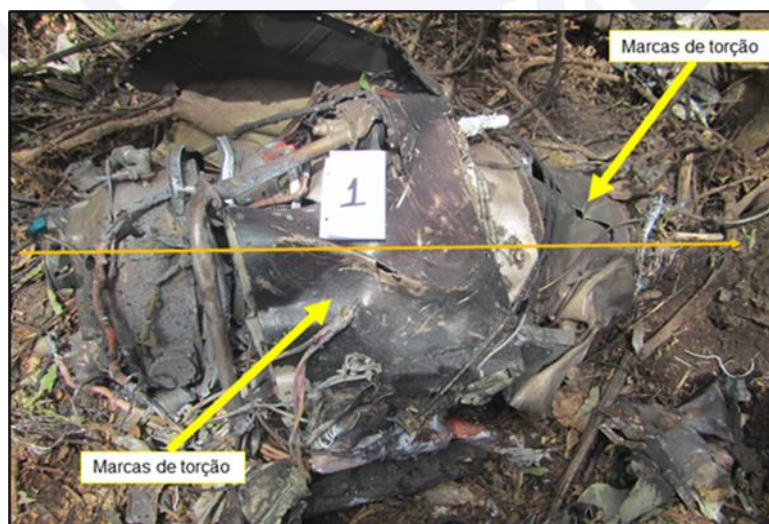
The engines had extensive damage, and both had been separated from their nacelles and their respective propellers. Its external parts showed evidence of torsional forces associated with compression caused at the moment of impact.

Figure 12 - Structure of the left engine with torsion marks.

Evidence of torsion found during the examination of the engines suggests that the collision with the ground occurred with the engines running. Due to the detachment of the nacelles and the sudden stop, an effort was transferred to its external parts, causing the observed deformations.

Thus, it was concluded that the engines were producing power at the moment of the collision with the ground and that there was no contribution of a failure of the powerplant to the occurrence of this accident.

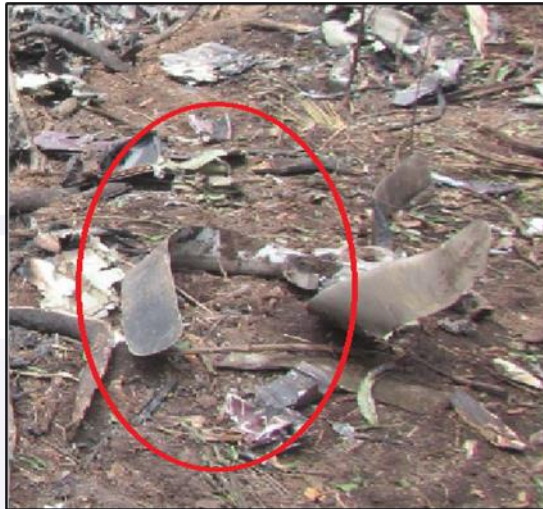
The propellers had substantial damage from the impacts that occurred. In one of the sets, it was identified a blade that presented deformation in the direction of flight (Figure 13).

Figure 13 - Image of one of the propeller sets. In the red highlight, one of its blades deformed in the direction of flight.

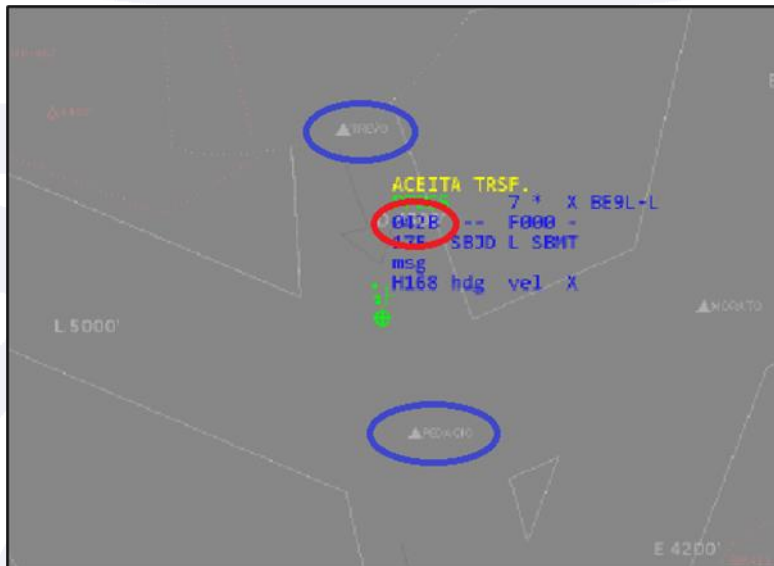
The ATC RADAR review images made it possible to observe that, in some moments of the path between the *TREVO* and *TRAVÉS ECHO JARAGUÁ* positions, the aircraft remained below the minimum altitudes established for the visual corridor (Figures 17 and 18).

Figure 17 - Synthesis of the ATC RADAR at 08:55:45 (UTC). Highlighted in red, altitude in hundreds of feet. Highlighted in blue, the *TREVO* and *PEDÁGIO* positions.

The fact that the aircraft remained below the minimum altitudes established for the visual corridor for much of the flight suggests that the pilot was finding it difficult to keep himself in visual conditions and, at the same time, to remain within the established limits for REA DELTA.

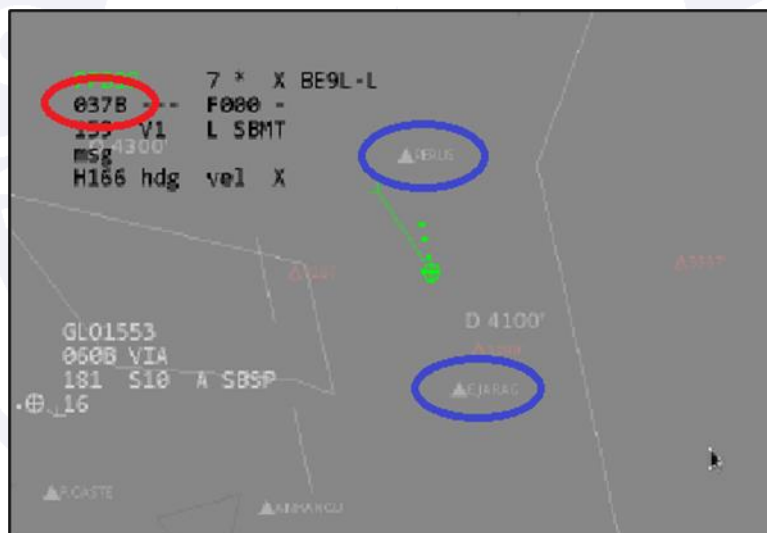
Figure 18 - Synthesis of the ATC RADAR at 08:59:39 (UTC). Highlighted in red, altitude in hundreds of feet. In the blue highlight, the *PERUS* and *ECHO JARAGUÁ* ABEAM positions.

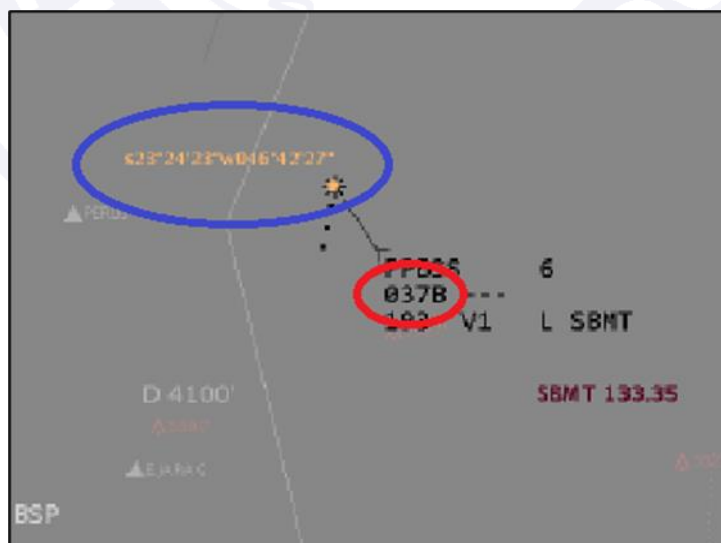
In the last available RADAR plot, the aircraft was at 3,700 ft altitude, on the east abeam of the *PERUS* position, to the right of the visual corridor, at the coordinate 23°24'23"S /046°42'27"W.

Figure 20 - Synthesis of the ATC RADAR at 09:02:27 (UTC). Highlighted in red, altitude in hundreds of feet. In the blue highlight, the position where the RADAR plot was lost.

Also, the fact that the aircraft had dropped to 3,700 ft during the repositioning to return to SBJD, when the lowest altitude of REA ECHO was 4,000 ft, associated with the weather conditions present in SBMT, where the SPECI at 0916 (UTC) reported a ceiling of 900 ft, show that the PIC sought to stay below the clouds.

Considering the last available RADAR plot, in which the aircraft was at 3,700 ft altitude, on the East beam of the *PERUS* position, the investigators concluded that the pilot was trying to maintain visual conditions and did not have a good visibility of the obstacles in front of him.
