Investigation Report

Type of Occurrence: Accident

Type: Epic LT

State File Number: BFU19-0272-CX

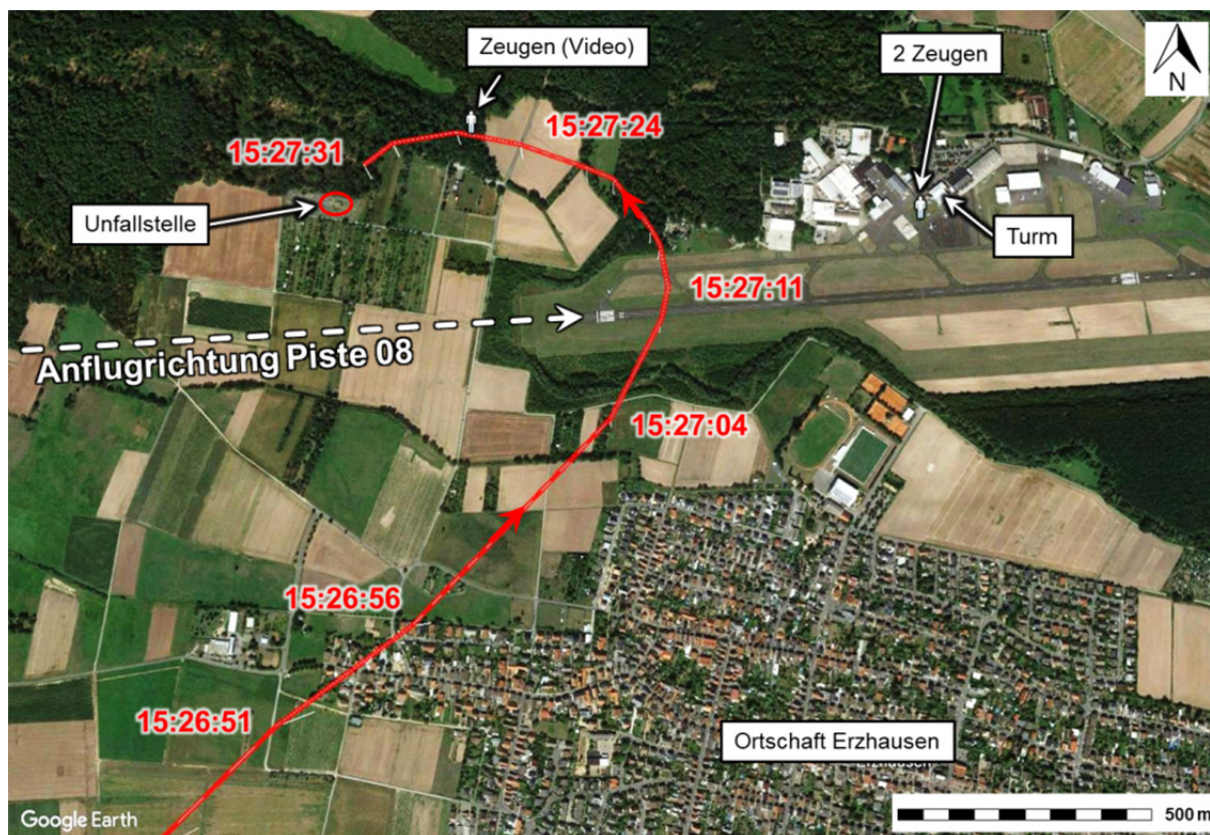
According to the radar recording, at 1524:52 hrs the airplane reached position DELTA and turned right in northern direction toward the approach path to runway 08 of Frankfurt-Egelsbach Airfield. Altitude was about 1,900 ft AMSL and ground speed 170 kt. At 1525:57 hrs, as the aircraft reached the southern border of the Aerodrome Traffic Zone (ATZ) it had descended to about 1,300 ft AMSL.

At 1526:30 hrs, at approximately the Tank- und Rastanlage Gräfenhausen (resting facility) at the Bundesautobahn A5 (motorway), the aircraft began to turn right up to a north-eastern direction. At the time, the aircraft was at 1,300 ft AMSL with a ground speed of about 140 kt.

At 1526:44 hrs, the Flugleiter addressed the pilot: “[...] do you have the field in sight?” The pilot responded: “Ah, not yet [...].” At the time, the airplane was about 1,000 m south-west of threshold 08 at the western outskirts of Erzhausen flying a north-eastern heading. According to the radar data, ground speed was about 125 kt at about 1,300 ft AMSL. The Flugleiter added: “I suggest to reduce, you are now on right base.” After the pilot had answered with “Roger”, the Flugleiter added: “You are number one to land. The wind is zero four zero, one zero knots.” Then the airplane started to descend.

At 1527:04 hrs, as the airplane was about 300 m south of threshold 08 flying a north-eastern heading, the radio message “[unintelligible] approach“, was recorded. From then on the airplane began to turn left.

At 1527:11 hrs, the airplane crossed runway 08 with a ground speed of about 100 kt at very low altitude with a northern heading.

At 1527:24 hrs the pilot said: “[...] may I the [...] make an orbit?” The Flugleiter answered: “Yes, do it to your left-hand side and do not overfly the highway westbound.”

At 1527:31 hrs, the last radar target was recorded at approximately 600 m north-west of threshold 08. About 100 m south-west of it, the airplane crashed to the ground and caught fire. All three occupants suffered fatal injuries.

Two witnesses, who were at the airfield close to the tower, stated that they had seen the airplane during the left-hand turn. They estimated the bank angle during the turn was 30-45°.

Fig. 1: Flight path according to radar data and location of witnesses

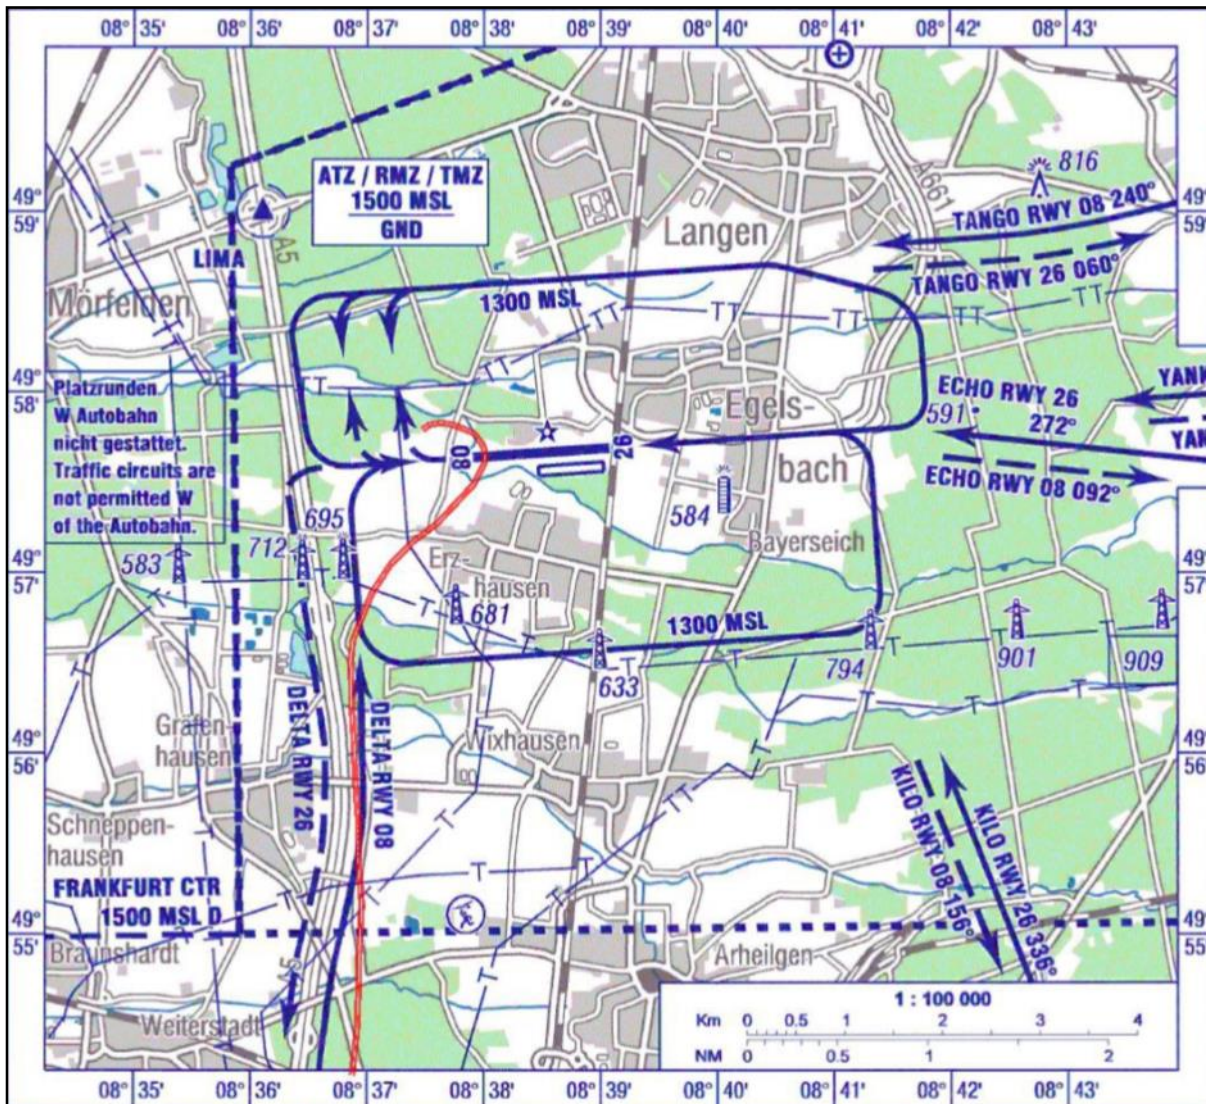
Entry via DELTA along the A5 motorway onto right base of runway 08.

3.6 After establishing visual contact with the APAPI, it is recommended to begin the final approach at a minimum altitude of 1300 ft MSL and an approach angle of 4.4°.

Fig. 3: Excerpt of the visual approach chart of Frankfurt-Egelsbach Airfield with flight path of the aircraft (red line).

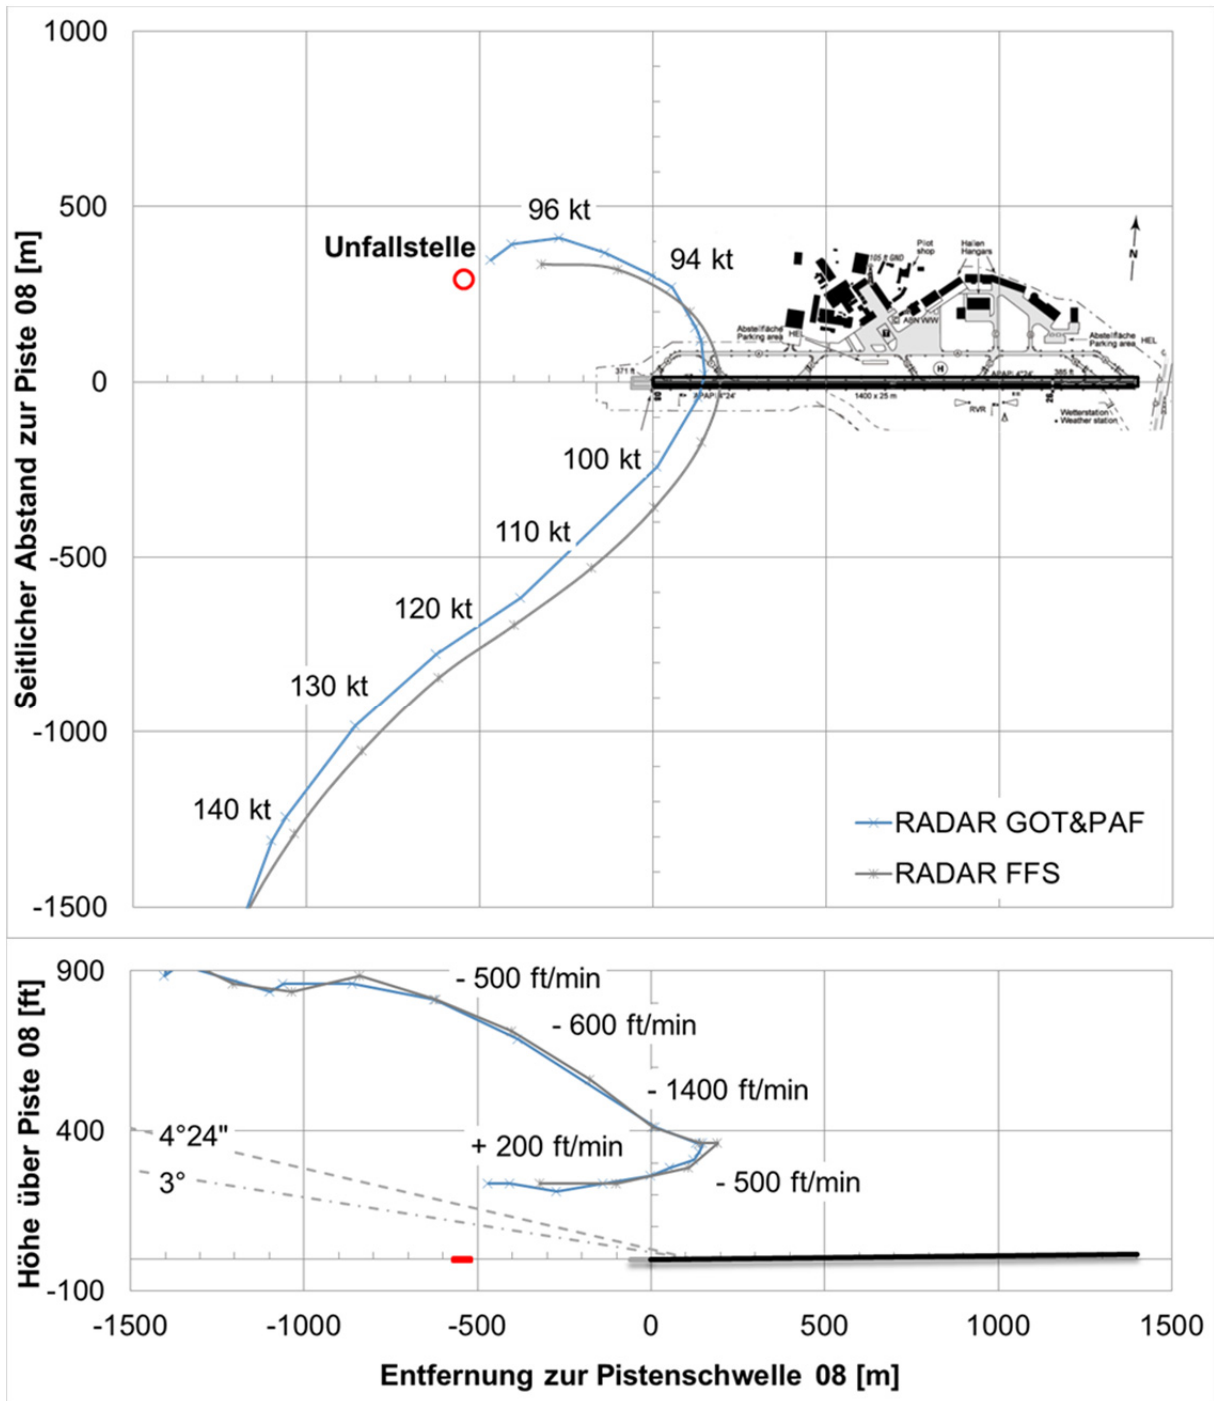
The air navigation service provider provided the BFU with the recorded radar data of individual radar stations. The data of the stations GOT, PAF and FFS were analysed more closely. Depending on the location of the station in relation to Frankfurt-Egelsbach Airfield, the position data was laterally slightly displaced but showed vertically and in time response a similar flight path. The data of the last flight phase was analysed in regard to the runway threshold 08 and depicted as top-view graph (Fig. 4 above) as distance in Meter. The vertical view shows relative altitude above runway 08 (Above Aerodrome Level - AAL) over the distance to the runway threshold (Fig. 4 below).

The calculated data revealed that initially the airplane flew north-east toward Frankfurt-Egelsbach Airfield. Altitude and ground speed decreased continuously. During the left-hand turn, altitude decreased further to about 230 ft AAL. Ground speed decreased to approximately 94 kt. The calculated curve radius was below 500 m. Towards the end of the radar recording, ground speed and vertical speed increased again slightly.

As illustration and comparison with the published standard approach procedures at Frankfurt-Egelsbach Airfield, the vertical speed of the airplane, calculated from the radar points, a 3° approach angle and the APAPI approach angle of 4°24" (4,4°) were included (Fig. 4 below) in the depiction of the vertical flight path.

Fig. 4: Flight path lateral and vertical with data of two radar stations in relation to runway 08

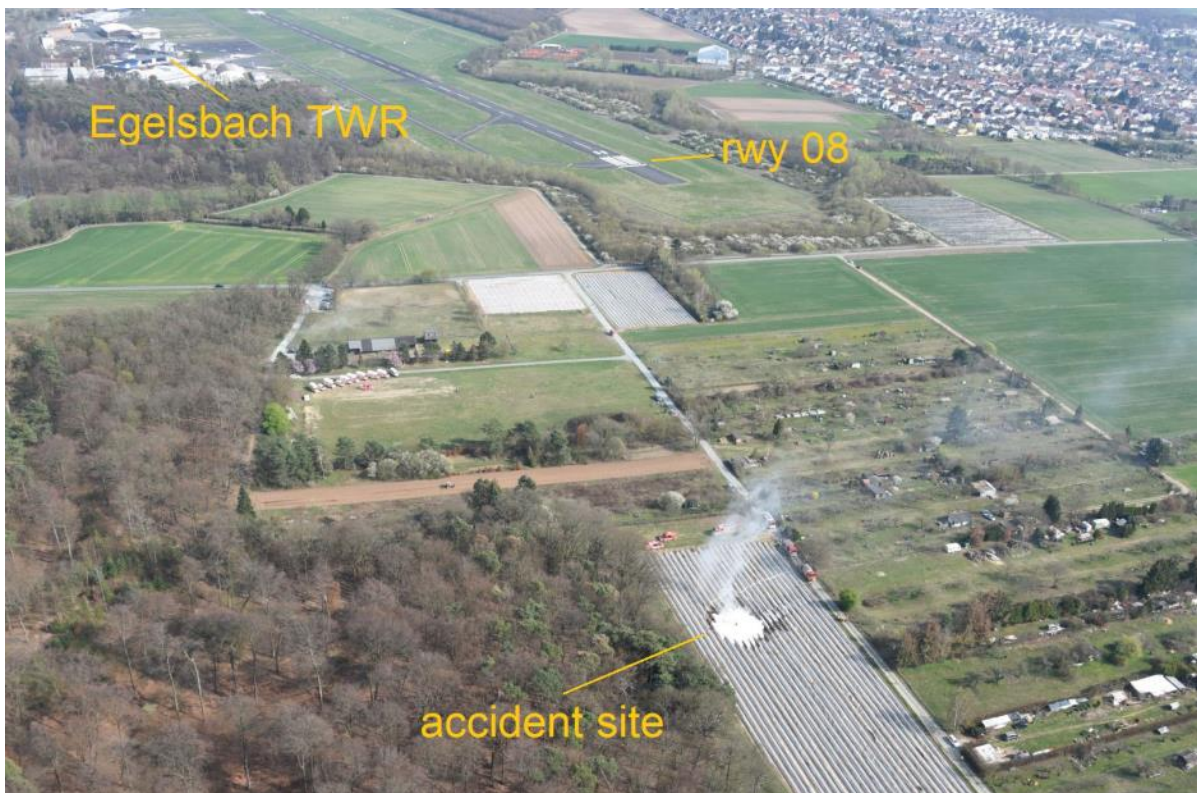
The accident site was located about 600 m north-west of threshold 08 and about 300 m north of the extended runway centre line, at a flat asparagus patch, which was partially covered with plastic.

The plastic had either burnt or melted in an almost circular area with a radius of about 20 m around the wreckage.

Fig. 5: Location of the accident site in relation to the airfield; viewed to south-east

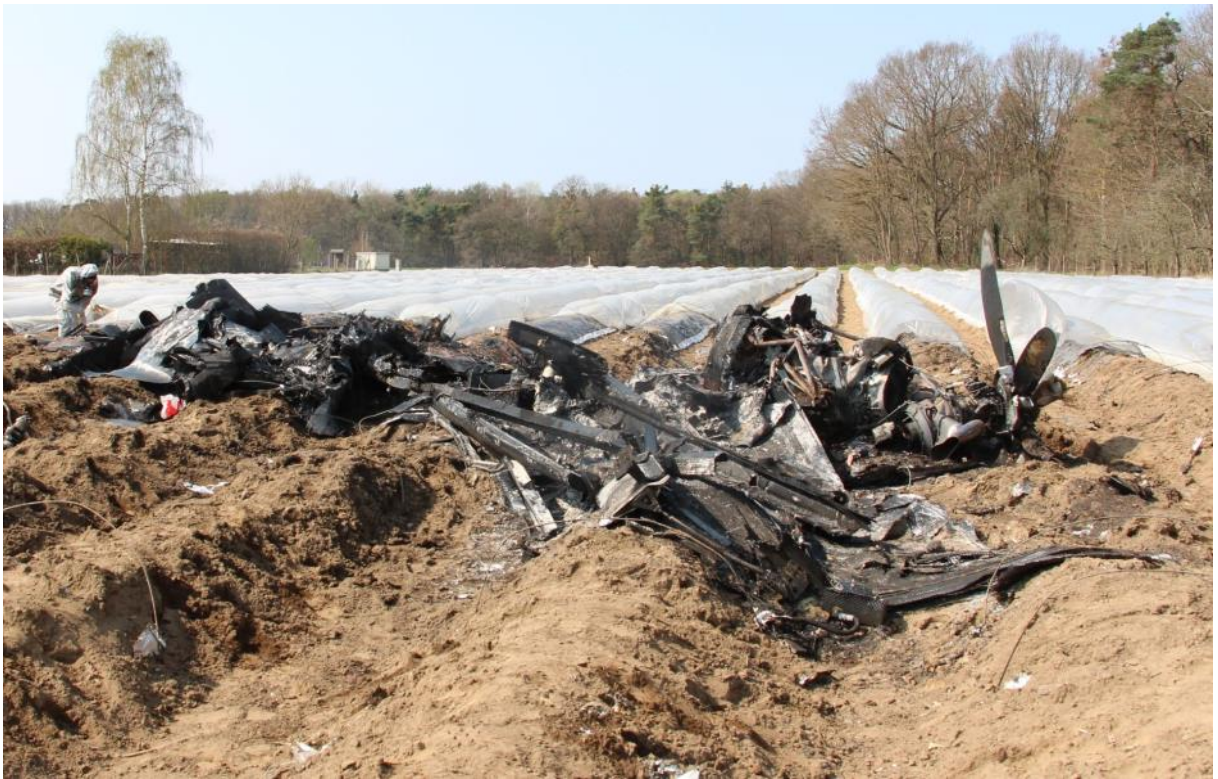
The traces at the accident site and the damage on the aircraft showed that the airplane had impacted the ground with an almost vertical flight path with nose down attitude and slight left bank angle. The fuselage nose including the spinner of the propeller pointed toward approximately 020°.

The entire fuselage and wing unit had been destroyed by fire. The aft part of the fuselage, between wing trailing edges and the empennage, was intact, but the structure had been destroyed by fire. The front part of the fuselage including cockpit had

been destroyed by fire except for the floor component. The cockpit displays (PFD and MFD) including SD-cards had been destroyed by fire.

The wings had separated from the fuselage and were lying on the ground turned left about the vertical axis by about 25°. On the right wing the flap was folded beneath the aft wing spar. The weather radar had been torn off the right wing and was lying about 5 m north of the wreckage. The landing gear was extended.

Fig. 6: Overview of the wreckage, viewed toward west

Due to the high degree of destruction, technical examination of the wreckage was possible only to a limited extent.

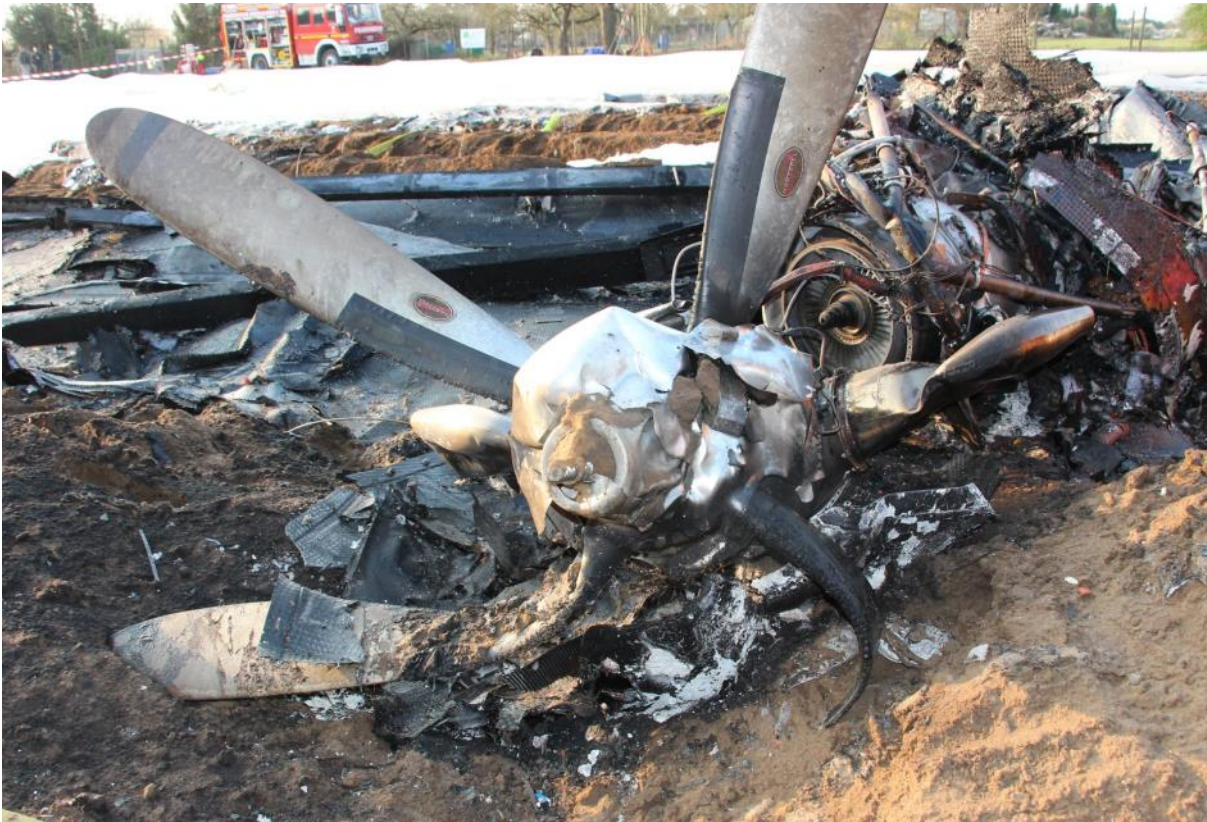
Fig. 7: Damage on the propeller blades and the spinner

Two of the four propellers blades were deformed contrary to their rotating direction. The examination of the engine with a Boroscope showed ingested earth and soot in the area of the first stage compressor rotor.

The sounds of a video recording of a witness, the determined damage at the propeller and the ingested soil in the engine prove that the engine was running at the time of impact.

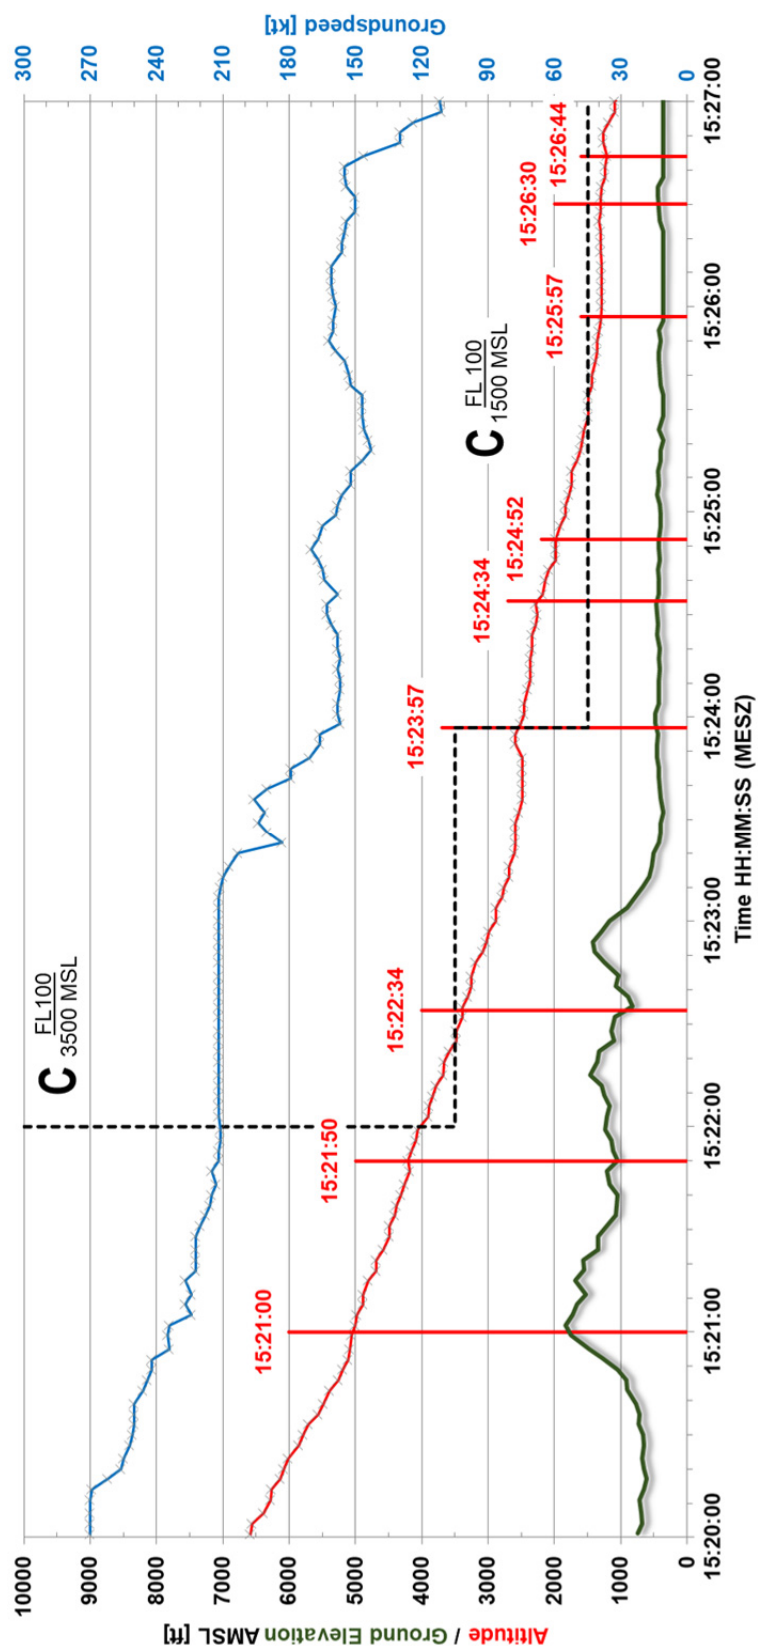
Appendix 1 vertical profile of the descent including airspace C boundaries

The radar data of the airplane shows that being in descent and coming from south-east the aircraft entered this section of airspace C at about 2,500 ft AMSL, i.e. significantly above 1,500 ft AMSL. Approximately one minute later, at the position DELTA, the airplane was still at 1,900 ft AMSL. The two airspace violations in short order, the missing acknowledgement of the transponder code and not selecting it either suggest that in this phase the pilot had a high workload.
