Aviation Investigation Final Report

Location:	Soldotna, Alaska	Accident Number:	ANC20LA074
Date & Time:	July 31, 2020, 08:27 Local	Registration:	N4982U (A1); N2587M (A2)
Aircraft:	De Havilland DHC-2 (A1); Piper PA 12 (A2)	Aircraft Damage:	Substantial (A1); Substantial (A2)
Defining Event:	Midair collision	Injuries:	6 Fatal (A1); 1 Fatal (A2)
Flight Conducted Under:	Part 135: Air taxi & commuter - Non-scheduled (A1); Part 91: General aviation - Personal (A2)

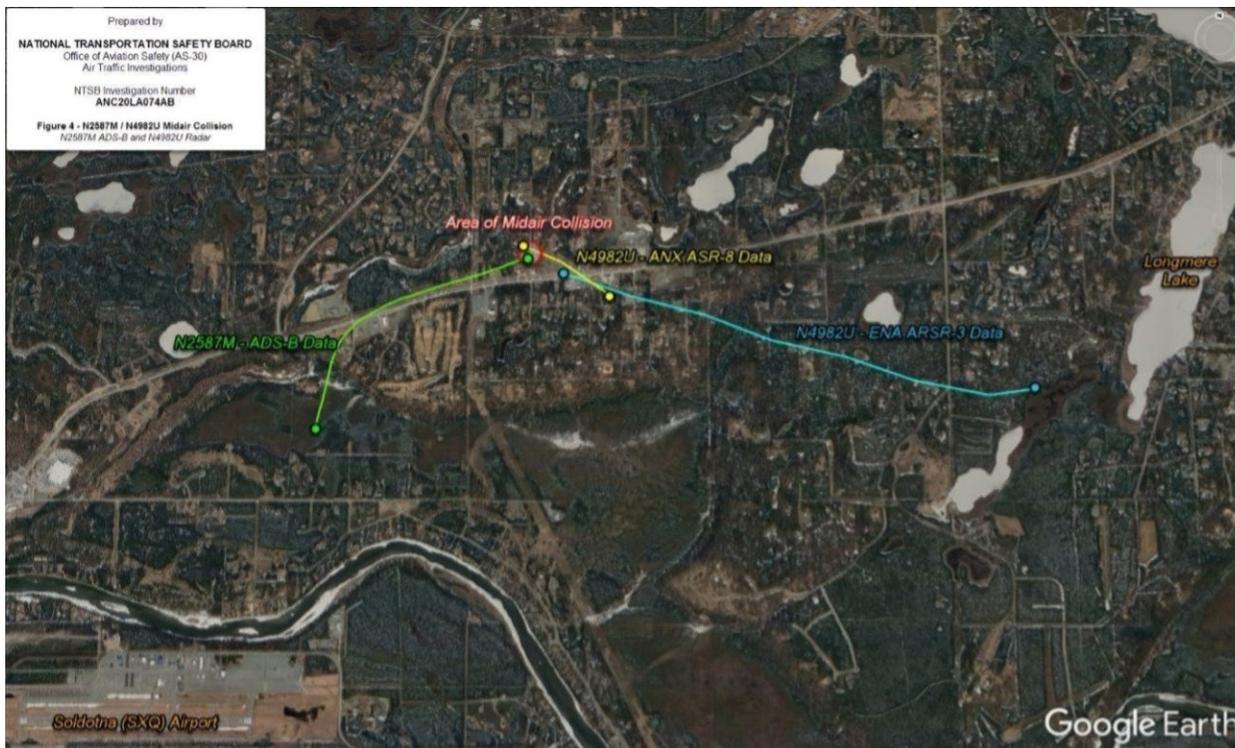
Flight track data revealed that the DHC-2 was traveling northwest about 78 knots (kts) groundspeed and gradually climbing through about 1,175 ft mean sea level (msl) when it crossed the Sterling Highway. The PA-12 was traveling northeast about 1,175 ft msl and about 71 kts north of, and parallel to, the Sterling Highway. The airplanes collided about 2.5 miles northeast of the Soldotna airport at an altitude of about 1,175 ft msl. See figure 1 for the airplanes' flight tracks.

Figure 1 - Flight track. ADS-B data (N2587M) and ENA/ANX radar data (4982U).

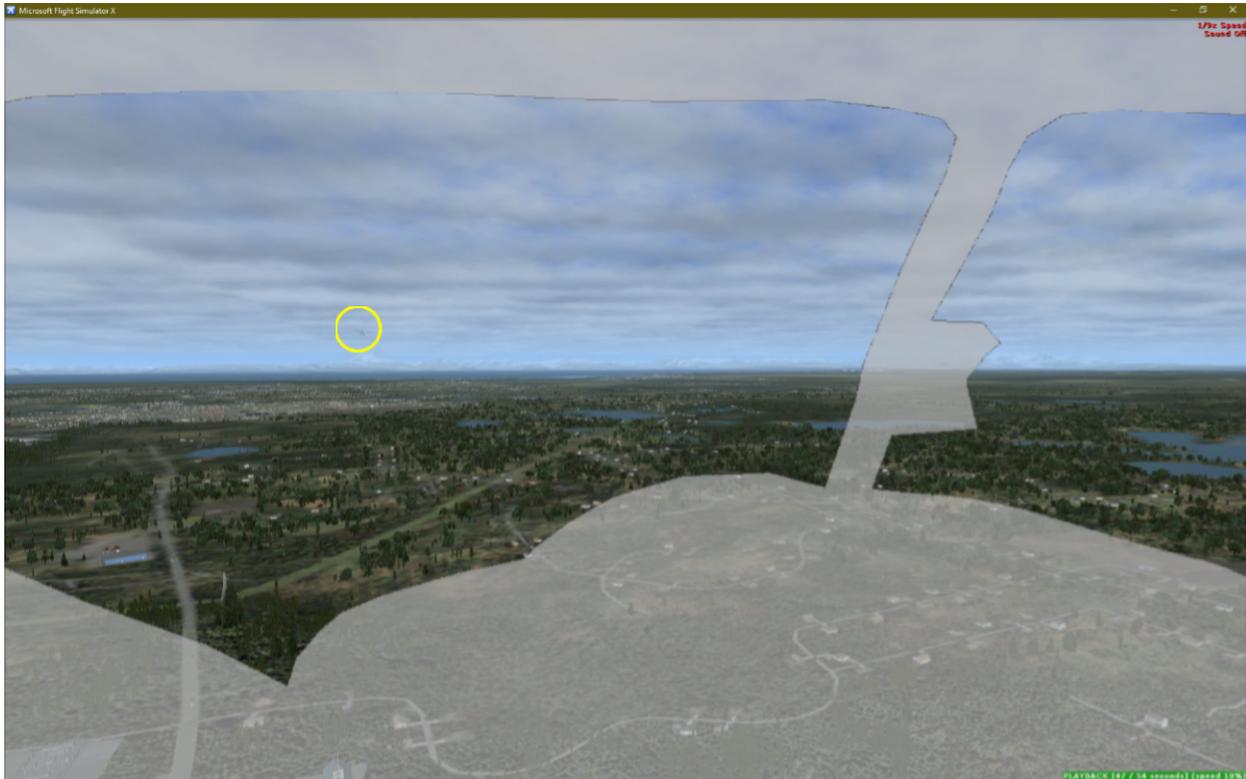
The cockpit visibility study revealed that for the 53-second period before the collision, the Piper would have been unobscured and visible from the DHC-2 pilot through the DHC-2 left windshield.

Figure 2 - Recreation of the view from the DHC-2 cockpit at 0826:27 (5.3 seconds before the collision). The location of the PA-12 is indicated by the yellow circle.

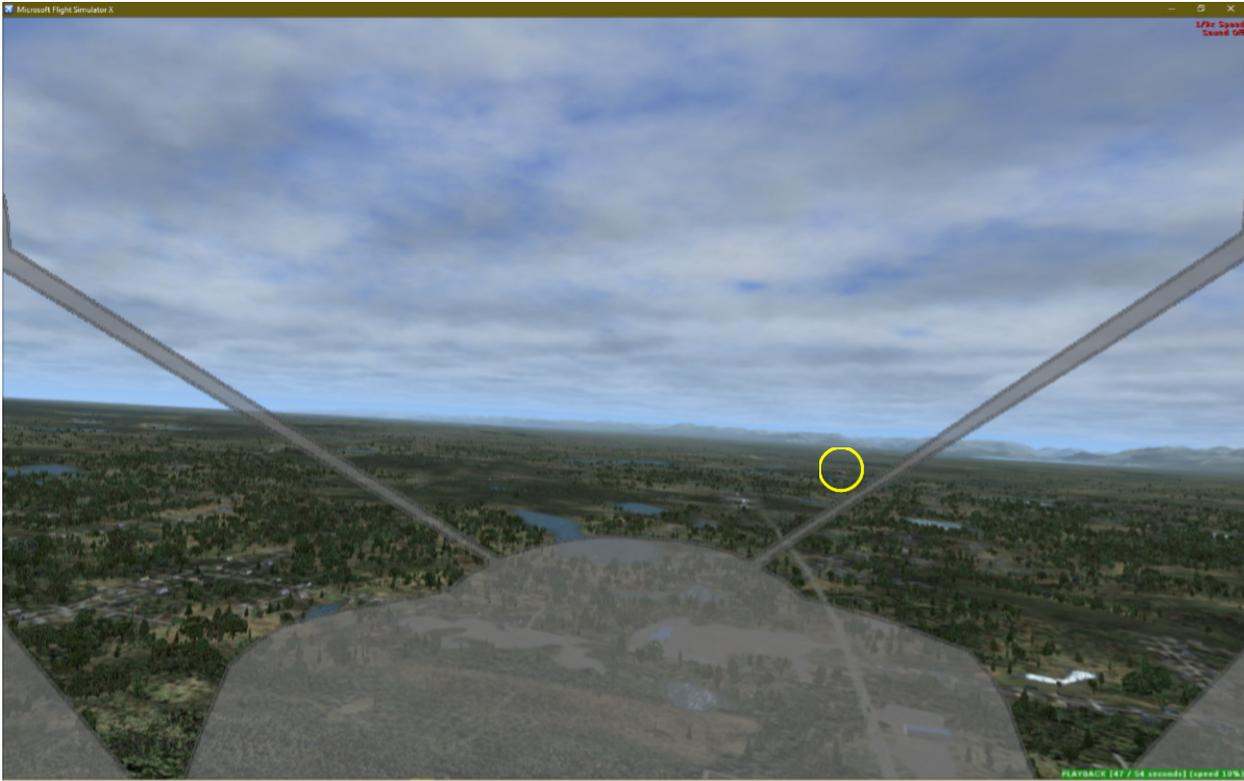
Regarding whether the PA-12 pilot could have seen the DHC-2, between 0825:39 to just before 0825:51 (12 seconds) the DHC-2 would have been unobscured and visible through the PA-12 right window. The DHC-2 would have then been obscured behind the PA-12 right wing root until about 0825:58. The DHC-2 would then have appeared on the right edge of, or been obscured by, a structural support tube inside the cockpit from about 0825:58 to about 0826:04 (6 seconds). From 08:26:04 to the collision at 08:26:32.3 (28.3 seconds), the DHC-2 would have been unobscured and visible in the PA-12 windshield, just to the left of the support tube.

Figure 3 - Recreation of the view from the Piper cockpit at 0826:27 (5.3 seconds before the collision). The location of the DHC-2 is indicated by the yellow circle.
