AIRCRAFT ACCIDENT REPORT

STERLING AIRWAYS INC.
CARAVELLE SE-210-10B3, OY-STL
FUJAYRAH, 50 NM EAST OF DUBAI AIRPORT
14. MARCH 1972

of the Investigation into the Accident involving Sterling Airway's
Caravelle Aircraft OY-STL in the Emirate Fujayrah on the 14th. March 1972.

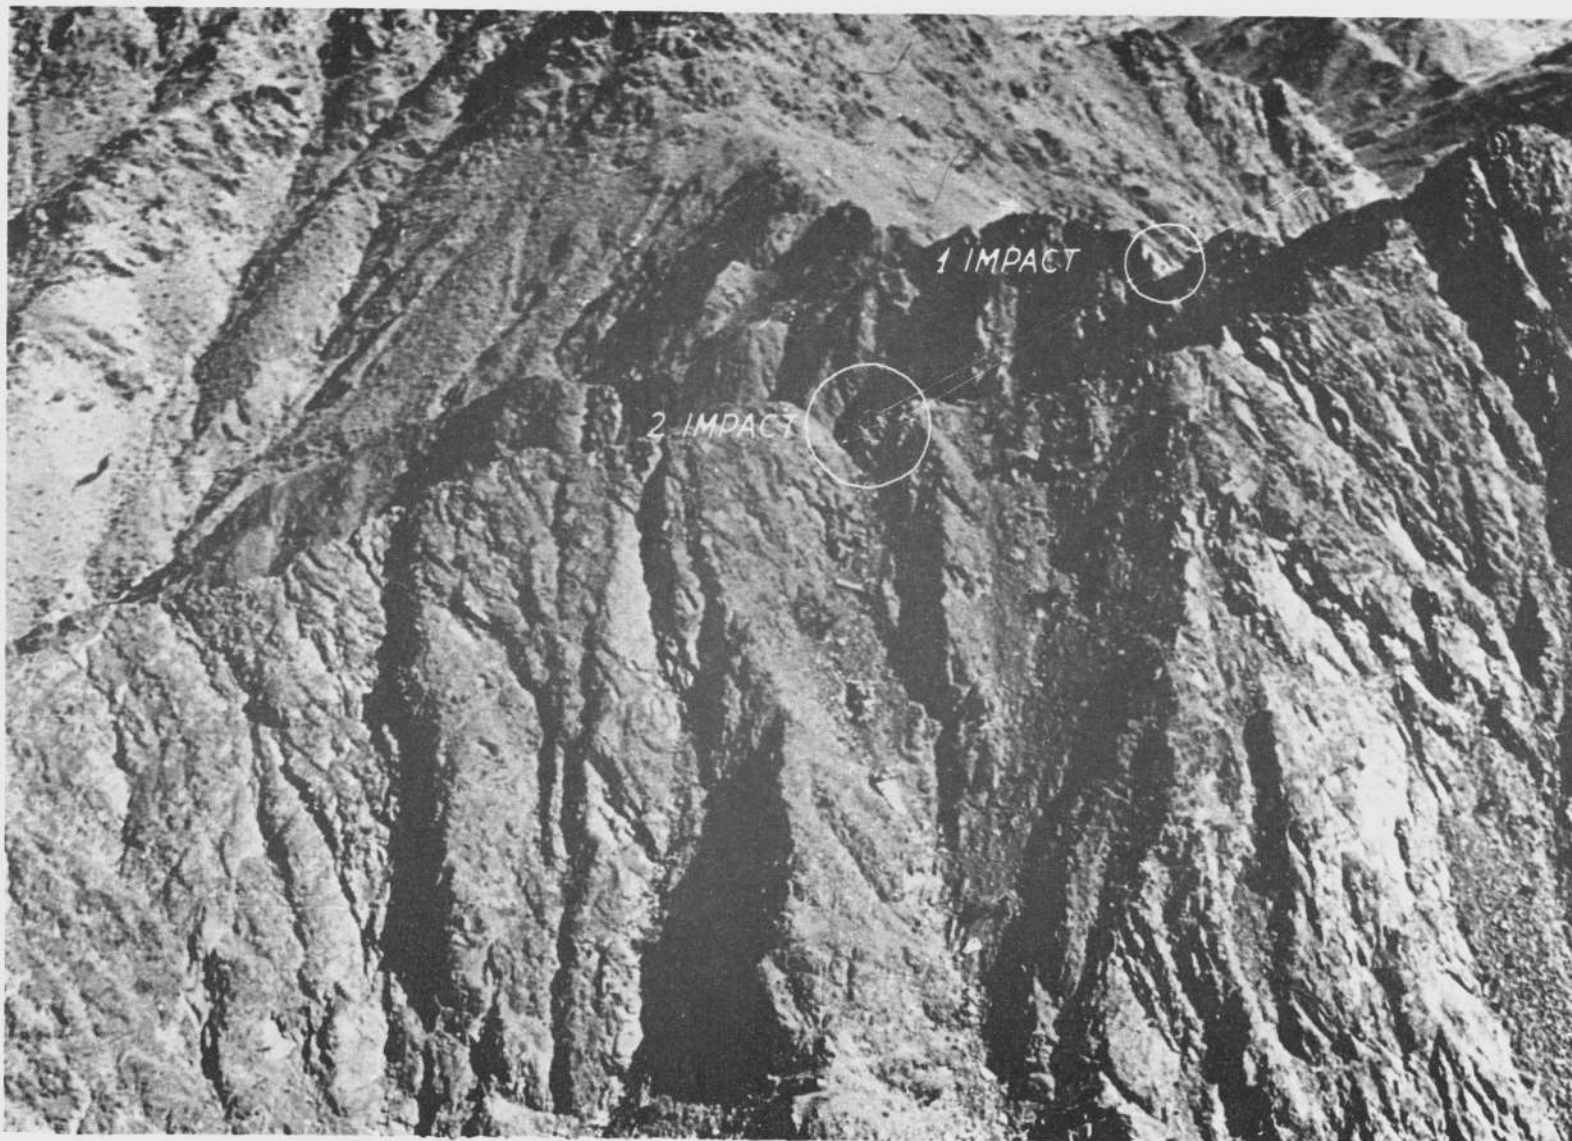
Accident site seen from west.
