Controlled flight into terrain involving Cessna 404, VH-OZO

6 km south-east of Lockhart River Airport, Queensland, on 11 March 2020

ATSB Transport Safety Report

AO-2020-017

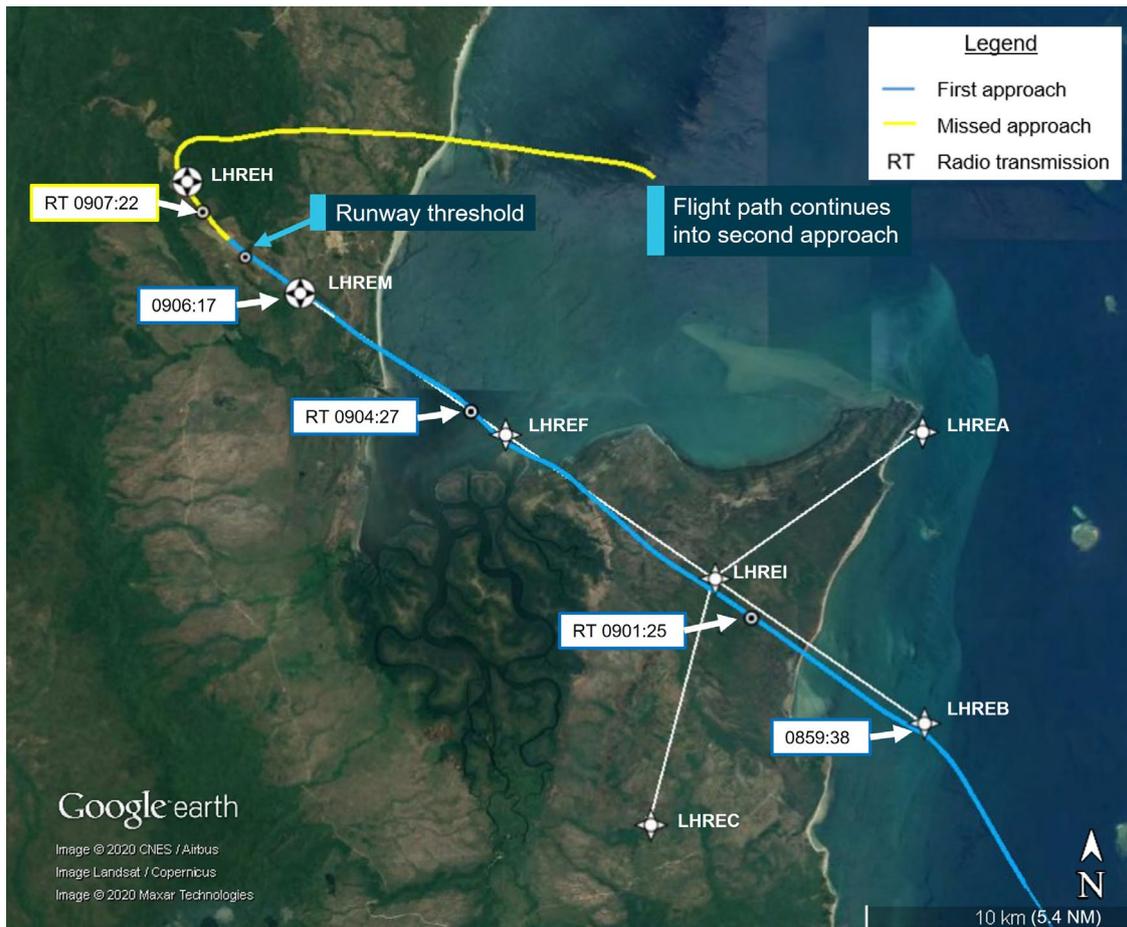
Figure 3: Flight track of VH-OZO during first RNAV GNSS approach at Lockhart River Airport with times, feature labels, and approach parameters superimposed

The pilot conducted the first approach consistent with the recommended (3°) constant descent profile, and the aircraft kept descending through the minimum descent altitude (MDA) of 730 ft and passed the missed approach point (MAPt). At about 400 ft, the pilot commenced a missed approach.

At 0859:38, the aircraft passed abeam LHREB, commenced descent from 5,400 ft and turned left to track to the runway in accordance with the RNAV GNSS procedure. At 0901:25, the pilot made a radio broadcast on the CTAF, advising the aircraft was 10 NM⁷ to the south-east of the aerodrome, inbound to runway 30 and on descent passing 4,000 ft. Shortly afterwards, the aircraft passed the intermediate fix (IF) LHREI at 4,000 ft.

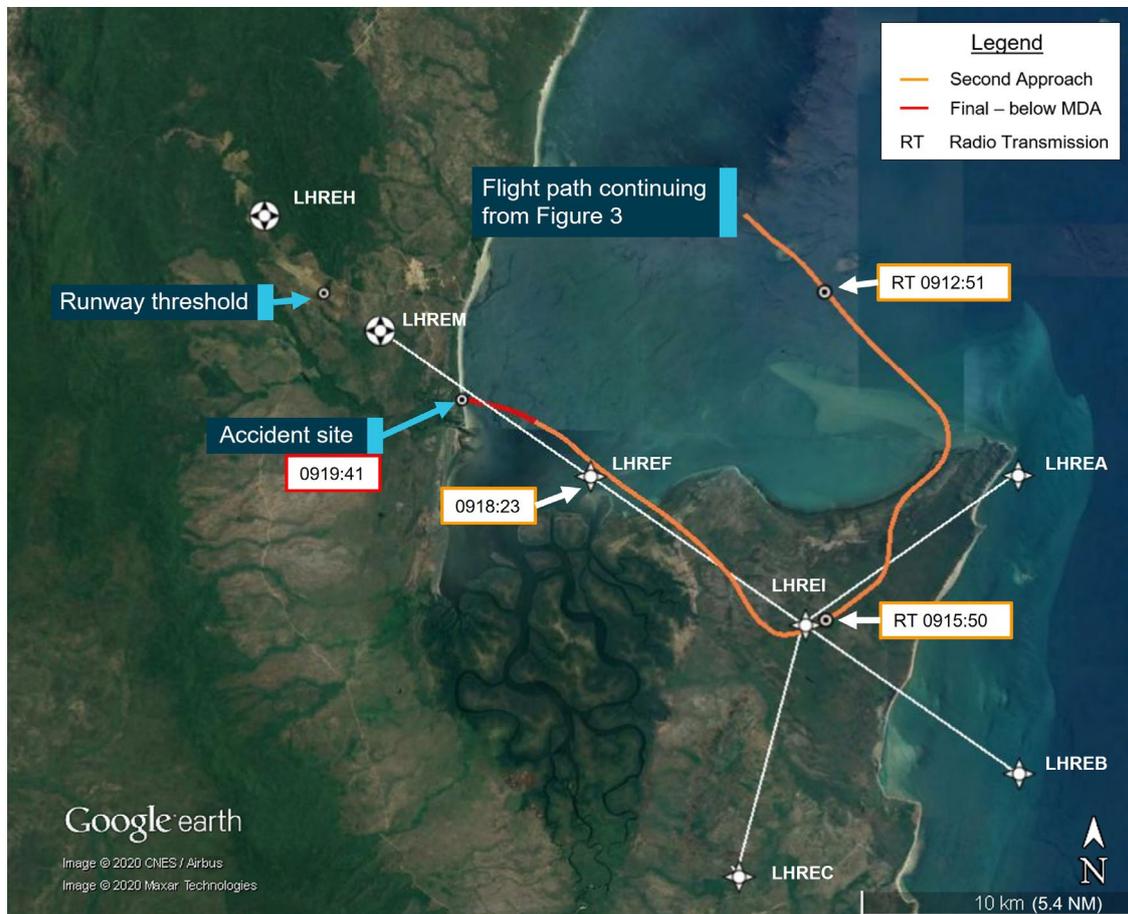
Figure 5: Flight track of VH-OZO during second RNAV GNSS approach at Lockhart River Airport with times, feature labels, and approach parameters superimposed

The most likely scenario to explain the descent 1,000 ft below the recommended descent profile on the second approach could not be determined. Regardless of the exact scenario, it is evident from the continued descent that the pilot did not effectively monitor the aircraft's altitude and descent rate for an extended period.

At about 0914:43, when about 2.7 NM from LHREI, the aircraft started descending from 3,500 ft. At this time, the aircraft was tracking towards the initial approach track between LHREA and LHREI (Figure 5).

The aircraft continued descending and passed over LHREI and turned right to fly parallel to the intermediate approach track at about 2,800 ft. According to the recommended flight profile for a 3° approach (Figure 2), the aircraft should have descended from 3,500 ft at about 4.2 NM from the FAF (9.2 NM from the MAPt). At this point, the aircraft was at about 2,500 ft.

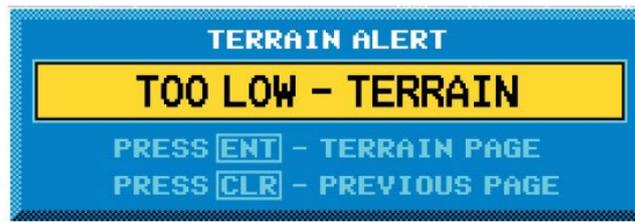
Figure 10: Premature descent alert on the GNS 430W display

Based on this information and the recorded data for the accident flight (*Recorded flight data*), provided that the terrain advisory/alert function was enabled, a yellow and black 'TERRAIN' annunciation would be generated in the lower left corner of the LCD display, accompanied by a yellow and black 'TOO LOW – TERRAIN' PDA pop-up alert (Figure 10), about 15 seconds prior to the terrain collision.

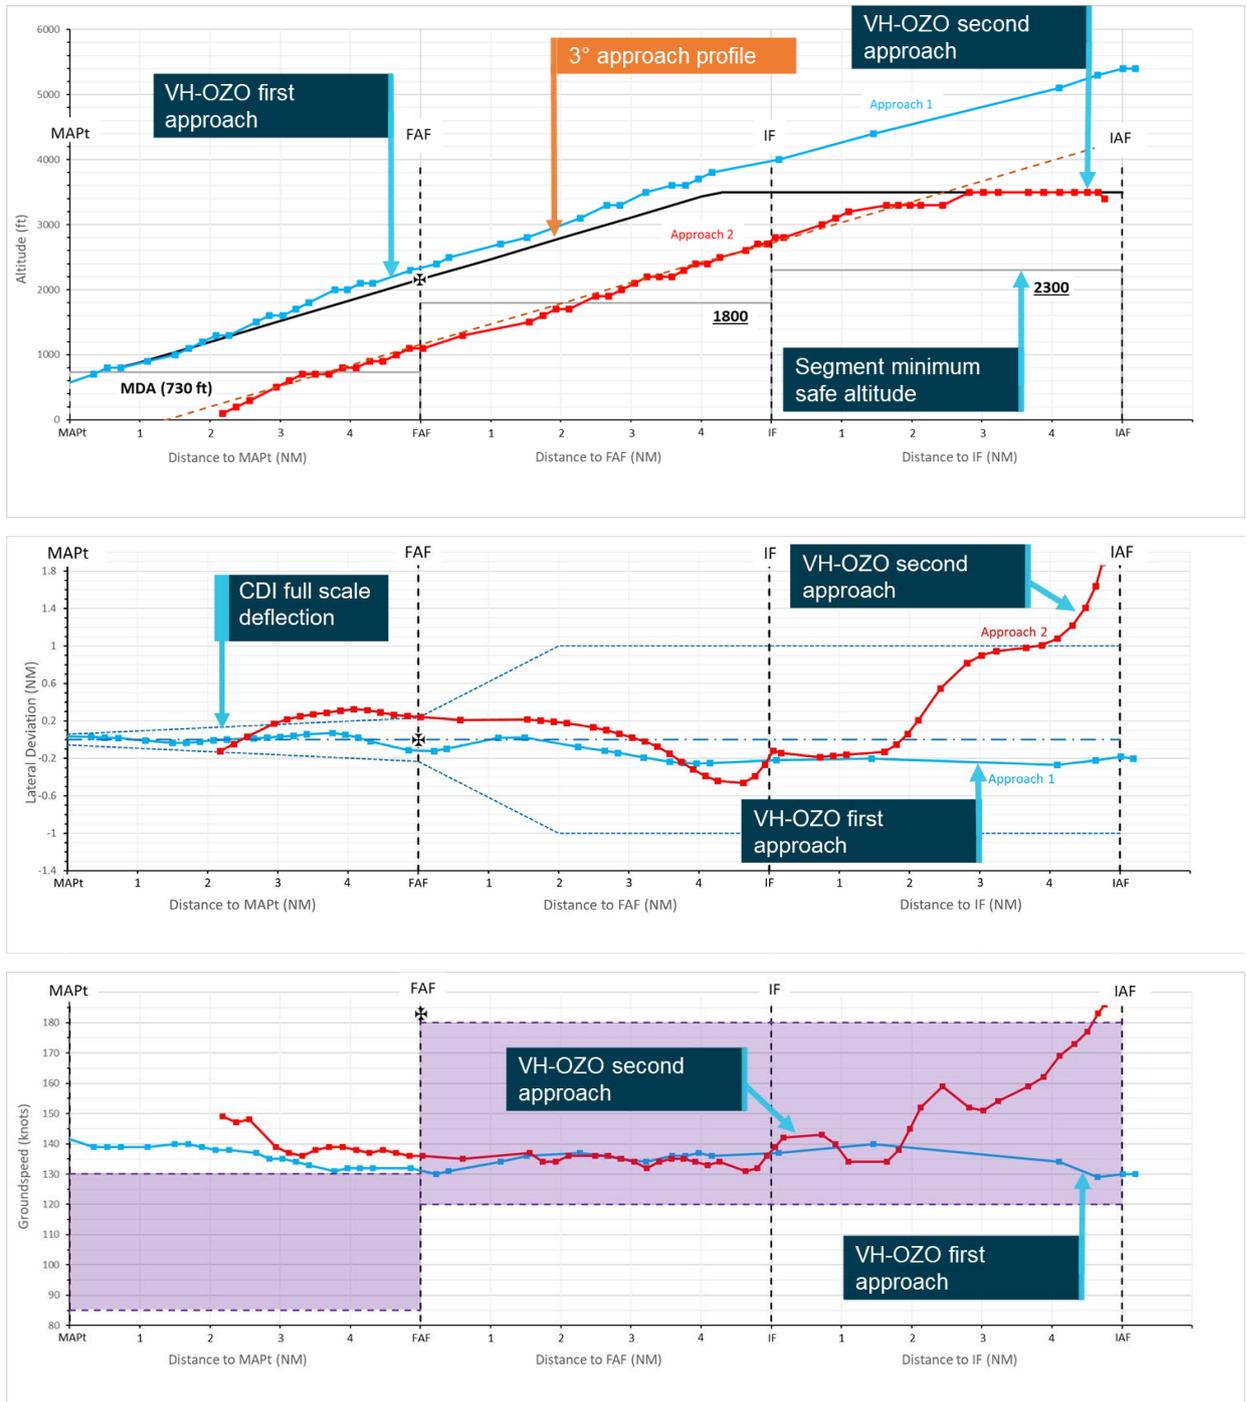
Figure 17: Recorded data for first and second approaches to Lockhart River

The upper panel shows altitude, the middle panel shows lateral deviation from the instrument approach path and the lower panel shows groundspeed. The purple bands on the groundspeed panel refer to the handling speeds (for indicated airspeed) specified in the Aeronautical Information Publication for a category B aircraft, such as the Cessna 404 (see Handling speeds). Source: OzRunways data overlaid with Airservices approach information, annotated by the ATSB

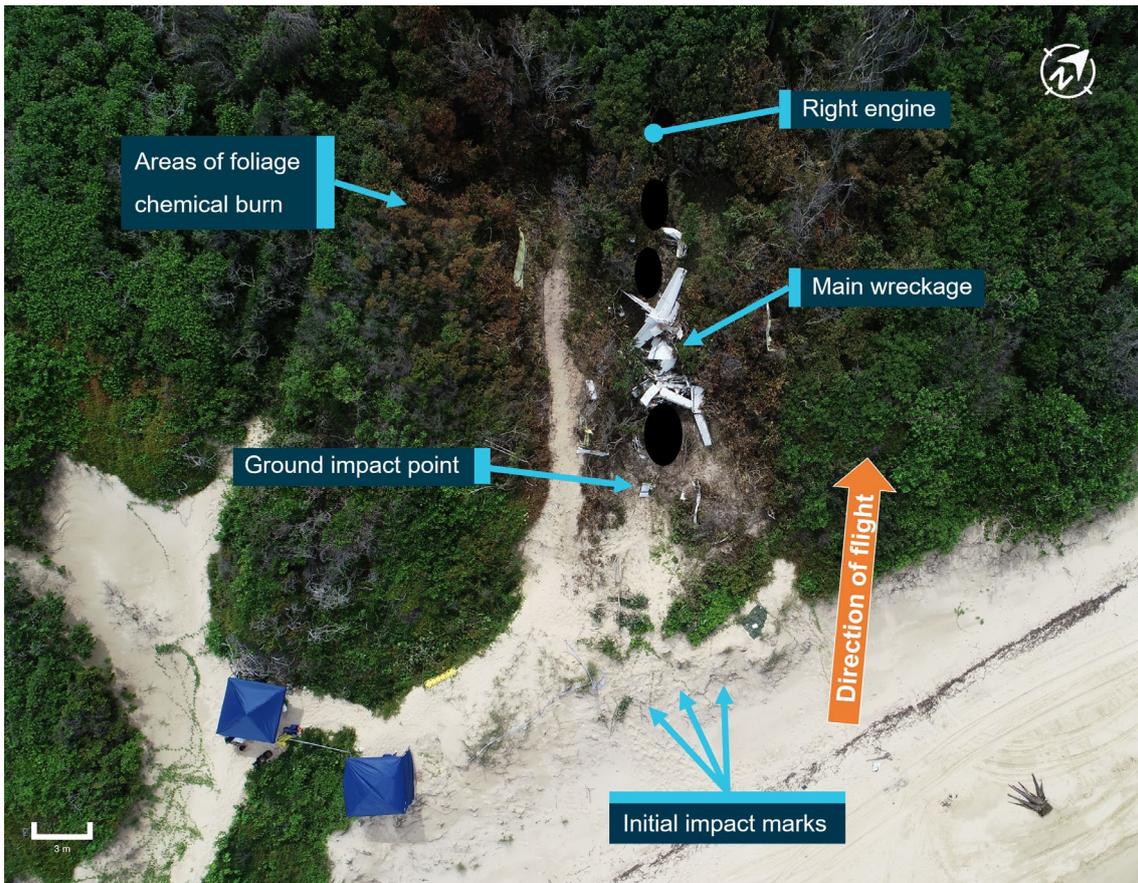
Figure 18: Overview of accident site

The wreckage trail was spread over a distance of about 20 m from the initial impact point and the trail indicated that the aircraft was on a heading of about 280° (magnetic), with the impact point about 30 ft above mean sea level (Figure 18).

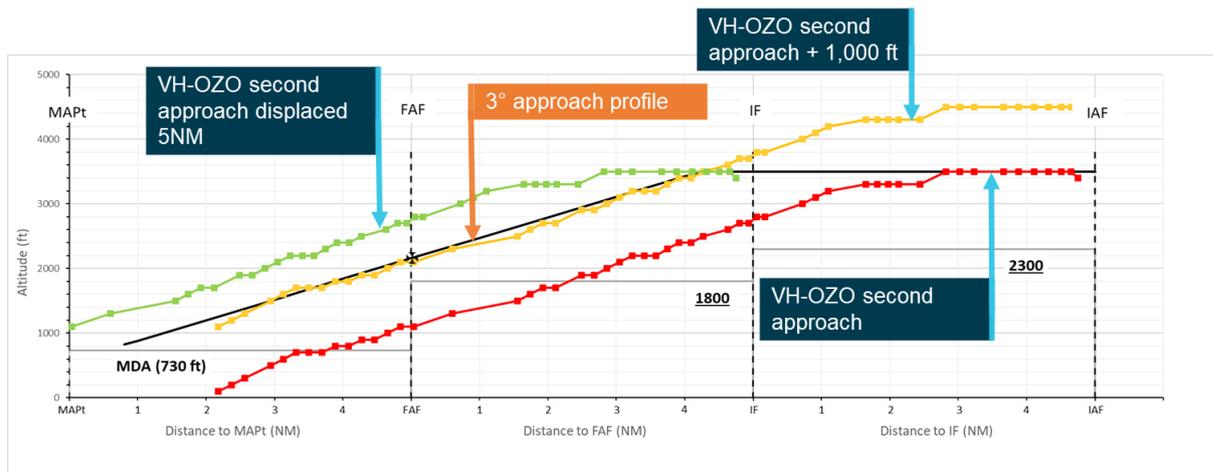
Figure 21: Second approach to runway 30 (red), second approach displaced 5 NM (green) and second approached raised 1,000 ft (yellow)

The second scenario is the pilot believed they were 1,000 ft higher than they actually were during most of the descent. This scenario is shown on Figure 21 (in yellow). With regard to this scenario:

- The scenario closely matches the recommended descent profile in terms of commencing the 3° descent at about the right point for a constant descent and then continuing the descent past the IF and FAF.

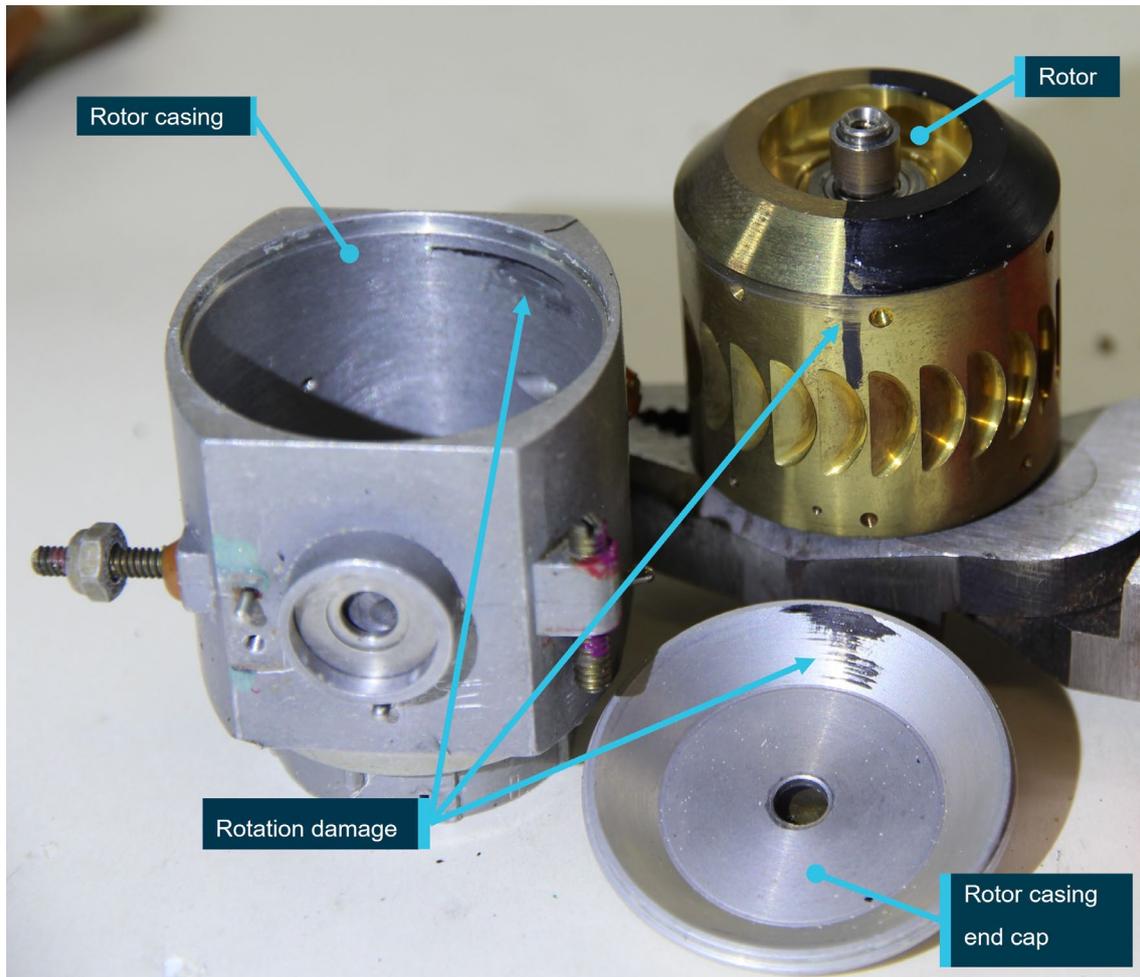
Figure 22: Left artificial horizon internal components showing rotational contact damage

The left artificial horizon instrument and directional guidance instrument were recovered from the aircraft after the accident, disassembled and examined. The left artificial horizon instrument was significantly damaged, however detailed examination of the components did not identify any pre-impact defects. Rotational scoring was noted between the rotor, the casing and the end cap with metal transfer evident (Figure 22). This indicates that the rotor was rotating with significant speed, highly likely produced by suction from the vacuum pump(s), when the aircraft impacted with terrain.

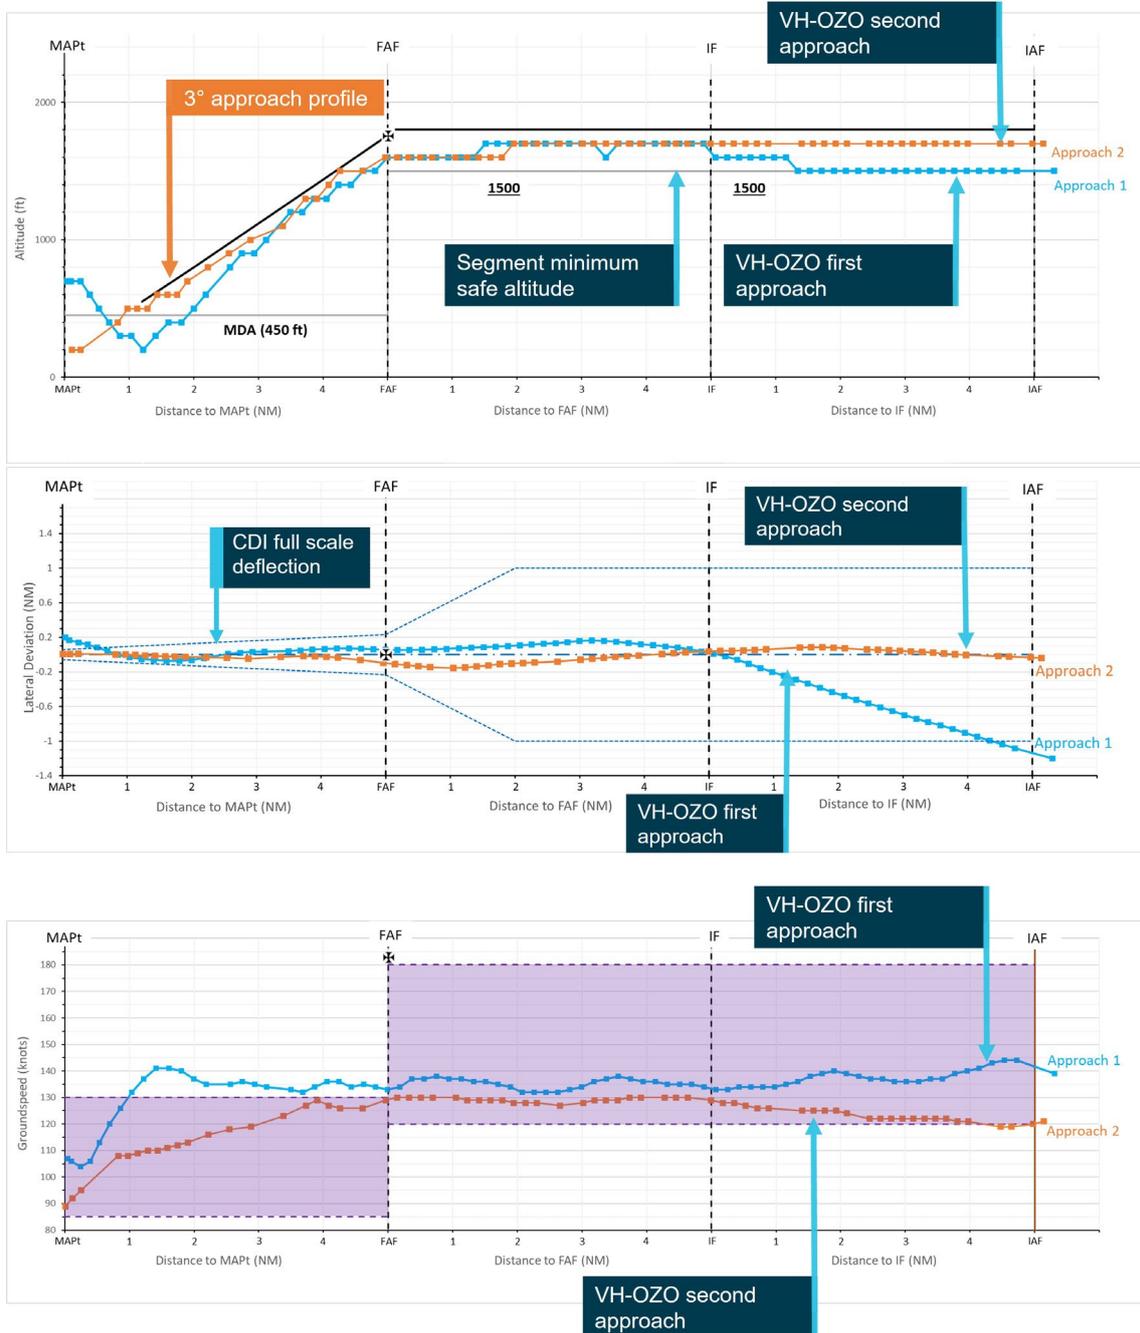
Figure 25: Recorded data for 2 RNAV approaches to Aurukun 22 January 2020

The descent rate from the FAF (recorded height 1,600 ft) until the aircraft reached 900 ft was about 650 ft/min, and the descent rate for the remainder of the descent was about 1,050 ft/min.
