Aviation Investigation Final Report

Location:	Hiles, Wisconsin	Accident Number:	CEN21FA459
Date & Time:	September 28, 2021, 09:00 Local	Registration:	N690LS
Aircraft:	ROCKWELL INTERNATIONAL 690B	Aircraft Damage:	Destroyed
Defining Event:	Loss of control in flight	Injuries:	3 Fatal
Flight Conducted Under:	Part 91: General aviation - Aerial observation

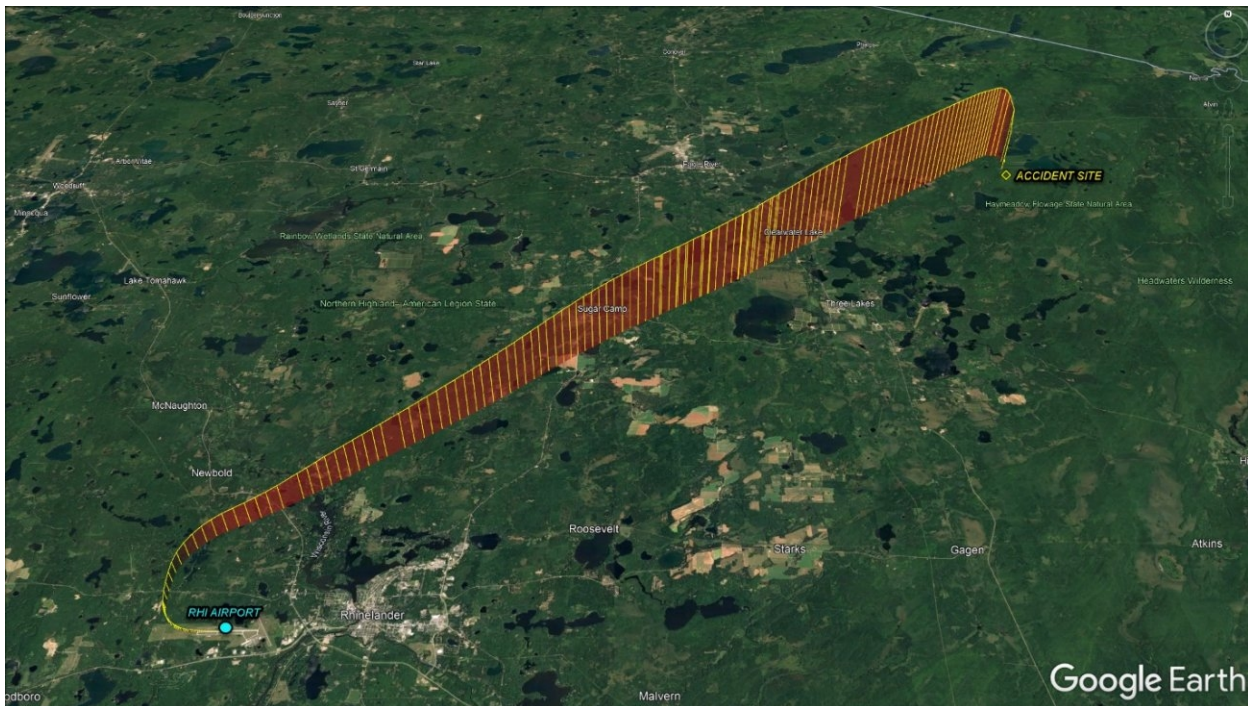
The airplane subsequently made a right turn with a rapid descent (see figure 1), and the ADS-B data ended at 0900:56. According to ATC audio, transmissions indicating “mayday, mayday, mayday” and “we’re in a spin” were broadcast while the accident airplane was in flight.

Figure 1. Airplane flightpath and accident site location.

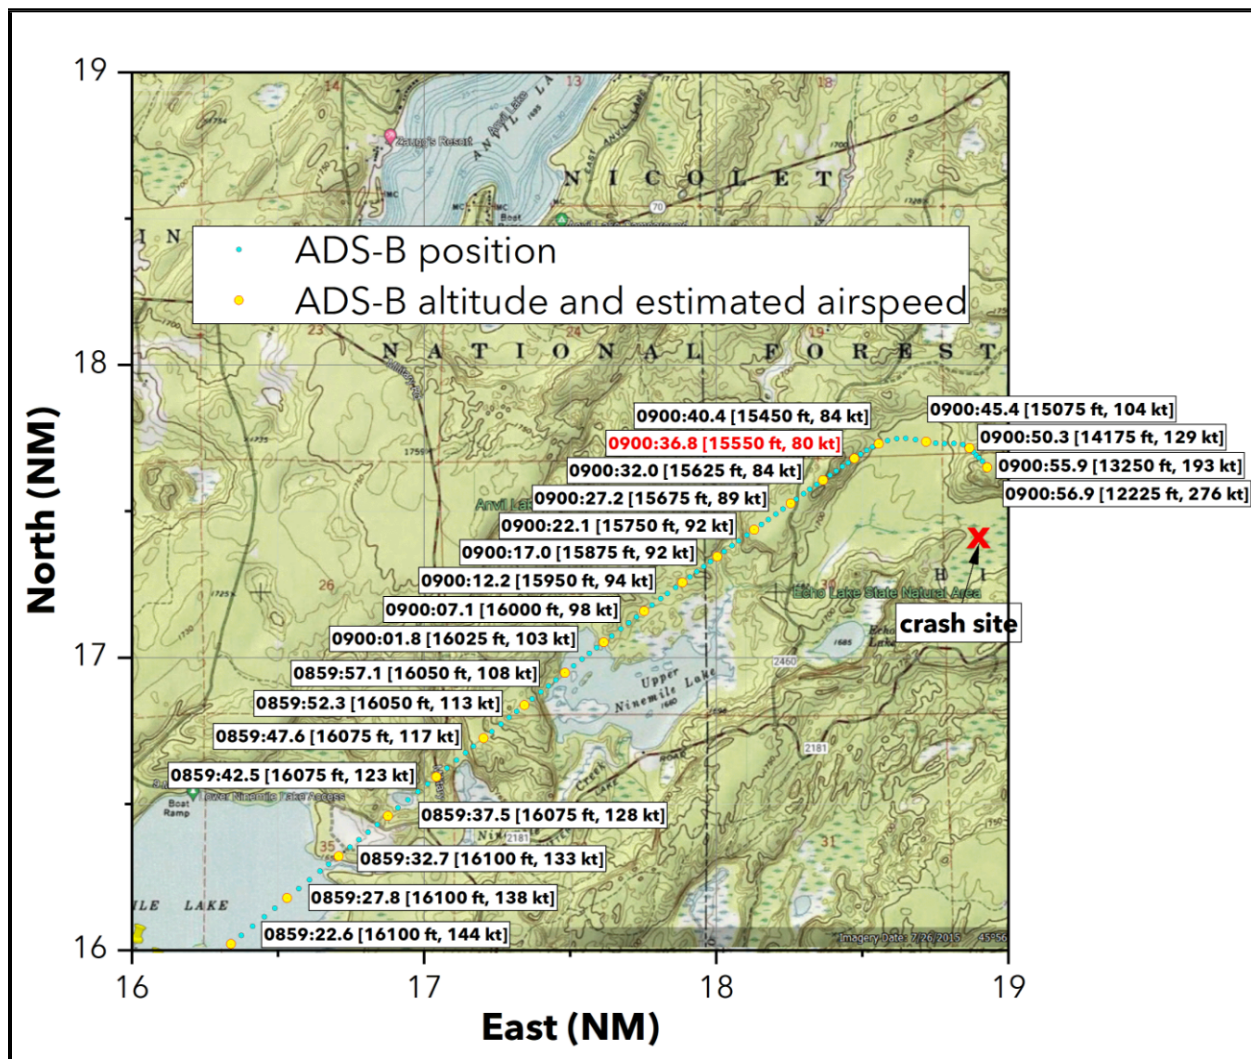
An aircraft performance study was conducted for this investigation. The study was largely based on ADS-B data. Figure 3 shows the ADS-B altitude and estimated airspeed for the 11-minute flight in an overhead view. The airplane's airspeed was estimated to be at the stall speed at the altitude, airspeed, and time marked in red in the figure.

Figure 3. ADS-B altitudes and airspeeds for the accident flight.

At 0900:38.7, the airplane pitched down in excess of 30° and descended at a rate that reached 20,000 ft per minute. About the time that the airplane pitched down, the estimated normal load factor decreased from about 1.6 Gs to less than 1 G.

The study stated that a decrease in normal load factor is consistent a stall when the wing reaches its critical angle of attack, at which time the air flow becomes separated at the wing and the wing can no longer generate the necessary lift. The study also stated that a spin could result if an airplane were in uncoordinated flight at the time of a stall.
