# Aviation Investigation Final Report

<b>Location:</b>	Honolulu, Hawaii	<b>Accident Number:</b>	DCA21FA174
<b>Date &amp; Time:</b>	July 2, 2021, Local	<b>Registration:</b>	N810TA
<b>Aircraft:</b>	Boeing 737-275C	<b>Aircraft Damage:</b>	Destroyed
<b>Defining Event:</b>	Loss of engine power (partial)	<b>Injuries:</b>	1 Serious, 1 Minor
<b>Flight Conducted Under:</b>	Part 121: Air carrier - Non-scheduled

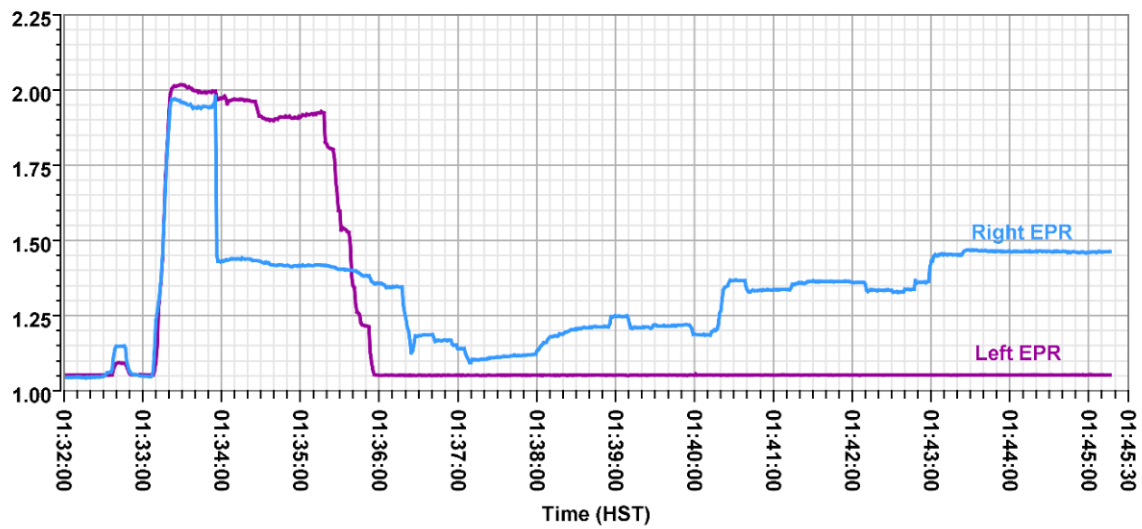
**Figure 2.** Left and right EPR values during the accident flight.

Note: The EPR decrease on the left engine between 0135:00 and 0136:00 (in purple) occurred between events 6 and 7 in figure 1.

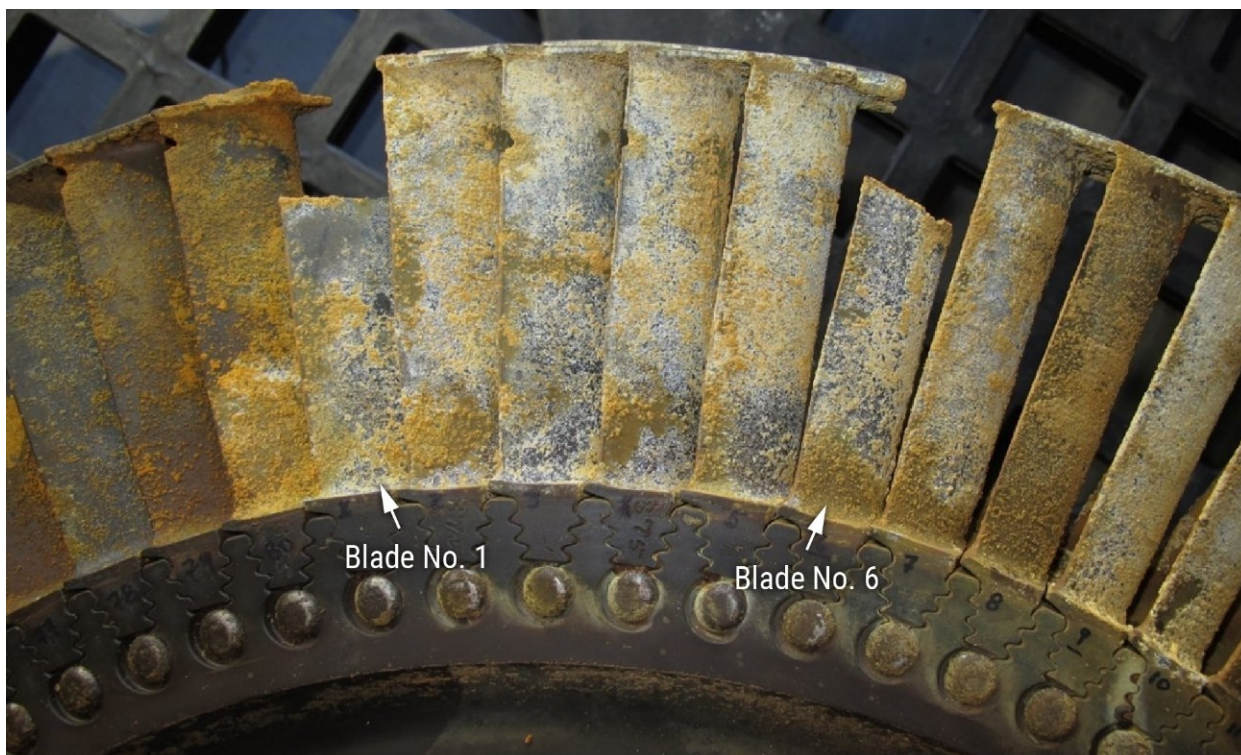
The teardown of the right engine showed that two high-pressure turbine stage 1 blades were missing their outer spans and that both had failed from a stress rupture fracture due to oxidation and corrosion of the internal blade lightening (weight-reduction) holes, which resulted in a loss of load-bearing cross-section. The blade failures caused downstream (secondary) damage to the low-pressure turbine, resulting in a loss of thrust, which would have been presented to the flight crew as a decrease in EPR on the right engine (along with the thud sound recorded on the CVR and the yaw to the right).

**Figure 4.** Fractured blades on the right engine high-pressure turbine.

Blade Nos. 1 and 6 were fractured transversely about 2.4 and 2.7 inches, respectively, above the platform trailing edge. Blade Nos. 3, 4, 79, and 80 exhibited trailing-edge outer diameter impact damage toward the outer span. Other blade trailing edges showed varying damage with missing material up to 0.04 inches radially. The blade fracture surfaces were heavily coated with ocean deposits.

The two fractured high-pressure turbine blades (Nos. 1 and 6) were examined at Pratt & Whitney's Materials and Processes Engineering Lab in East Hartford, Connecticut. The examination determined that the blades failed by stress rupture resulting from a loss of load-bearing material due to oxidation and corrosion. The oxidation occurred around the blades' internal lightening (weight-reduction) holes and had significantly reduced each blade's load-bearing cross-section. The fracture through the oxidized regions exhibited comparatively flat features, consistent with brittle fracture. The fracture across the remaining load-bearing blade material either exhibited a rough (intergranular) texture, which was consistent with stress rupture, or was covered by ocean deposits.

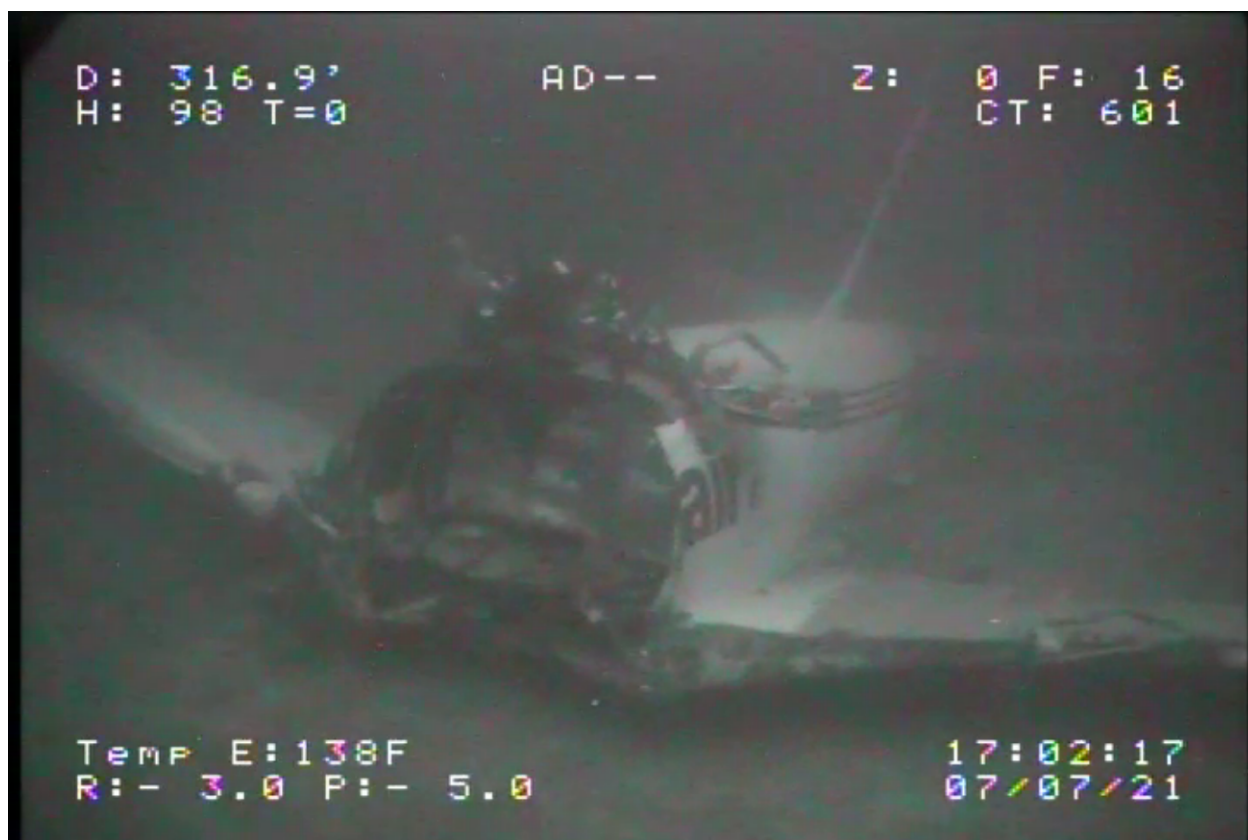
**Figure 5.** Aft fuselage (Source: Sea Engineering Inc.).

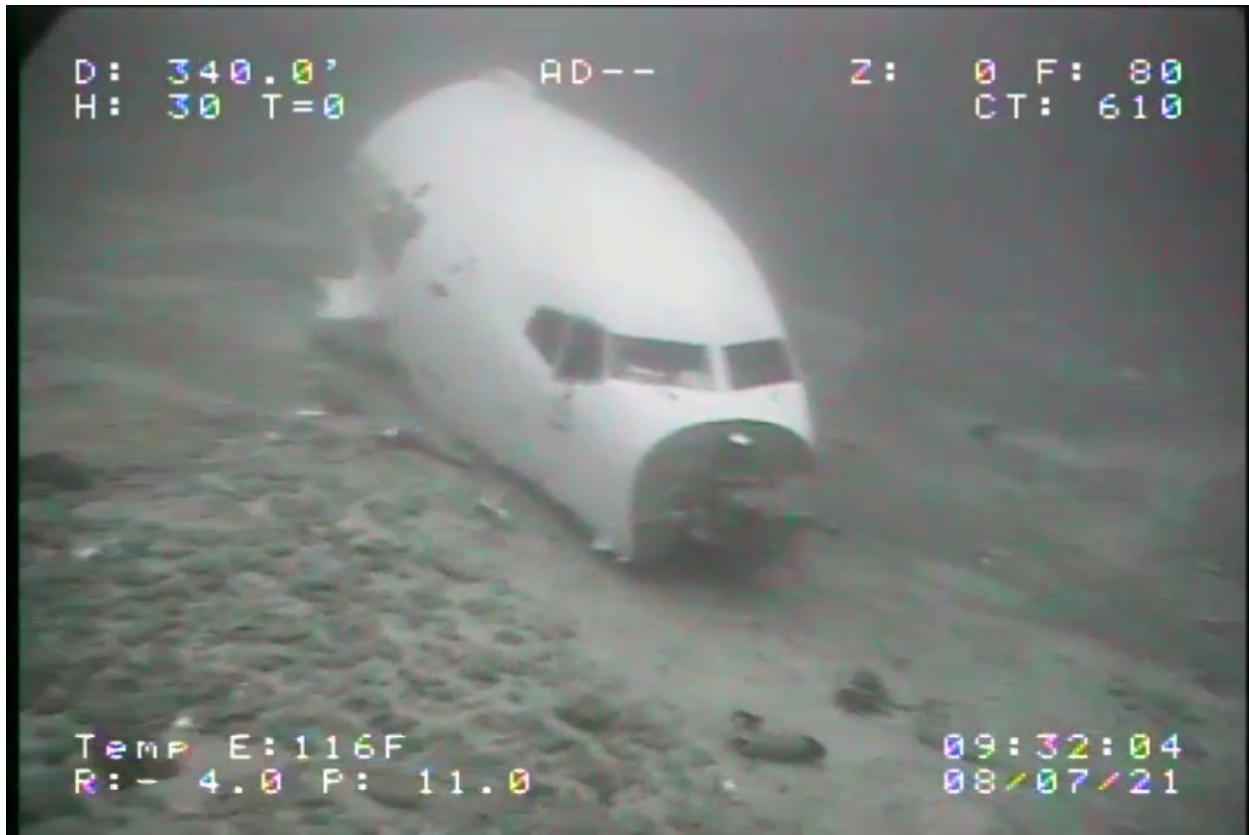
**Figure 6.** Forward fuselage (Source: Sea Engineering Inc.).
