Aviation Investigation Final Report

Location:	Truckee, California	Accident Number:	WPR21FA286
Date & Time:	July 26, 2021, 13:18 Local	Registration:	N605TR
Aircraft:	BOMBARDIER INC CL-600-2B16	Aircraft Damage:	Destroyed
Defining Event:	Loss of control in flight	Injuries:	6 Fatal
Flight Conducted Under:	Part 91: General aviation - Personal

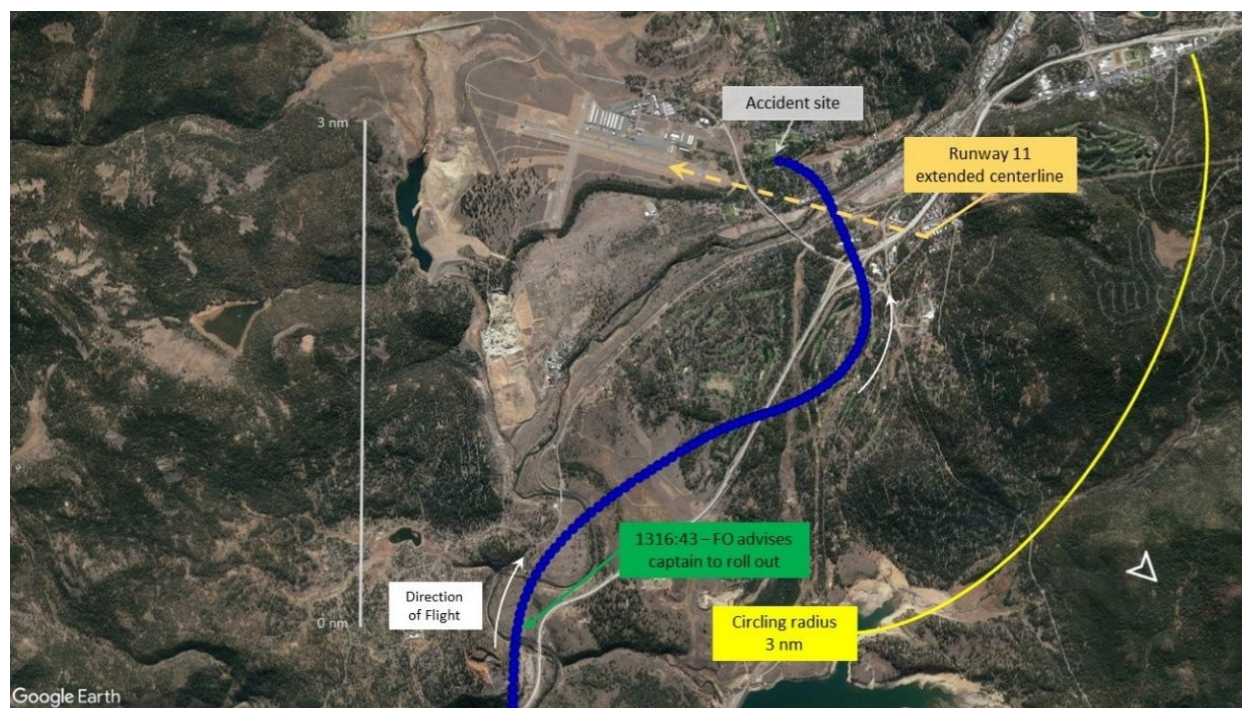
At 1316:20, the FO deployed full flaps (45°) after confirming with the captain. A second later (near YAKYU waypoint), the FO said, "There's the airport," told the captain to make a 90° right turn, and contacted Truckee tower, which cleared the airplane to land. The FO attempted to point out the airport to the captain, and the captain asked "where?" twice. At 1316:43, the FO told the captain to roll out (level the wings, stopping the turn) and turn the autopilot off. The airplane was at the beginning of the downwind leg turn (about 213° magnetic) when the FO told the captain to roll out, and the airplane rolled out on a heading of about 233°. Figure 2 depicts the turns taken by the airplane in the approach and the maximum circling radius of 3 nm allowed for category C aircraft at TRK in the airport's approach charts (the airplane was at least 1.3 nm from that maximum circling radius).

Figure 2. The airplane's downwind leg and allowed circling radius.
