Aviation Investigation Final Report

Location:	Yakutat, Alaska	Accident Number:	ANC22LA035
Date & Time:	May 24, 2022, 15:10 Local	Registration:	N703TH
Aircraft:	DEHAVILLAND DHC-3	Aircraft Damage:	Substantial
Defining Event:	Loss of control in flight	Injuries:	4 Serious
Flight Conducted Under:	Part 135: Air taxi & commuter - Non-scheduled

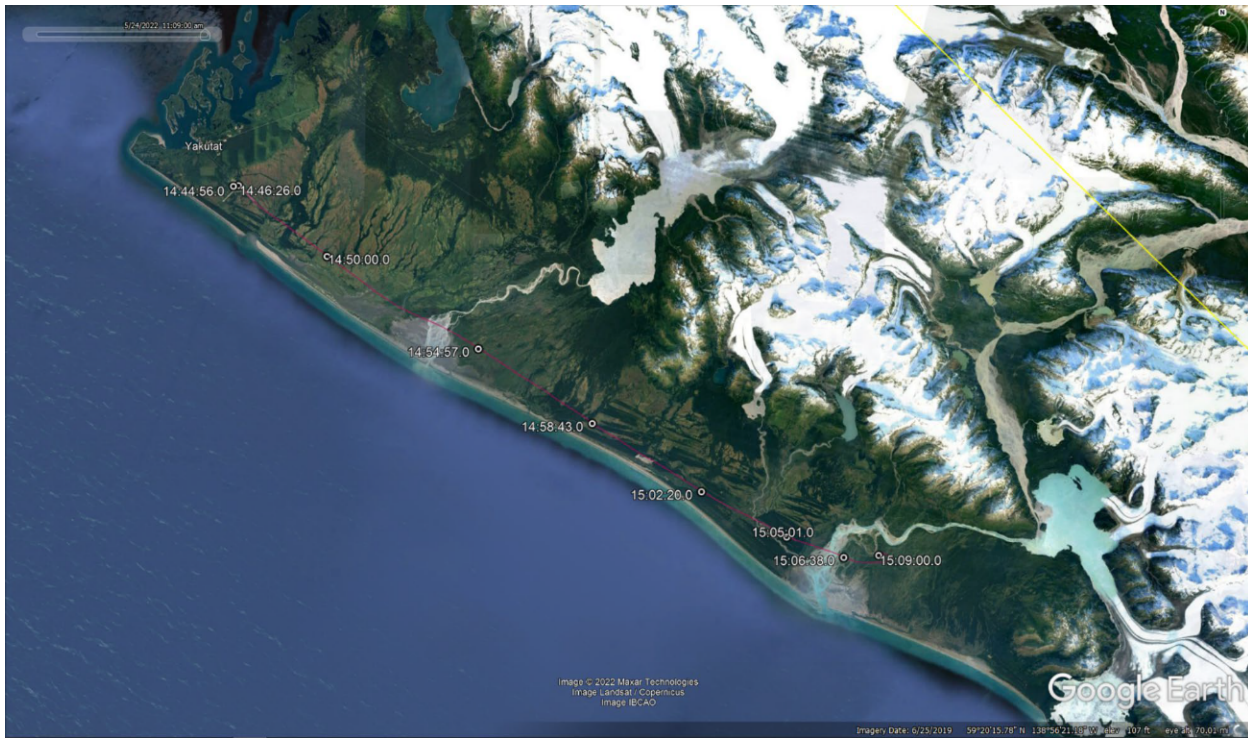
A Garmin aera 796 was recovered from the accident site. GPS data logs for the day of the accident revealed that the airplane departed at about 1446 and after the initial climb continued southeast for about 18 minutes at GPS altitudes between 492 and 1,280 ft, with a groundspeed between 111 and 127 knots. About 2 minutes before the accident, the airplane initiated a gradual left turn to the east and entered the traffic pattern for the 3AK. For the remainder of the flight the groundspeed varied from 10 knots to 255 knots. The last fully recorded in-flight data point was at 1509, when the airplane was at a GPS altitude of 335 ft with a groundspeed of 13 kts and on a track of 56° (see figure 1).

Figure 1 - Accident airplane's flight track.

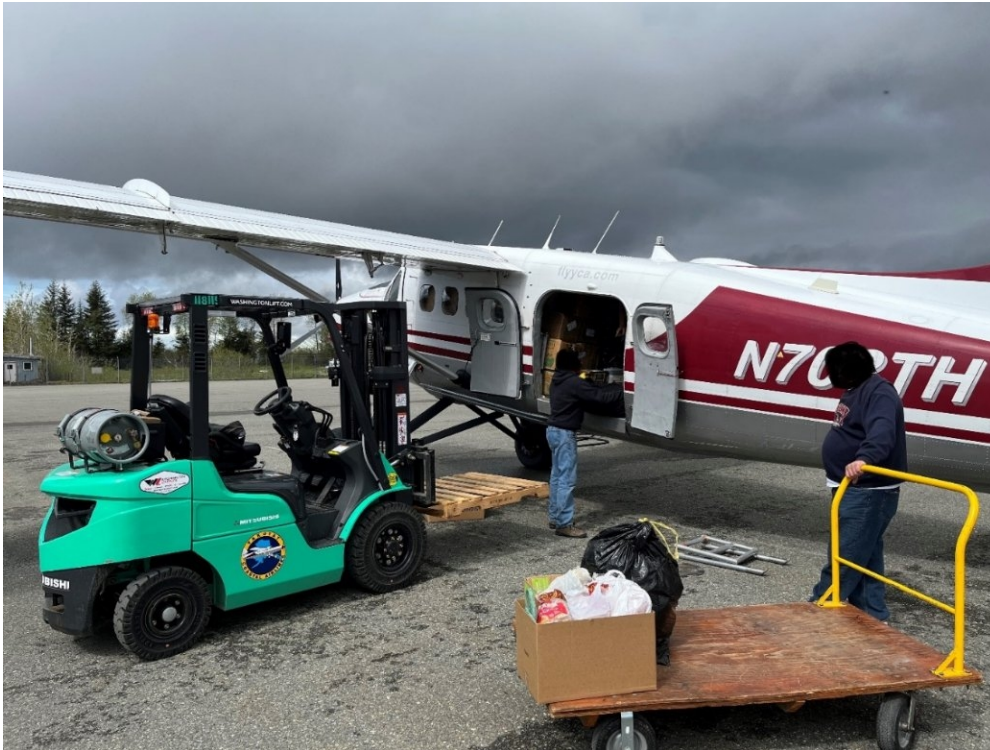
The accident flight was operated under the provisions of Part 135 as an on-demand charter and was subject to the regulation's applicable rules and the requirements set forth in the company's operations specifications (OpSpecs). Per §135.399, the operator was not allowed to operate the accident airplane without complying with "the takeoff weight limitations in the Approved Flight Manual or equivalent." The requirements of § 135.87 state, in part, that no person may carry cargo (including carry-on baggage) in an aircraft unless it is not located in a position that obstructs the access to, or the use of the aisle between the crew and the passenger compartment (see figure 2).

Figure 2 - Accident airplane being loaded for the accident flight. (Source: A passenger on the accident flight)
