Aviation Investigation Final Report

Location:	Steamboat Springs, Colorado	Accident Number:	CEN22FA069
Date & Time:	December 10, 2021, 18:09 Local	Registration:	N744Z
Aircraft:	Piper PA46-500TP	Aircraft Damage:	Substantial
Defining Event:	Controlled flight into terr/obj (CFIT)	Injuries:	1 Fatal
Flight Conducted Under:	Part 91: General aviation - Personal

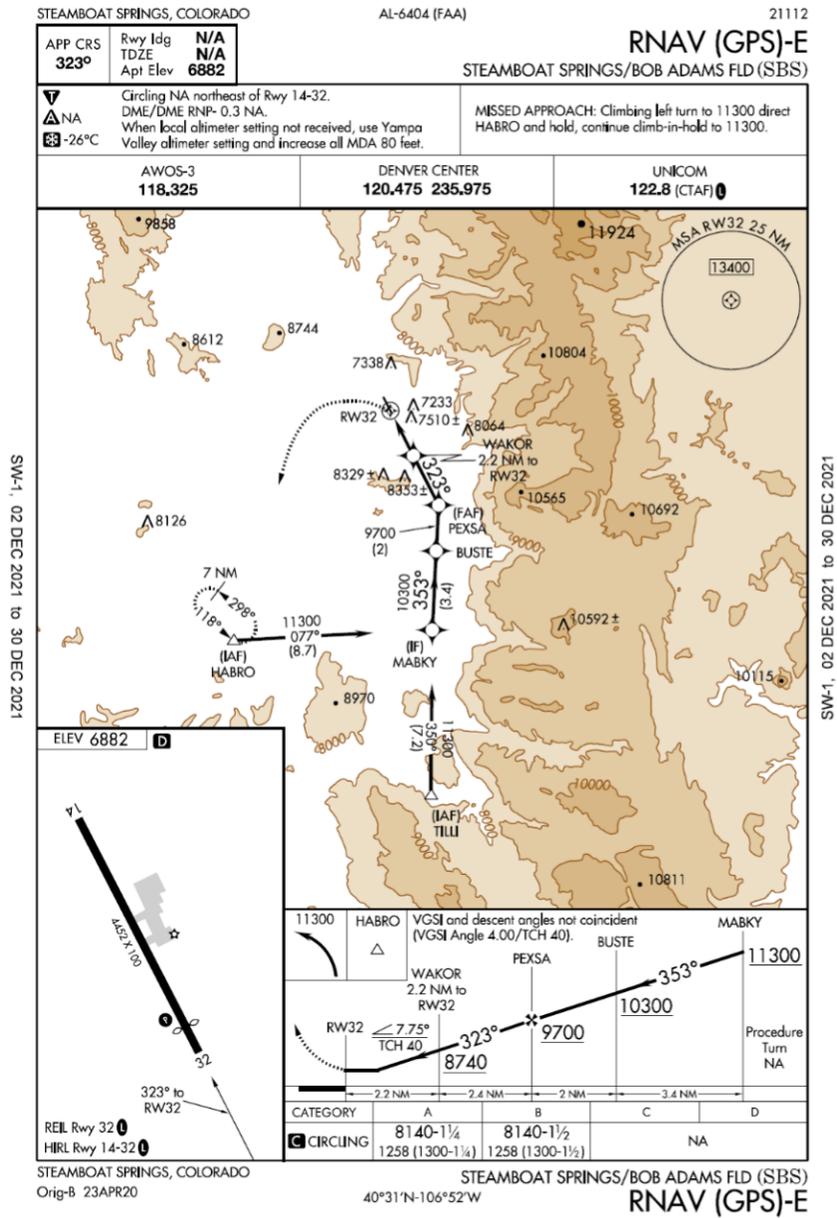
Figure 1: Published Instrument Approach Procedure

For terrain clearance, the procedure required the airplane to cross the final approach fix PEXSA at or above 9,700 ft mean sea level (msl) and WAKOR, the next waypoint located 2.2 nm from runway 32 threshold, at or above 8,740 ft msl. The ADS-B data showed that the accident airplane crossed PEXSA about 9,100 ft msl and WAKOR about 8,200 ft msl respectively.

The procedure allowed for a descent to the minimum descent altitude of 8,140 ft msl or 1,258 ft above ground level after passing WAKOR. The missed approach point for the procedure was

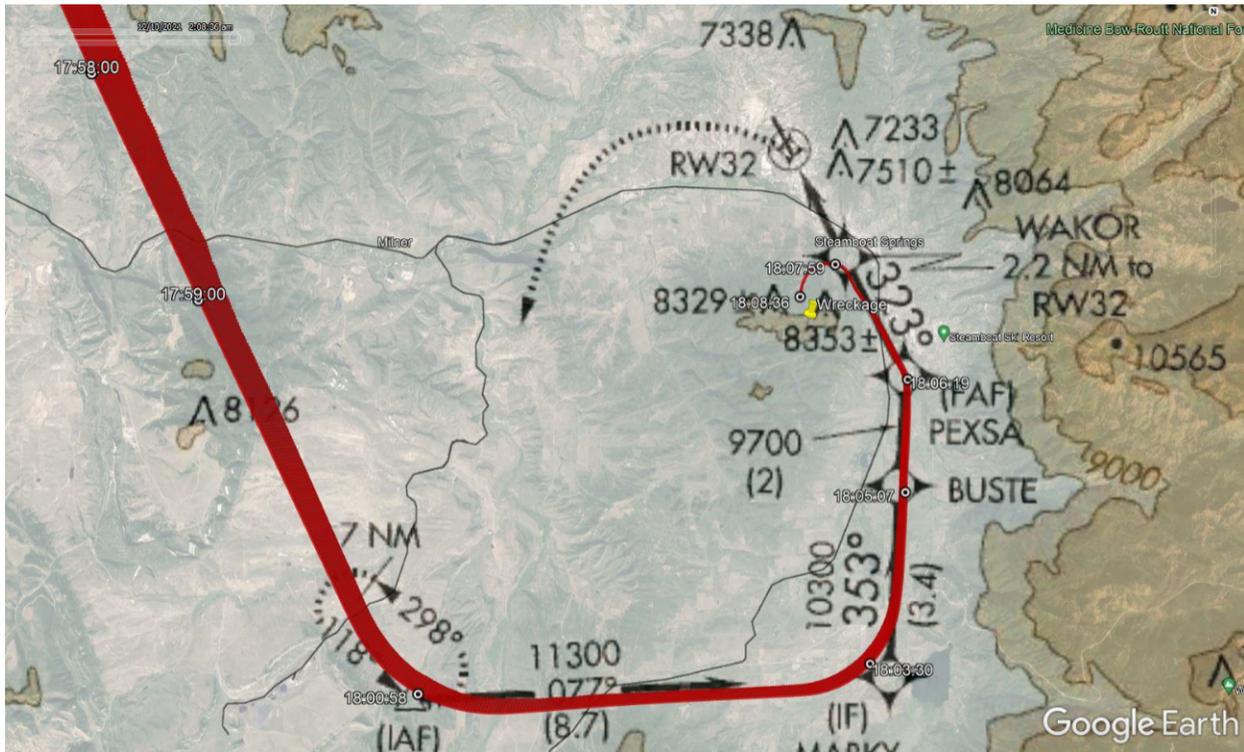
the runway 32 approach end, and then required a climbing left turn to 11,300 ft msl and indicated the pilot should proceed direct to the HABRO waypoint to enter a holding pattern. Immediately after passing WAKOR, the airplane made a left turn as shown in figure 2 and descended to an altitude of about 7,850 ft msl. The airplane subsequently began to climb, and the last ADS-B data point recorded at 1808:49 indicated an altitude of about 8,125 ft msl and was located about 3.5 miles north of the accident site.

Figure 2: A Google Earth plot showing the accident airplane's ground track in the vicinity of the KSBS terminal area. An FAA published approach plate for the RNAV (GPS)-E approach has been overlaid with a 50% opacity. A yellow pin has been added indicating the position of the wreckage.
