Aviation Investigation Final Report

Location:	Tatum, Texas	Accident Number:	CEN21FA195
Date & Time:	April 19, 2021, 13:46 Local	Registration:	N801EC
Aircraft:	Cessna 340A	Aircraft Damage:	Destroyed
Defining Event:	Loss of control in flight	Injuries:	1 Fatal
Flight Conducted Under:	Part 91: General aviation - Flight test

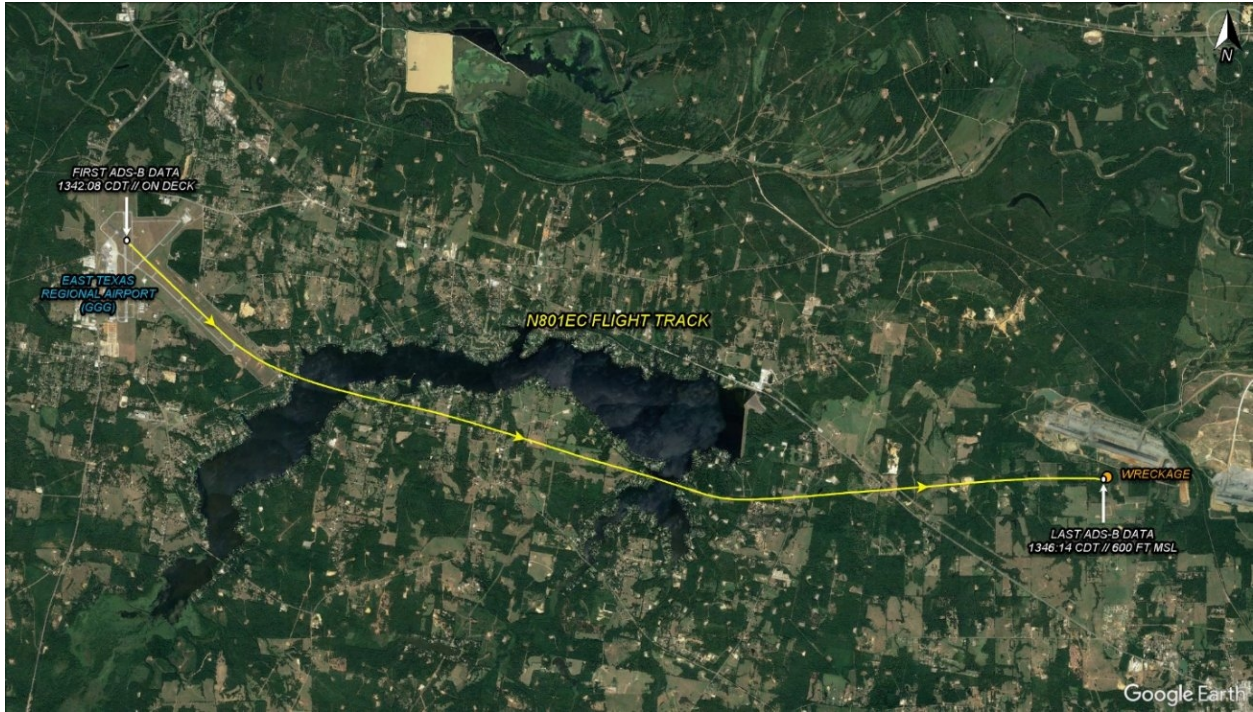
Figure 1. Airplane flightpath.

According to air traffic control (ATC) information, the controller cleared the pilot to operate under visual flight rules to the east of the airport. Communications between ground control, tower control, and the pilot were normal during the taxi, takeoff, and climb. Automatic dependent surveillance–broadcast (ADS-B) data showed that the airplane took off from runway 13 at GGG about 1340. The data also showed that, after takeoff, the airplane was in a steady climb to the east of GGG. The airplane climbed to an altitude of 2,750 ft mean sea level (msl) and then descended to 2,675 ft msl. The last recorded data point, at 1346, showed that the airplane was heading east at an altitude of 2,675 ft msl and a groundspeed of 152 knots. The airplane impacted wooded terrain about 3/4 mile east of the last recorded data point. Groundspeeds and headings were consistent throughout the flight with no abrupt deviations (see figures 1, 2, and 3). Radio and radar communications were lost 6 minutes after takeoff. No radio distress calls were received from the pilot.

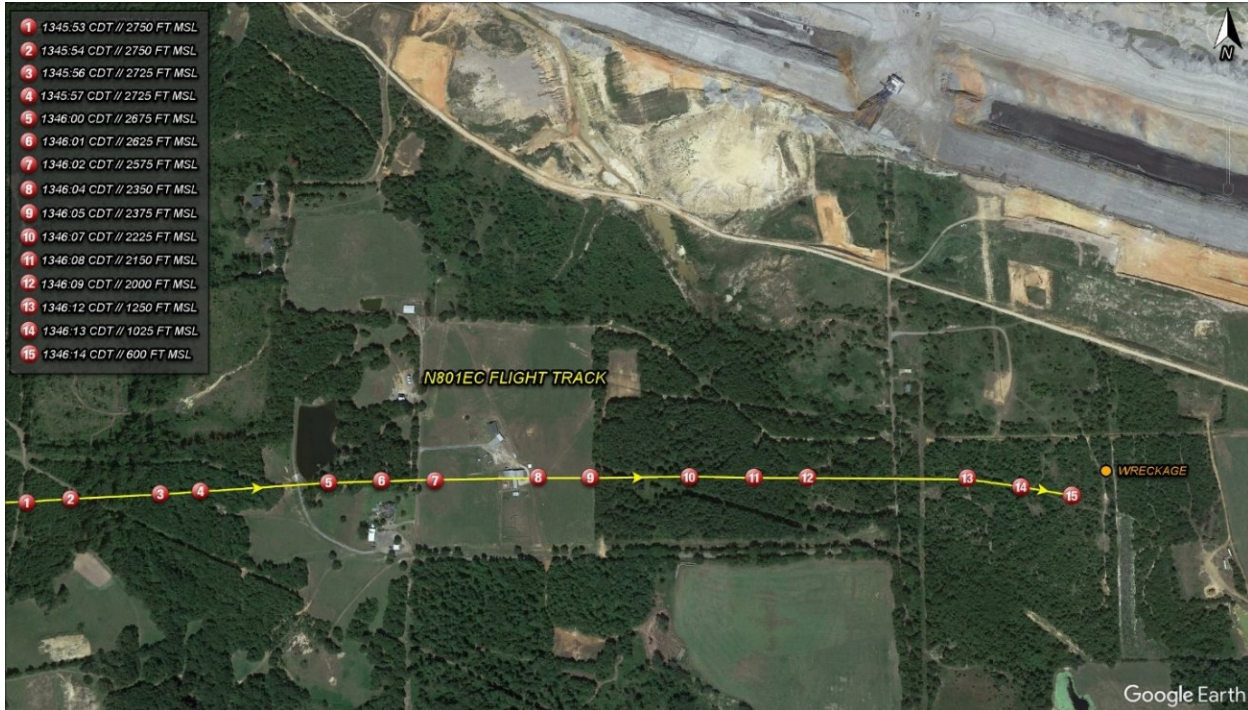
Figure 3. Flight track with final data points.

The pilot was planning to perform a functional test of the airplane’s newly upgraded autopilot system. Automatic dependent surveillance-broadcast data showed that, after takeoff, the airplane turned east and climbed to 2,750 ft. Air traffic control information indicated that the controller cleared the pilot to operate under visual flight rules to the east of the airport. Communications between ground control, tower control, and the pilot were normal during the ground taxi, takeoff, and climb. Radio and radar communications were lost 6 minutes after takeoff, and no radio distress calls were received from the pilot. The airplane impacted wooded terrain about 3/4 mile to the east of the last recorded radar data point. Groundspeeds and headings were consistent throughout the flight with no abrupt deviations.

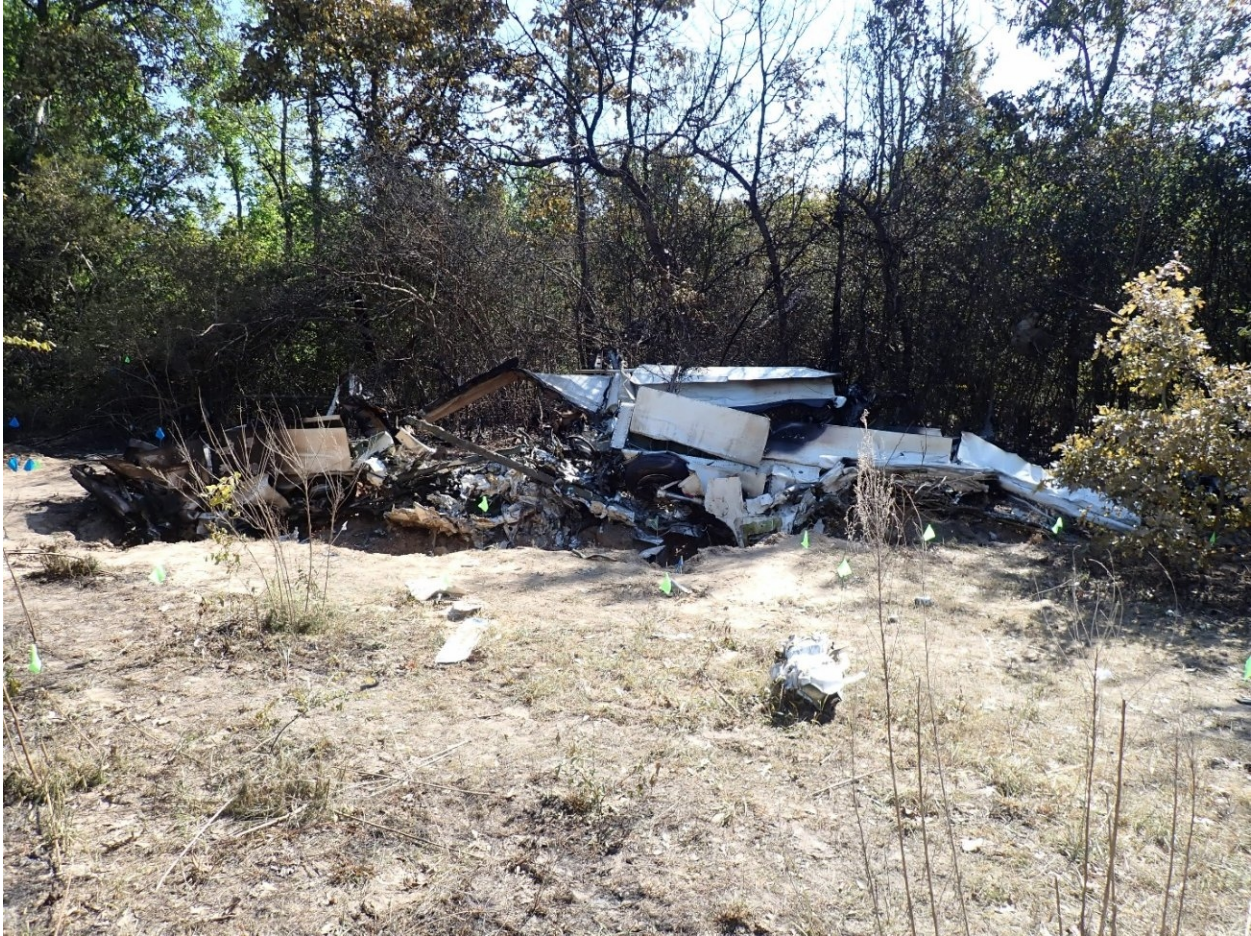
Figure 4. Airplane wreckage.

The accident site was located at an elevation of 361 ft msl. The airplane impacted wooded terrain in a nose-down, near-vertical flight attitude. The forward fuselage and cabin were embedded into the ground and were mostly consumed from a postimpact fire. The empennage and aft fuselage were folded forward over the cabin area and were charred and consumed by fire. Both left and right wings showed leading-edge aft crushing along their respective spans. Portions of both wings were charred, melted, and consumed by the fire (see figure 4).

Both the left and right engine nacelles were separated from the wings, and the engine and propeller assemblies were embedded in 3-ft-deep craters forward of the main airplane wreckage. The engines sustained heavy impact damage, and the propellers were fractured and separated at their crankshafts immediately aft of the flanges. All three blades on the left and right propellers were bent aft and showed leading-edge polishing and chordwise rubs and scratches.

Flight control continuity was confirmed. The elevator trim cables stop blocks were secured to the cables and undamaged. They were found against the forward stop meaning the trim tab was at full down travel (elevator leading edge full down) which indicated that the airplane was trimmed full nose up at impact.

The airplane's instrument panel, avionics, autopilot, and engine controls were broken out, fragmented, melted, and consumed by the postimpact fire. Avionics and instrument tubing and wiring behind the panel were melted and consumed by the fire. A functional test of the autopilot system could not be performed due to the damage that it sustained in the accident.
