Aviation Investigation Final Report

Location:	Wilton, California	Accident Number:	WPR22LA015
Date & Time:	October 14, 2021, 16:00 Local	Registration:	N857PF
Aircraft:	WSK-MIELEC AN-2TD	Aircraft Damage:	Substantial
Defining Event:	Loss of control in flight	Injuries:	2 Serious, 2 Minor
Flight Conducted Under:	Part 91: General aviation - Personal

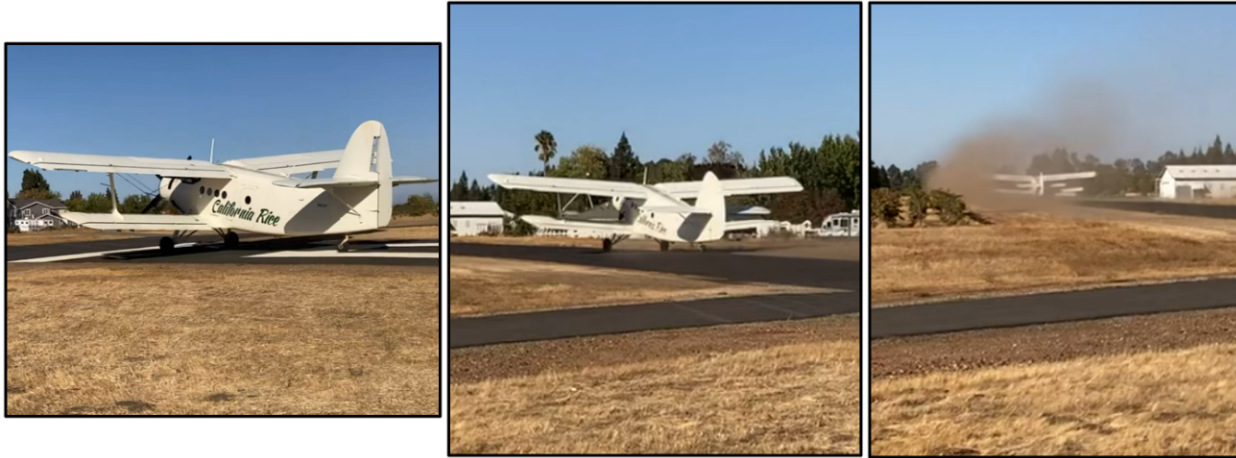
Figure 1: The Airplane Starting the Takeoff Roll

There were two witnesses located at the airport that took videos of the airplane departing. One video showed the airplane just prior to the takeoff roll. The tailwheel is positioned backward and, as the airplane starts the roll, the tailwheel swivels and the airplane moves to the right of the runway (see Figure 1 below).

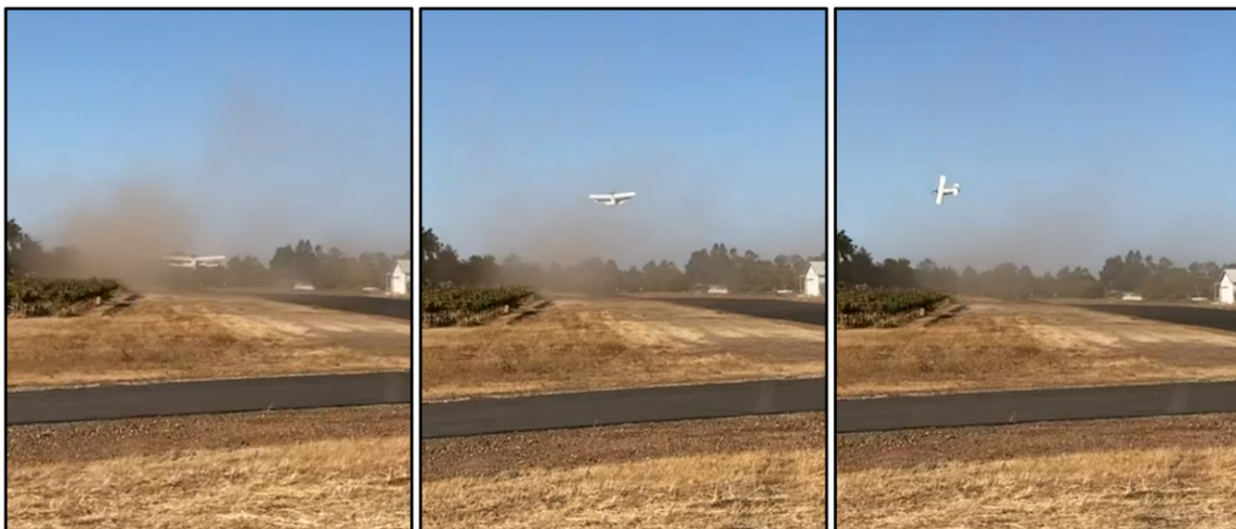
Figure 2: The Airplane Airborne

The airplane then veered to the left of the runway and became airborne shortly thereafter. In the approximate 10 seconds that followed, the airplane pitched up at an increasingly higher and higher angle-of-attack. The airplane then made a sharp left turn and goes behind the trees as it descends (see Figure 2 below).
