# Aviation Investigation Final Report

<b>Location:</b>	Beaver Island, Michigan	<b>Accident Number:</b>	CEN22FA031
<b>Date &amp; Time:</b>	November 13, 2021, 13:49 Local	<b>Registration:</b>	N866JA
<b>Aircraft:</b>	BRITTEN-NORMAN BN-2A	<b>Aircraft Damage:</b>	Substantial
<b>Defining Event:</b>	Aerodynamic stall/spin	<b>Injuries:</b>	4 Fatal, 1 Serious
<b>Flight Conducted Under:</b>	Part 135: Air taxi & commuter - Non-scheduled

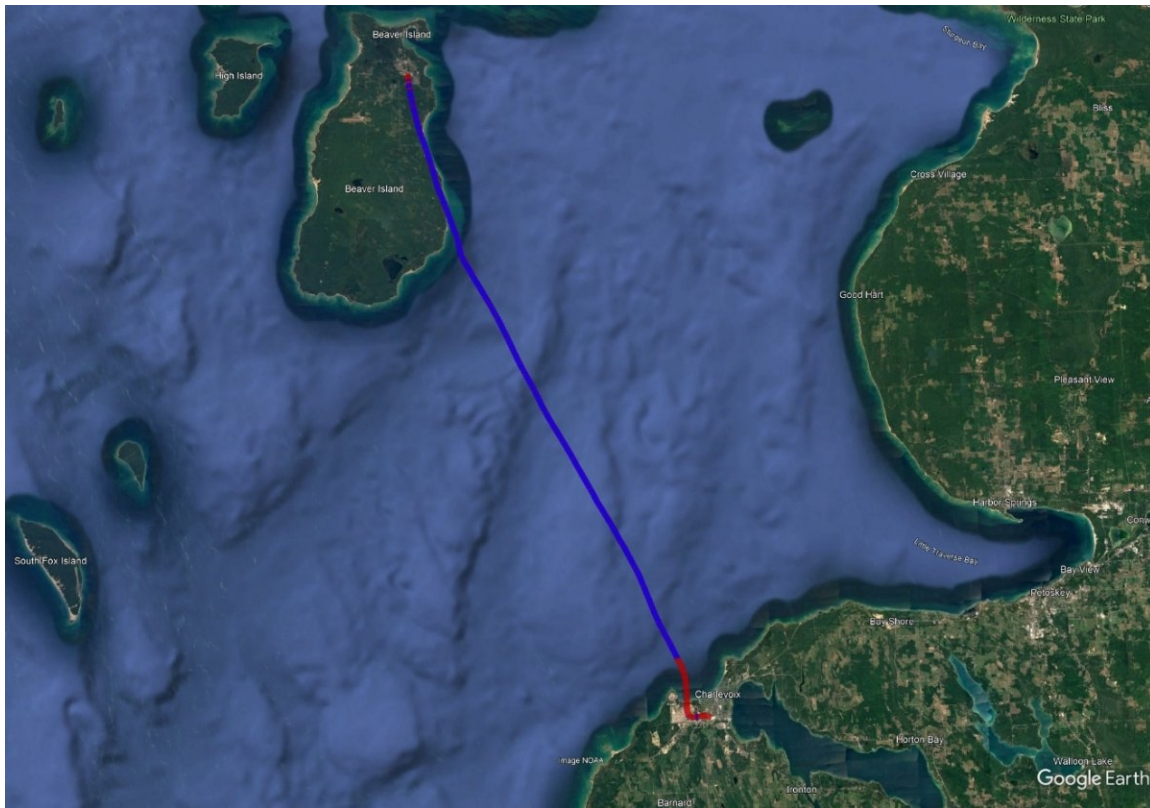
The ADS-B data showed that the airplane departed Charlevoix Municipal Airport (CVX), Charlevoix, Michigan, at 1332. After departing CVX, the airplane turned north and proceeded directly toward Welke Airport (6Y8), Beaver Island, Michigan. The enroute portion of the flight was conducted about 1,500 ft above mean sea level (msl), and the airplane remained at this altitude until it was about 3 nautical miles (nm) from 6Y8. At this point, the airplane descended and maneuvered toward a straight-in approach to runway 35 at 6Y8. The ADS-B data ended about 0.24 nm south of the accident site.

Figure 1: Overview of the accident flight. ADS-B flight track depicted in blue, GPS flight track depicted in red.

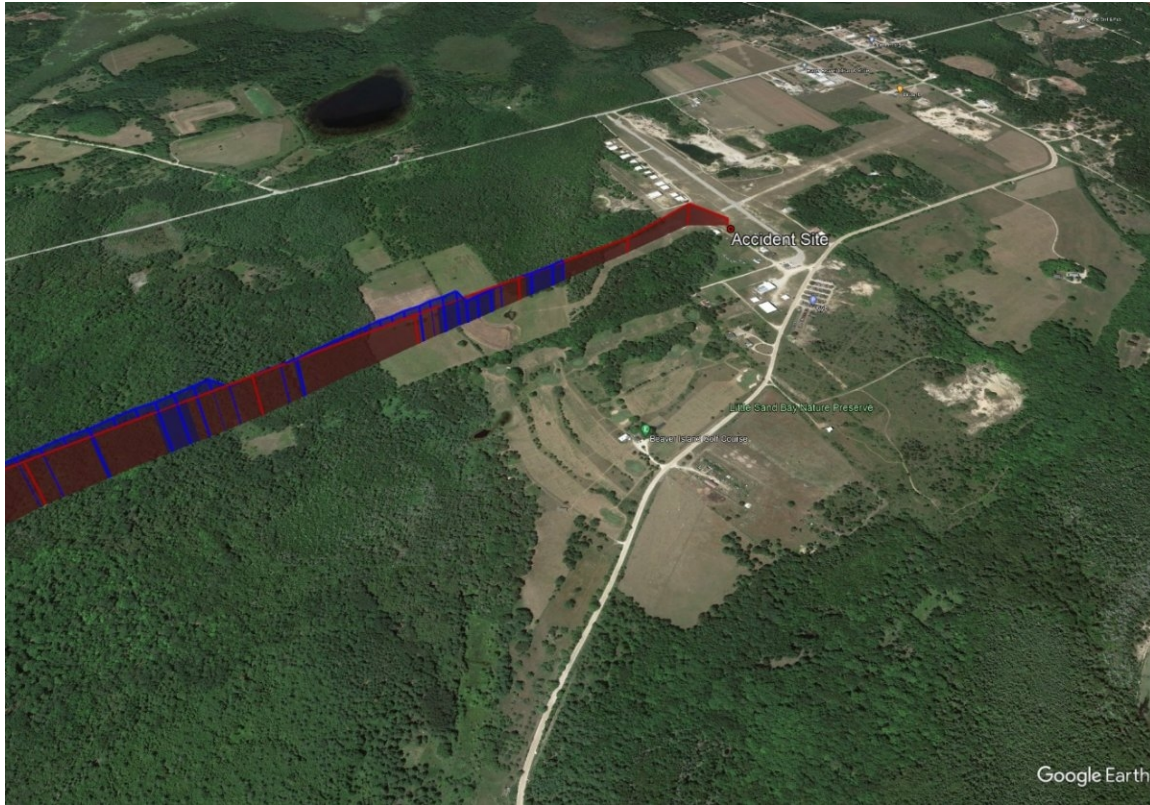
The track data from a handheld GPS that was used in the airplane coincided with the ADS-B data but recorded additional data that ended at the accident site.

*Figure 2: Plot of ADS-B and GPS flight track data for the final portion of the accident flight. ADS-B data depicted in blue. GPS data depicted in red.*

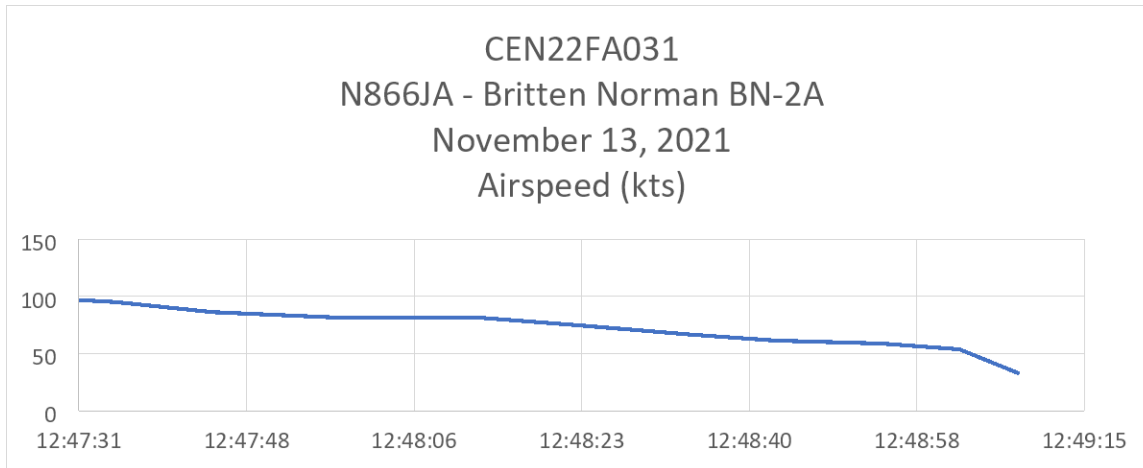
The GPS recorded position, heading, altitude, and ground speed among other data. The airplane's airspeed was calculated from the GPS groundspeed considering the recorded winds at the Beaver Island Airport (SJX), located about 2 nm southwest of the accident site. When the airplane was 1,200 ft from the runway threshold, the calculated airspeed was 58 knots, and when 600 ft from the threshold the airspeed was 54 knots. The final recorded data point coincided with the wreckage location and the recorded airspeed was 33 knots. Figure 3 depicts the plotted airspeed during the final portion of the accident flight.

Figure 3. Airspeed during the final portion of the flight.

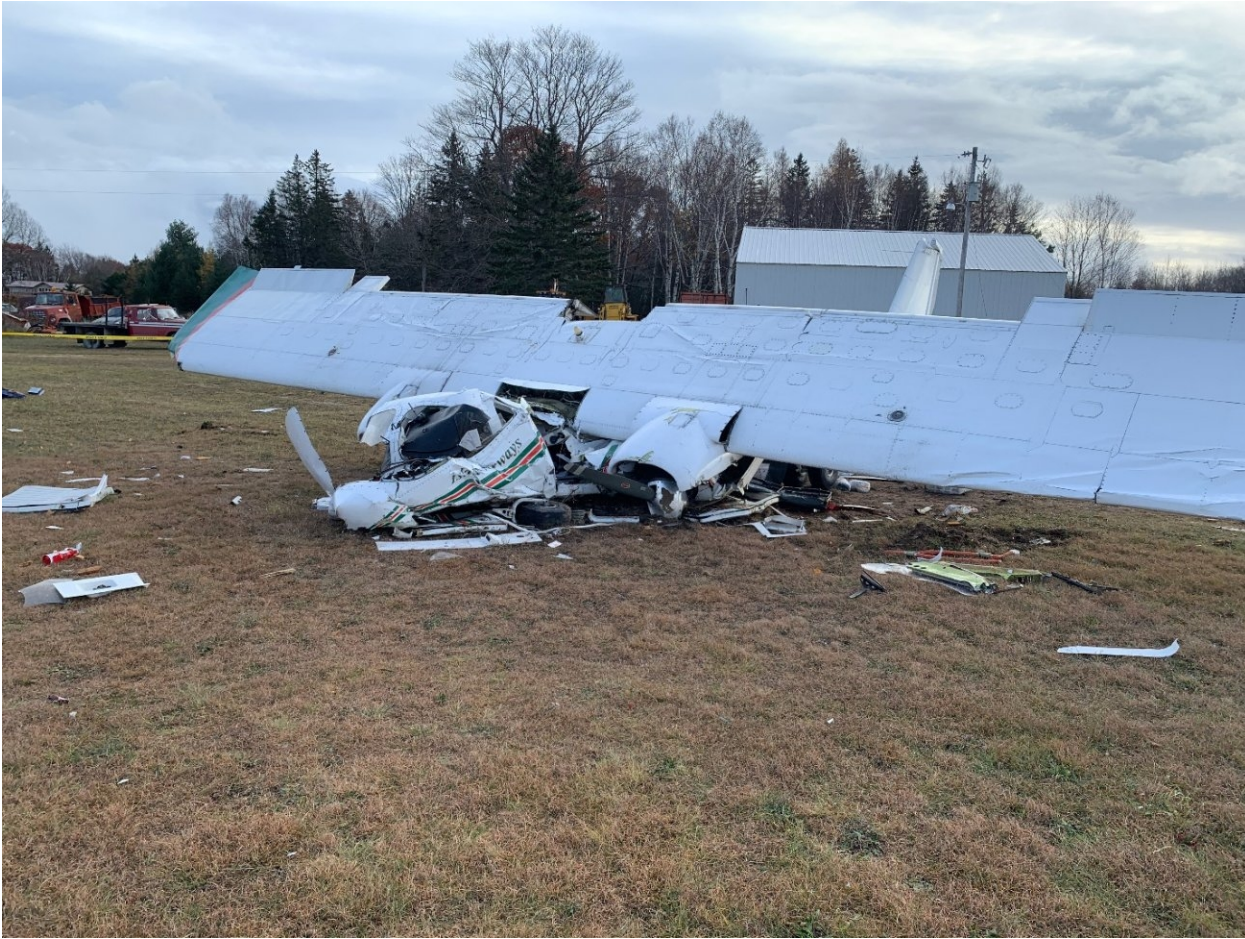
The airplane impacted the ground about 110 ft east of the extended centerline of runway 35, and 320 ft south of the runway threshold. The turf runway was 3,500 ft long and had a displaced threshold just beyond its intersection with paved runway 9/27. Impact signatures indicated that the airplane struck the ground in a left-wing-low, nose-low attitude. The front of the fuselage was crushed upward and aft.

*Figure 4. Overall view of the airplane wreckage at the accident site.*

All major components of the airplane were located at the accident scene. Flight control continuity was established from the cockpit controls to each respective control surface except for cuts made by first responders for occupant extraction. Engine control continuity was established from the cockpit to each engine except for cuts made by first responders for occupant extraction. The wing flaps were found in an extended position.

Examination of the airframe, engines, and propellers did not reveal any preimpact mechanical malfunction or failures that would have precluded normal operation.
