Aviation Investigation Final Report

Location:	Provincetown, Massachusetts	Accident Number:	ERA21FA354
Date & Time:	September 9, 2021, 15:27 Local	Registration:	N88833
Aircraft:	Cessna 402C	Aircraft Damage:	Substantial
Defining Event:	Collision with terr/obj (non-CFIT)	Injuries:	7 Serious
Flight Conducted Under:	Part 135: Air taxi & commuter - Scheduled

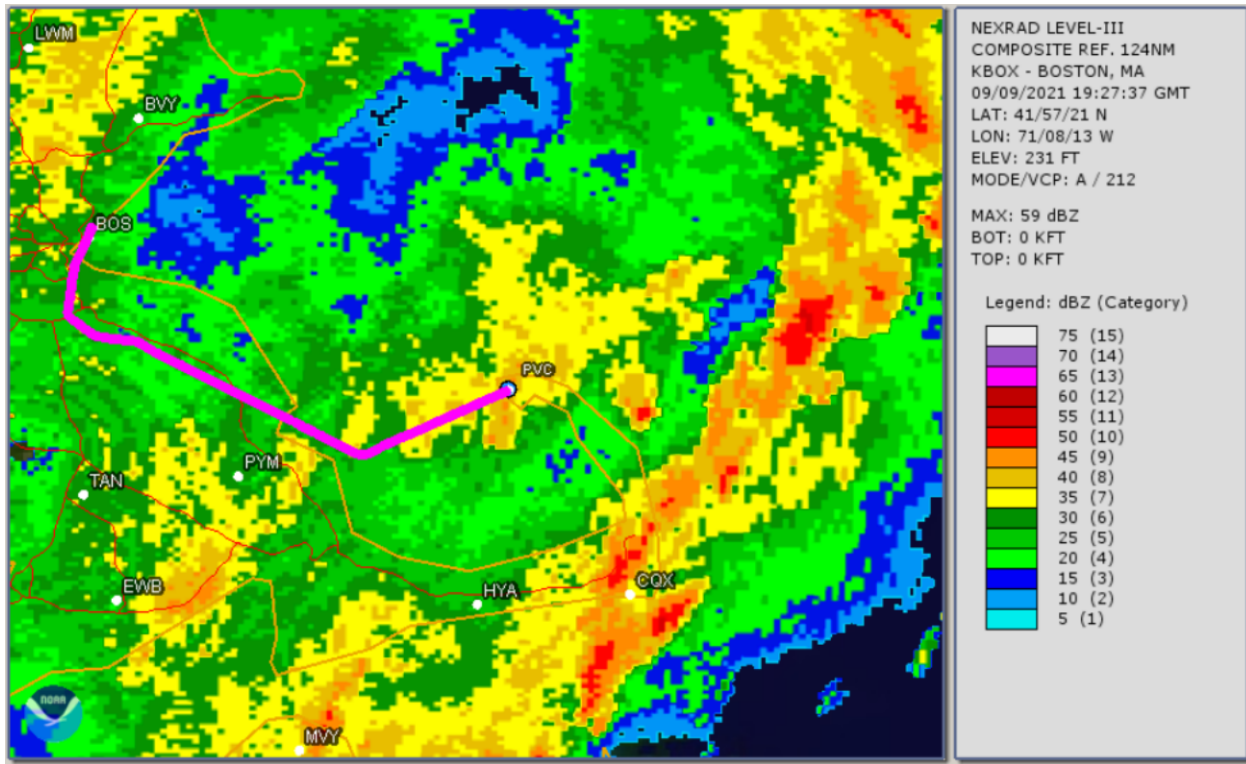
Figure 1 – Boston WSR-88D Composite reflectivity image and flight track at 1527 EDT

A review of the weather conditions at the time of the accident indicated a low-pressure system and associated cold front was moving across Massachusetts with moderate to heavy rain and thunderstorms across the region. A convective SIGMET was current during the period over the route of flight and destination airport. IFR conditions were reported approximately 40 minutes

before departure with LIFR conditions at the time of the accident due to moderate to heavy rain and low ceilings at 200 ft above ground level.

The High Resolution Rapid-Refresh (HRRR) sounding indicated an unstable atmosphere favorable for convection, with a low potential for any non-convective low-level wind shear at the time of the accident. The sounding (and satellite imagery) did not indicate any microburst potential over the accident site at the time of the accident. Furthermore, WSR-88D weather radar imagery did not detect any outflow boundaries or microburst at the time of the accident.
