Aviation Investigation Final Report

Location:	Brookshire, Texas	Accident Number:	DCA22MA009
Date & Time:	October 19, 2021, 10:00 Local	Registration:	N987AK
Aircraft:	McDonnell Douglas DC-9-87 (MD-87)	Aircraft Damage:	Destroyed
Defining Event:	Flight control sys malf/fail	Injuries:	2 Serious, 1 Minor, 20 None
Flight Conducted Under:	Part 91: General aviation - Personal

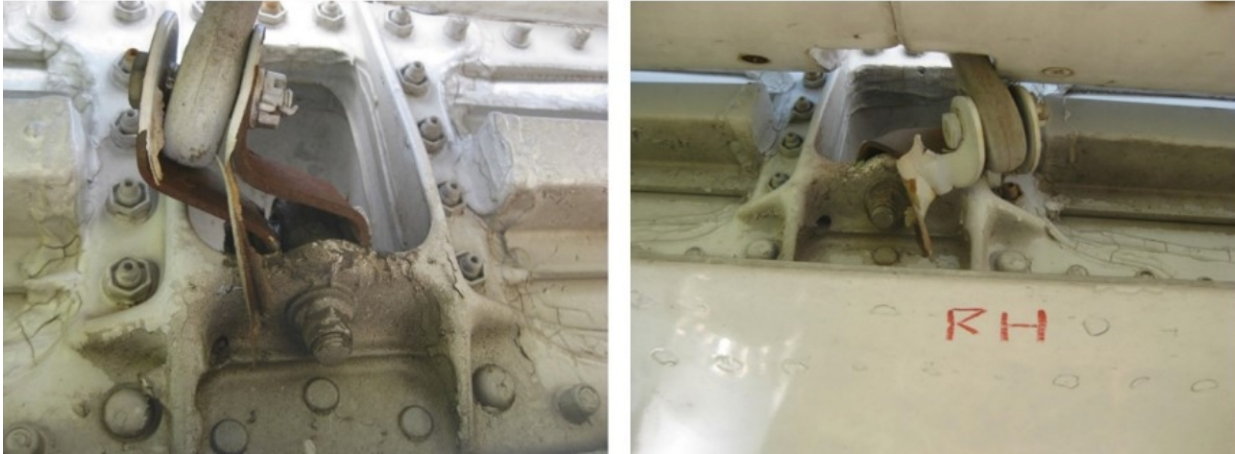
The investigation determined that, at some point during the 6 months since the airplane was last flown, the inboard geared tab linkages for both elevators had moved beyond their normal range of travel into an overcenter position, resulting in the jammed condition of the elevators in the trailing-edge-down position. No evidence of any other mechanical malfunction, elevator or pitch control system failure, structural failure, or actions by the flight crew or maintenance personnel was identified that could have resulted in the jammed condition. Further, the jammed condition was not detectable during the flight control check the first officer performed during taxi; the elevator control system design is such that, even with this type of jammed elevator condition, the control column feel and travel would be normal during taxi (when the aerodynamic forces on the elevator control tabs would be minimal).

Examination found that the inboard actuating cranks for both elevators' geared tabs were bent, and their respective attachment linkages were bent outboard (see figure 5).

Figure 5. Left and right elevator inboard geared tab linkages (left and right, respectively), viewed from underneath each elevator. Each linkage is bent outboard.

The actuating crank and linkages were found locked overcenter beyond their normal range of travel. Once the actuating cranks were disconnected and the bent linkages removed, the elevators could be moved (using hand pressure) through their normal range of motion. No other elevator or pitch control system component anomalies were identified. Tests and examinations of the components removed from the system revealed no evidence of mechanical failures or damage, or any actions by the flight crew or maintenance personnel, that could have caused the overcenter condition.
