Aviation Investigation Final Report

Location:	Thomson, Georgia	Accident Number:	ERA22FA004
Date & Time:	October 5, 2021, 05:44 Local	Registration:	N283SA
Aircraft:	Dassault Falcon 20	Aircraft Damage:	Destroyed
Defining Event:	Miscellaneous/other	Injuries:	2 Fatal
Flight Conducted Under:	Part 135: Air taxi & commuter - Non-scheduled

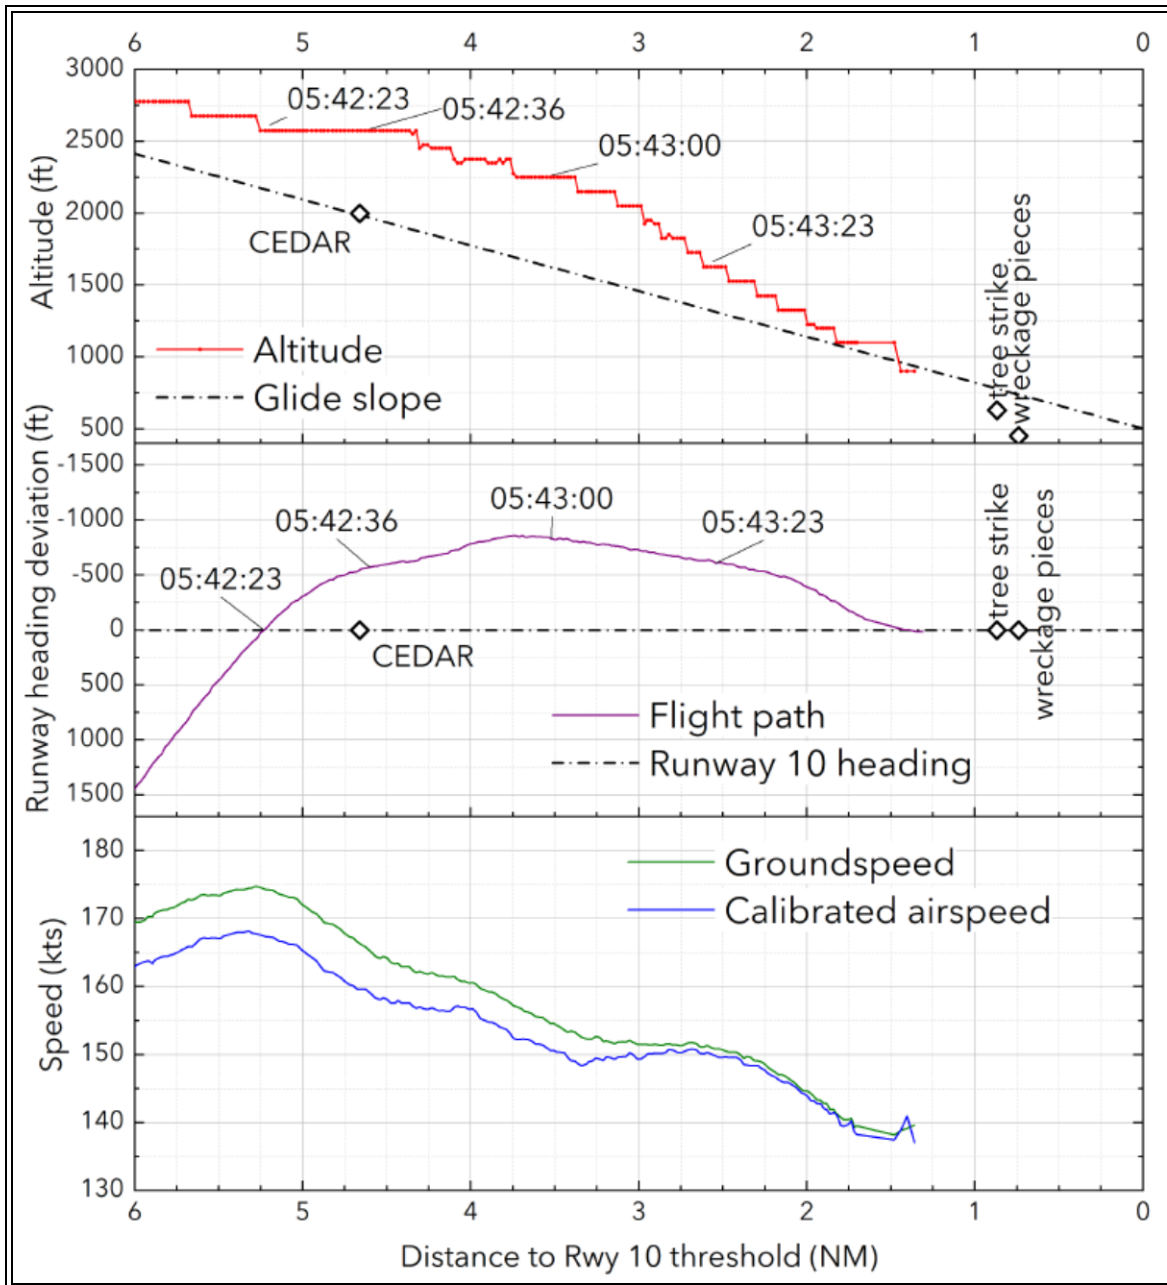
An automatic dependent surveillance – broadcast (ADS-B) performance study conducted by the National Transportation Safety Board's (NTSB) Vehicle Performance Division found that the airplane crossed CEDAR (the final approach fix) at 2,600 ft mean sea level (msl) and 500 ft to the left of the extended runway centerline. After CEDAR, the flight track continued toward the runway and continued to be about 600 ft above the 3° visual glide path and further deviated to the left of the runway heading until about 3 nautical miles from the threshold, when the descent rate increased. The airplane's airspeed at that time was about 150 kts. ADS-B coverage ended at 05:43:54, about 3,000 ft short of the first recorded tree strike. The final recorded altitude was 900 ft msl (400 ft above ground level [agl]) and the calculated airspeed was 137 kts. Figures 1 and 2 provide an overview of the flight track data, expected approach path, and summary CVR comments related to the approach.

Figure 1: Altitude compared to 3° visual glide slope, flight path compared to runway heading, and calculated ground and airspeeds for final 6 NM of the approach.

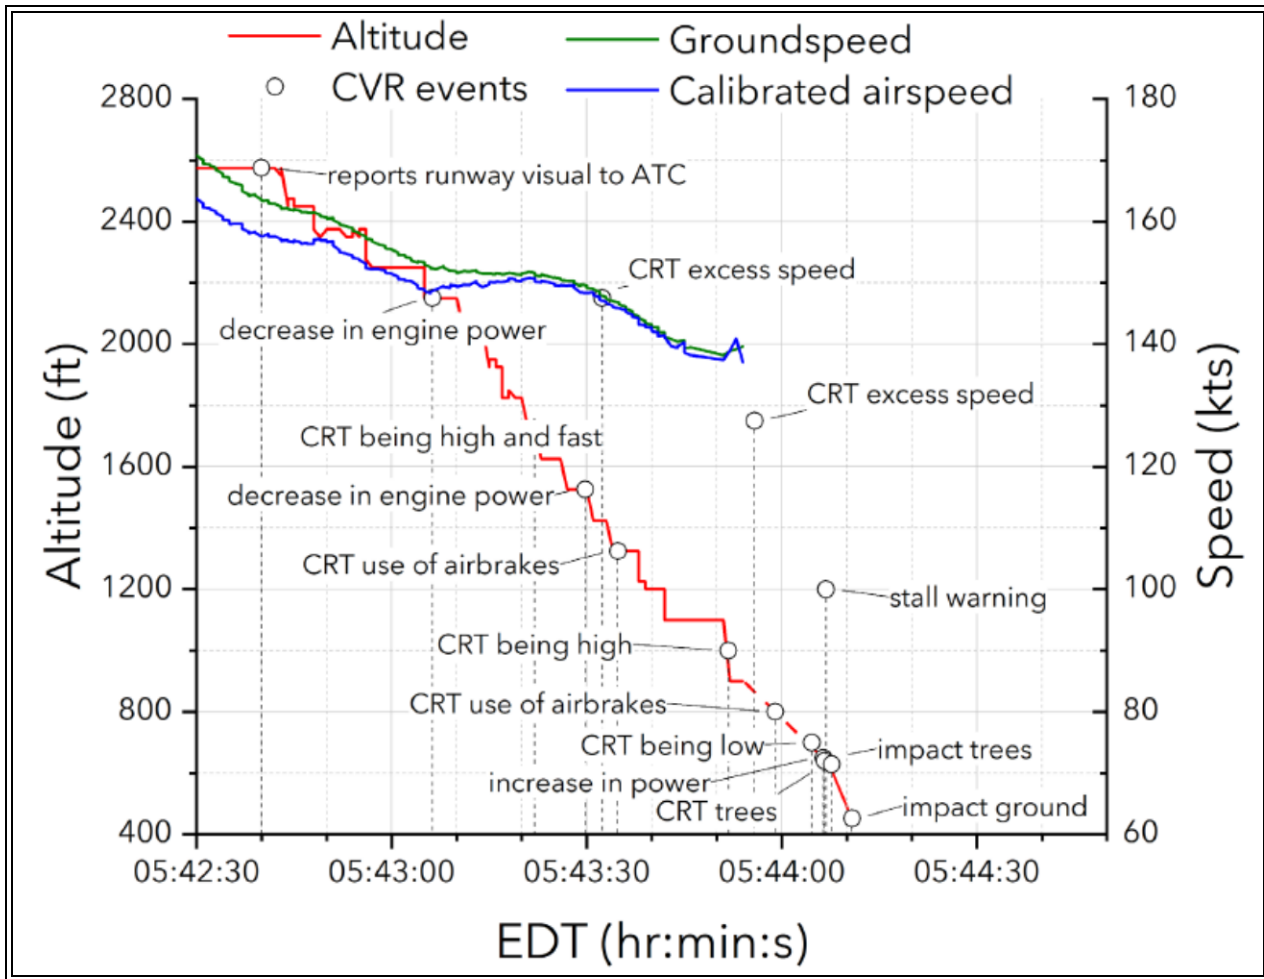
Figure 2: Altitude, calibrated airspeed, and groundspeed with selected end of flight CVR events. "CRT" is "Comment related to -". Red dotted line shows estimated altitude trend. ADS-B data ended at 05:43:54.

The recorded CVR audio from the cockpit area microphone channel was evaluated in an attempt to determine the engines' N1 operating speeds during the final approach phase of the accident flight. The sound spectrum study found that for about the last minute of the flight the engine N1 speeds were near flight idle, and further decreased to flight idle for the final 30 seconds before the initial impact with trees. After the initial impact was heard, both N1 speeds were observed to rise rapidly before the recording ended.

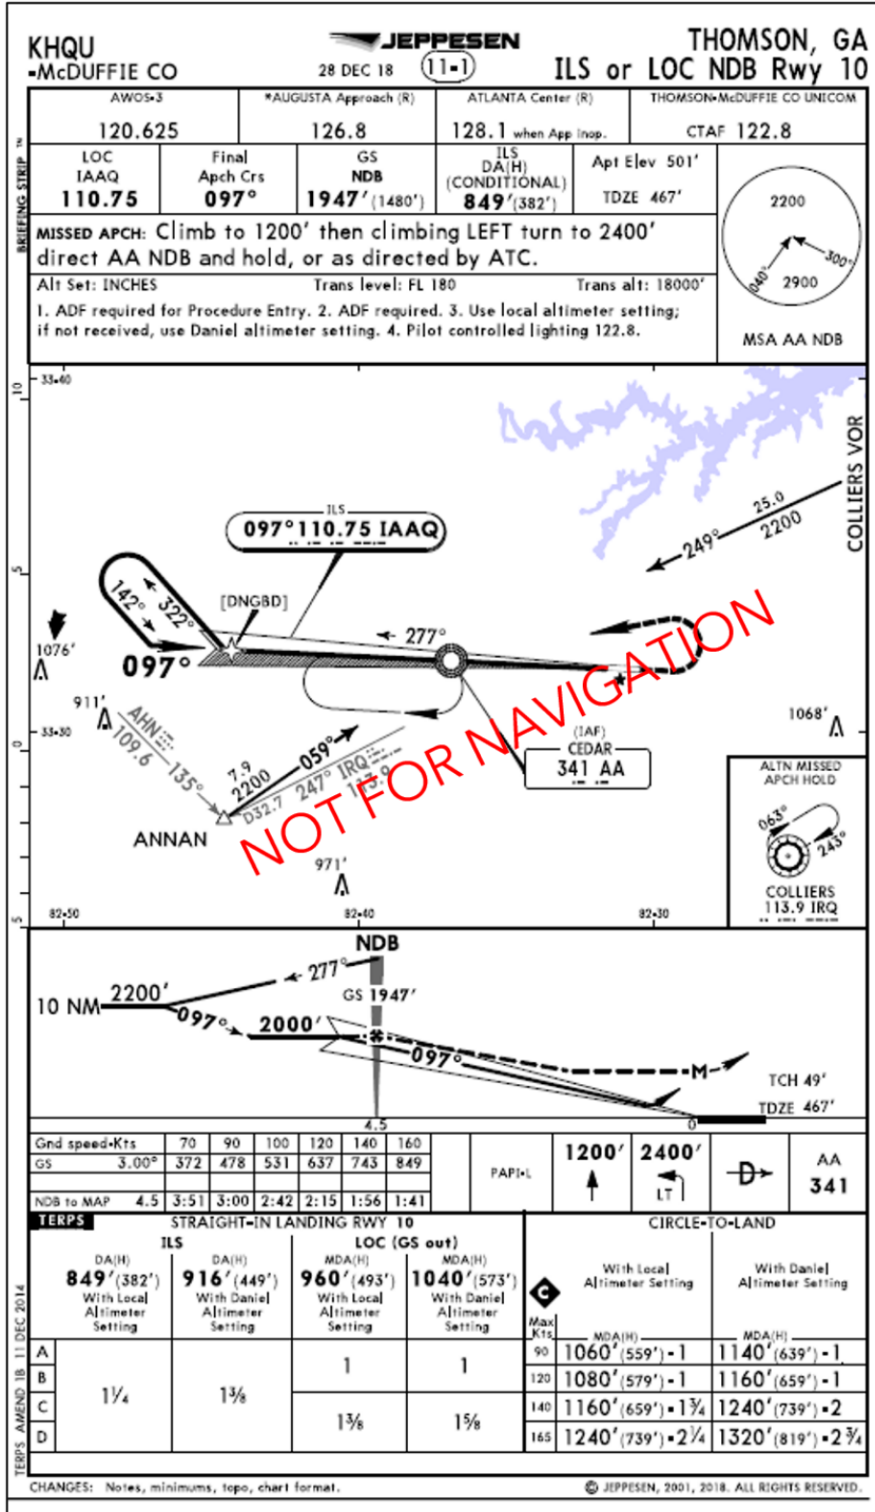
The only ILS or localizer approach to HQU was to runway 10. The approach required automatic direction finding (ADF) equipment for the procedure entry. The approach published a minimum altitude of 2,000 ft msl at the final approach fix CEDAR. The published procedure entry required that the airplane fly outbound on a 277° heading and complete a procedure turn back to the final approach course of 097°. The minimum descent altitude was 960 ft msl (492 ft agl), with the glideslope out of service and the local altimeter setting. The approach plate stated that a precision approach path indicator (PAPI) was available on the left side of the runway.

Figure 3: Instrument approach procedure chart for the ILS or LOC NDB Runway 10 Approach

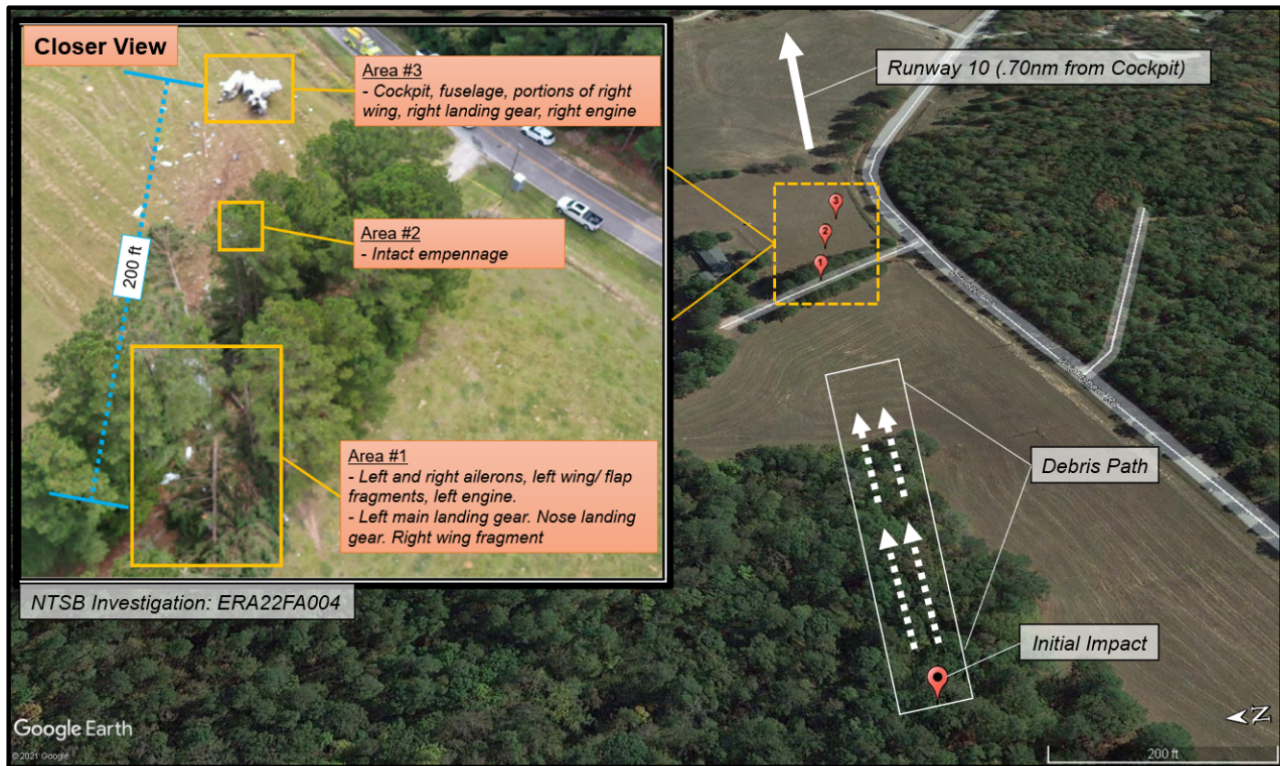
The initial impact point coincided with broken pine tree branches among a forest where the trees were about 150 ft tall. The debris path was oriented on a heading of about 100° and spanned about 880 ft from the initial impact to the main wreckage area. The airplane was heavily fragmented; however, there was no evidence of fire. The largest fragments of wreckage were concentrated in three primary areas overviewed in Figure 4. The figure shows the initial impact point and a pop-out drone image that describes the three areas.

Figure 4: Overview of the wreckage path and concentrated areas of wreckage (Drone image courtesy of Georgia Bureau of Investigations)
