Aviation Investigation Final Report

Location:	Pewaukee, Wisconsin	Accident Number:	CEN23LA037
Date & Time:	November 15, 2022, 15:00 Local	Registration:	N247DH
Aircraft:	Fairchild SA227-AT	Aircraft Damage:	Substantial
Defining Event:	Loss of control in flight	Injuries:	2 Minor, 1 None
Flight Conducted Under:	Part 135: Air taxi & commuter - Non-scheduled

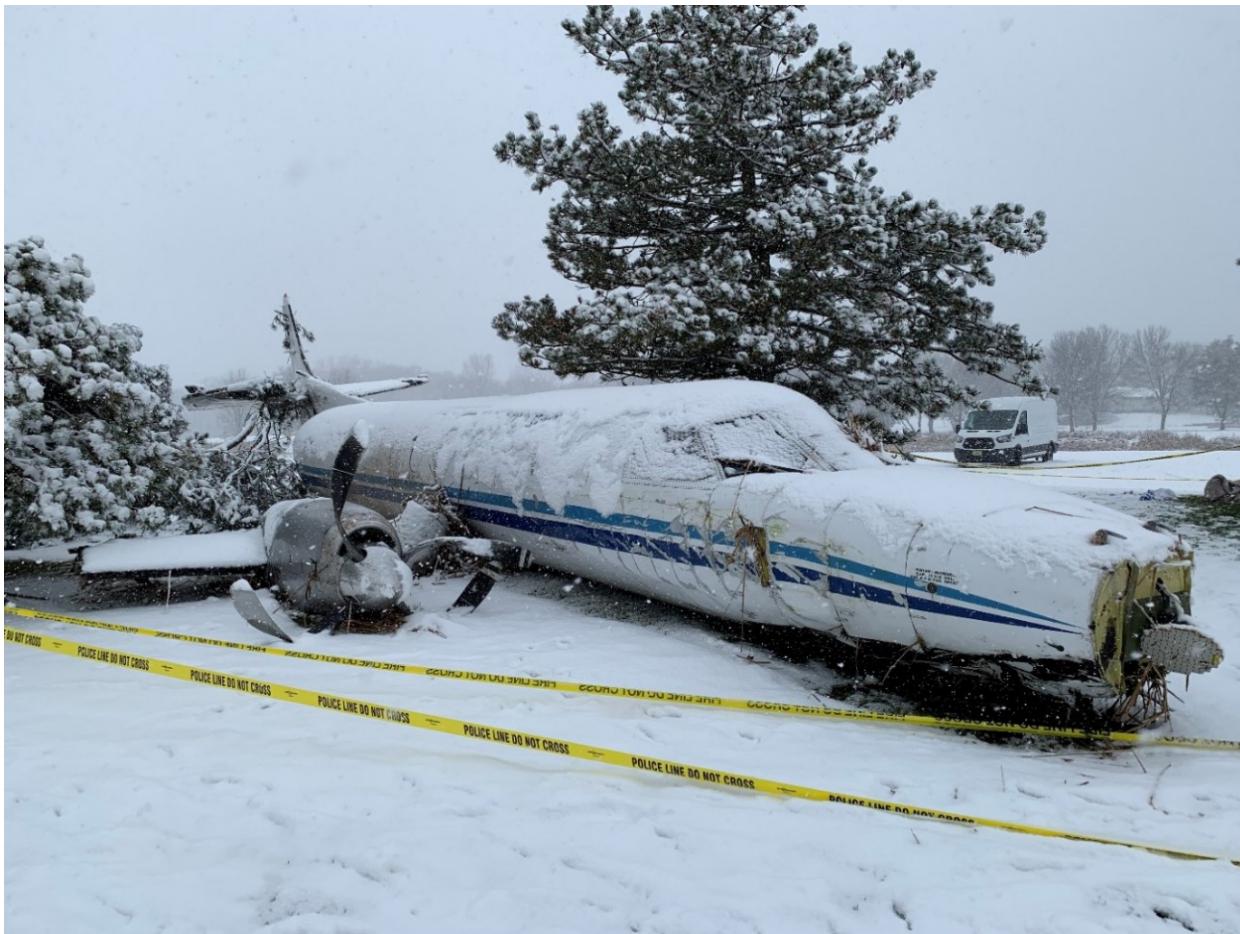
Figure

During the accident sequence the airplane contacted trees, separating the wings from the airplane and resulting in substantial damage to the wings and fuselage.

1: The airplane at the accident site. (Photo courtesy of FAA)
