# AIRCRAFT ACCIDENT INVESTIGATION AND INQUIRY BOARD

## FINAL REPORT

### HL7525 AIRBUS A330-322

***PLACE OF OCCURRENCE: MACTAN-CEBU INTERNATIONAL  
AIRPORT, LAPU-LAPU CITY, CEBU, PHILIPPINES***

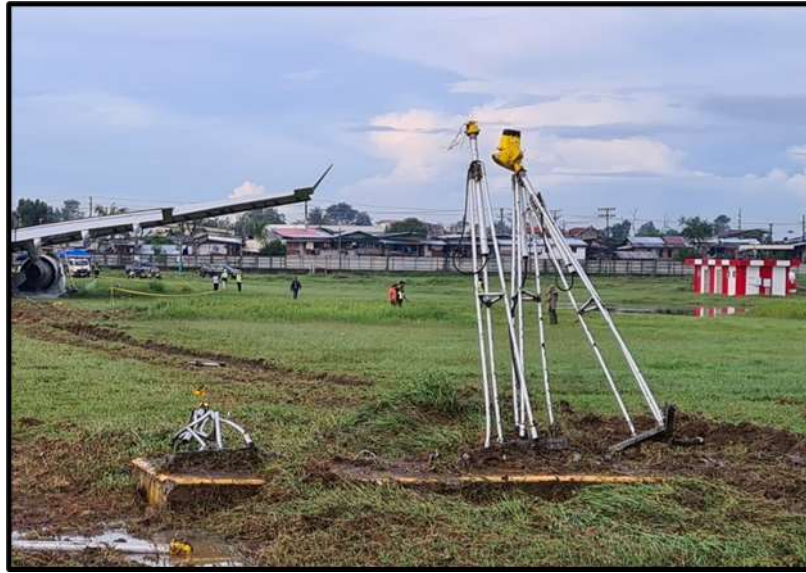
Figure 2 - RPVM RWY 04 Approach lights.

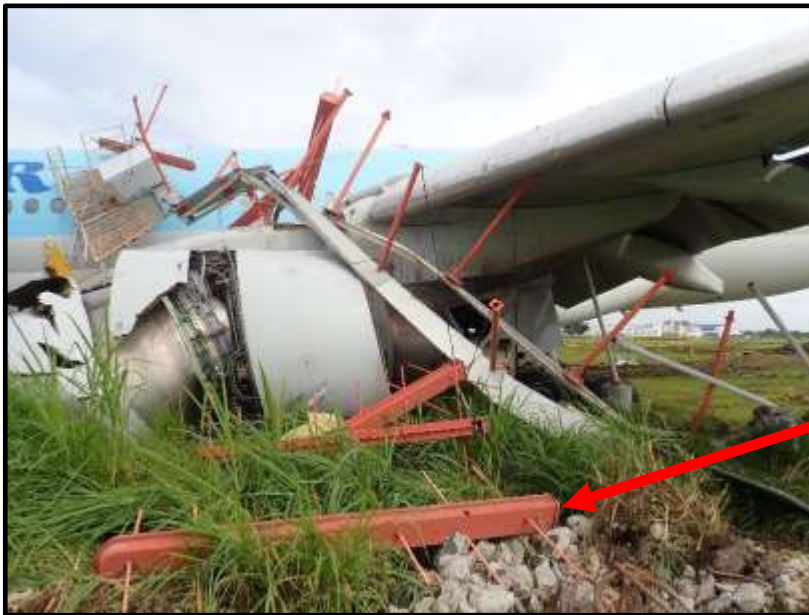
**1.4.2** One (1) ILS Localizer Antenna (Figure 3).

Figure 3 - RPVM RWY 22 Localizer antenna.

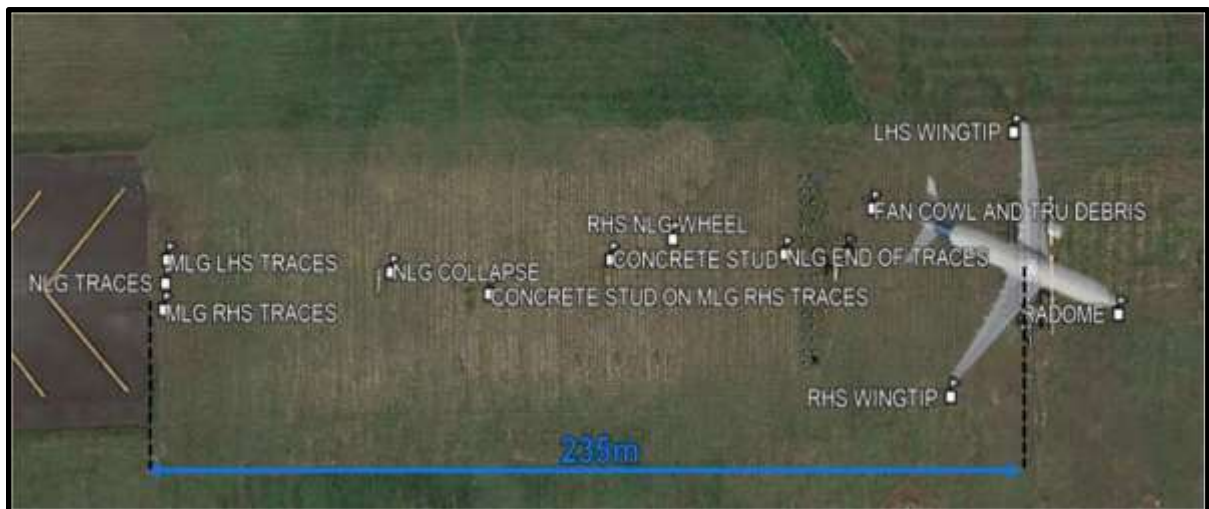
The aircraft failed to stop and overran the end of the runway. The aircraft exited RWY 22 with traces of all the landing gears. The NLG collapsed after hitting the concrete base slab of the approach light, after which its RH NLG wheel was detached upon hitting another concrete stud. The aircraft collided with the ILS localizer antenna and another runway approach lighting system before the aircraft came to a complete stop at the grassy portion about 235 meters from the end of RWY 22 at coordinates 10°17'41.8" N 123°57'59.9" E with a final heading of 245° (Figure 5).

Figure 5 - The aircraft path exiting RWY 22.

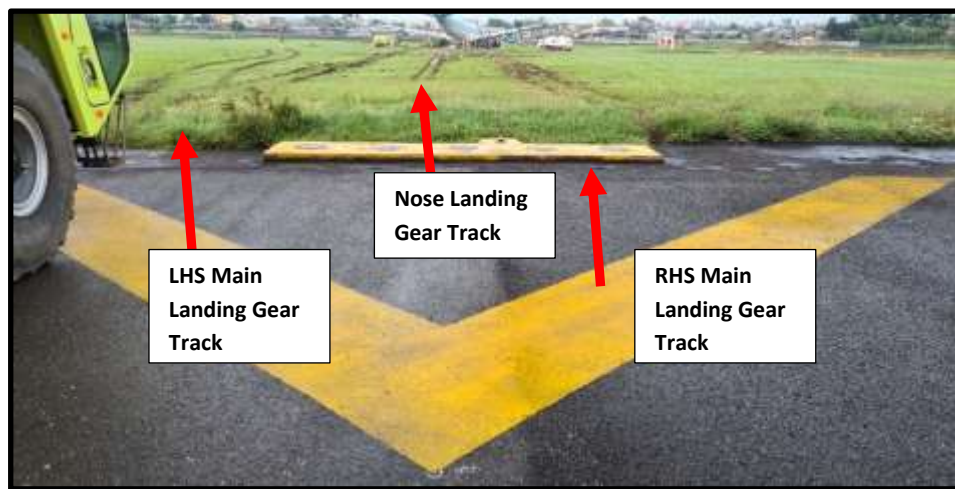
The area where the aircraft exited RWY 22 have visible tire marks on the ground leading to the aircraft. (Figure 7).

Figure 7 - The aircraft tire marks exiting RWY 22.

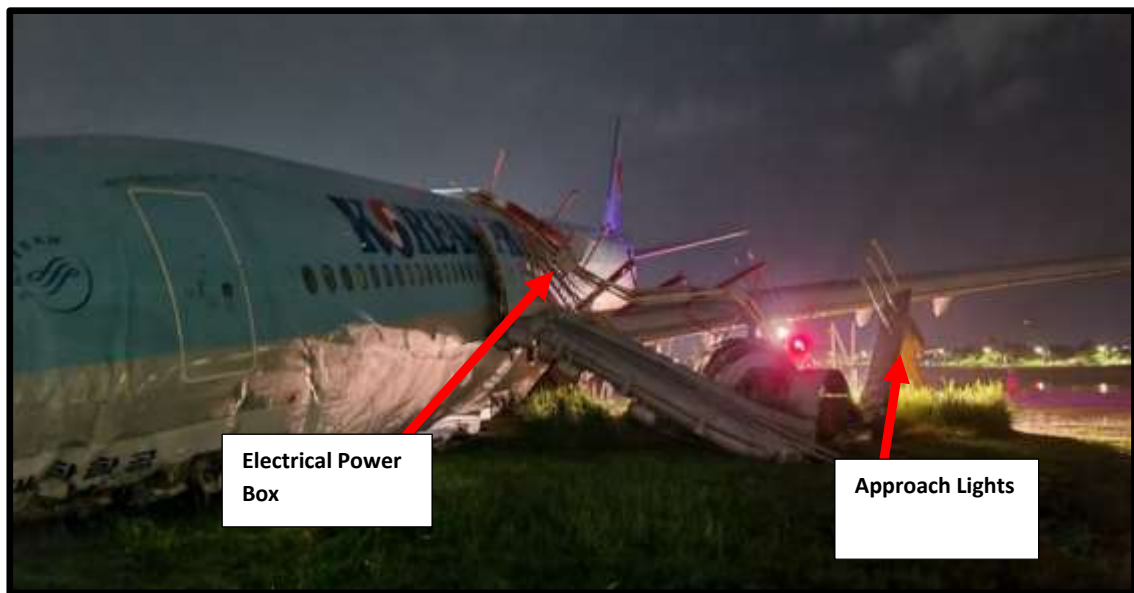
The ILS localizer antenna coiled to the aircraft wings and fuselage. The electrical power box was also damaged. The approach lights with concrete stands were also affected by the collision (Figure 8). Presence of the detached NLG wheel was observed within the path of the aircraft (Figure 9).

Figure 8 - The aircraft left wing colliding with the Electrical Power box and Approach lights.

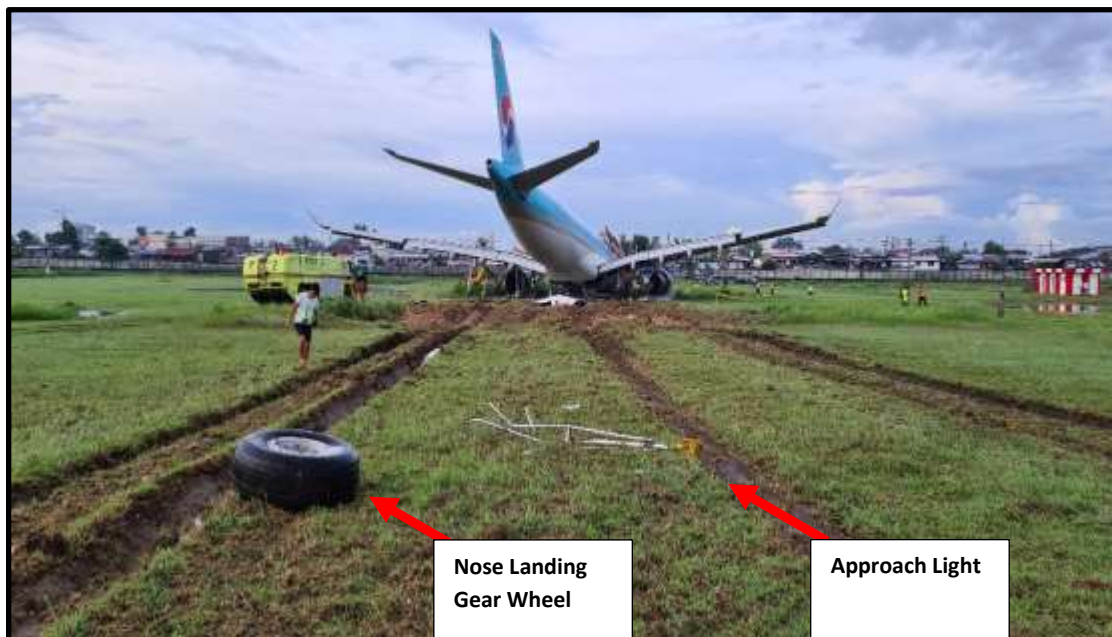
Figure 9 - Presence of the detached NLG wheel was observed within the path of the aircraft.

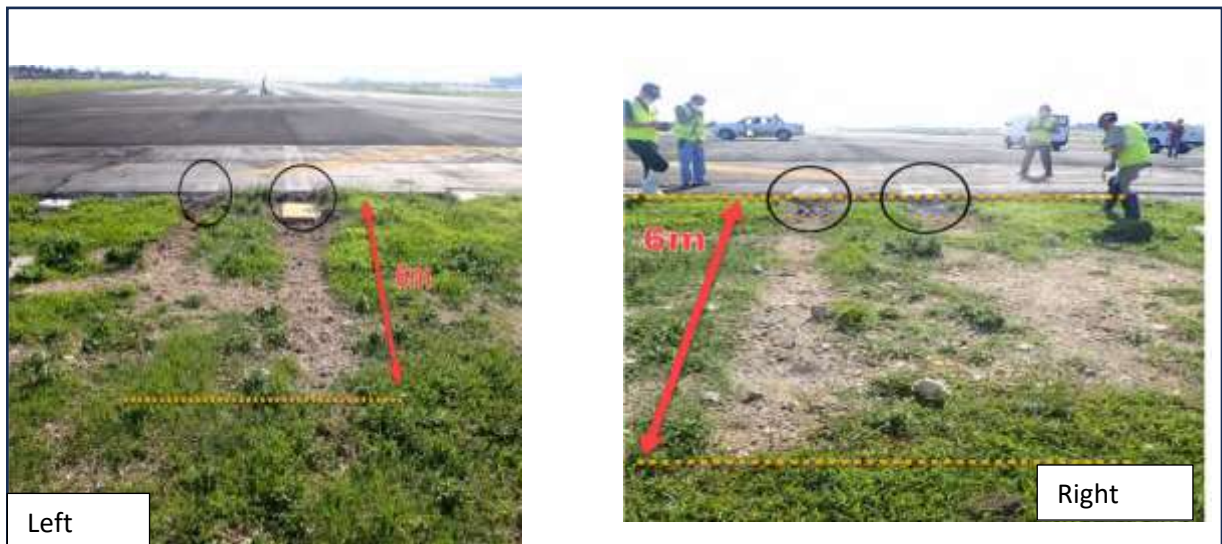
edge portion of RWY 22 (Figure 11-left). The RH MLG also hit the other edge portion (Figure 12-right).

Figure 11 and 12 - The aircraft main landing gear tire marks before the paved portion of RWY 22.

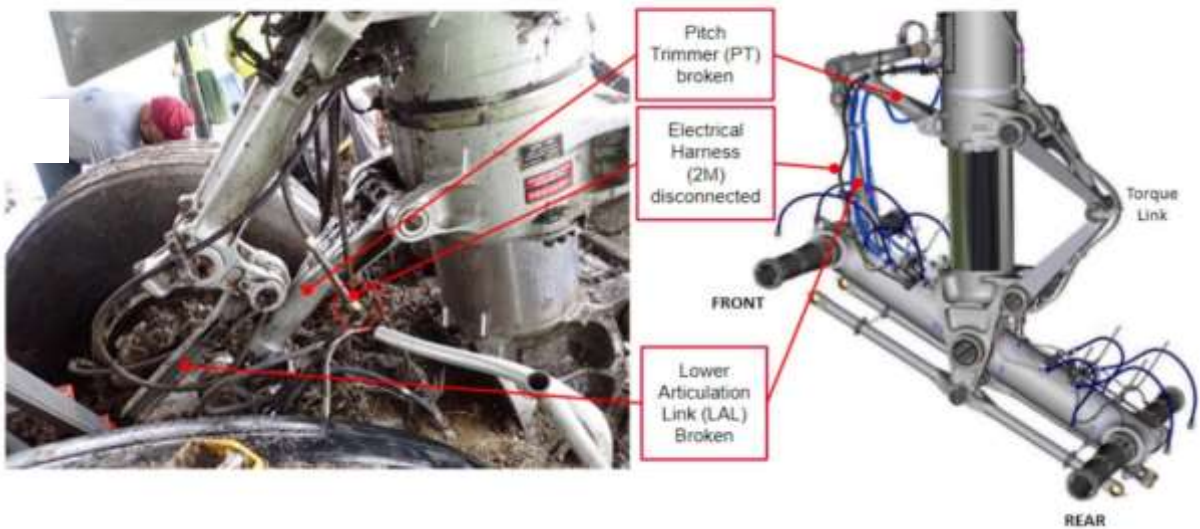
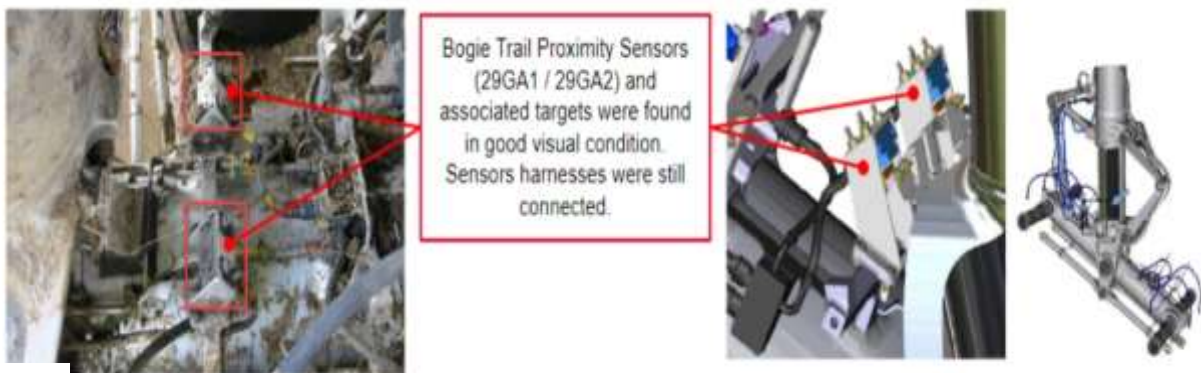
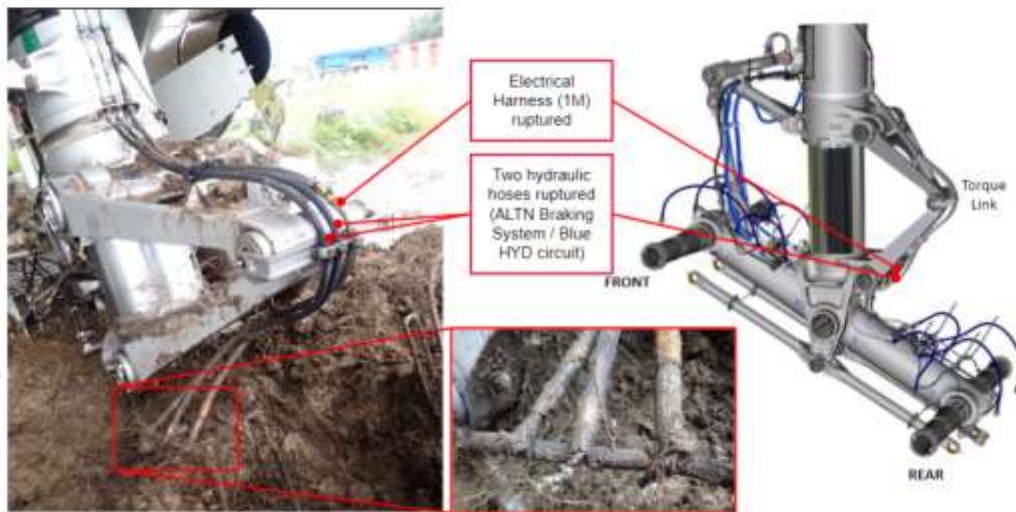
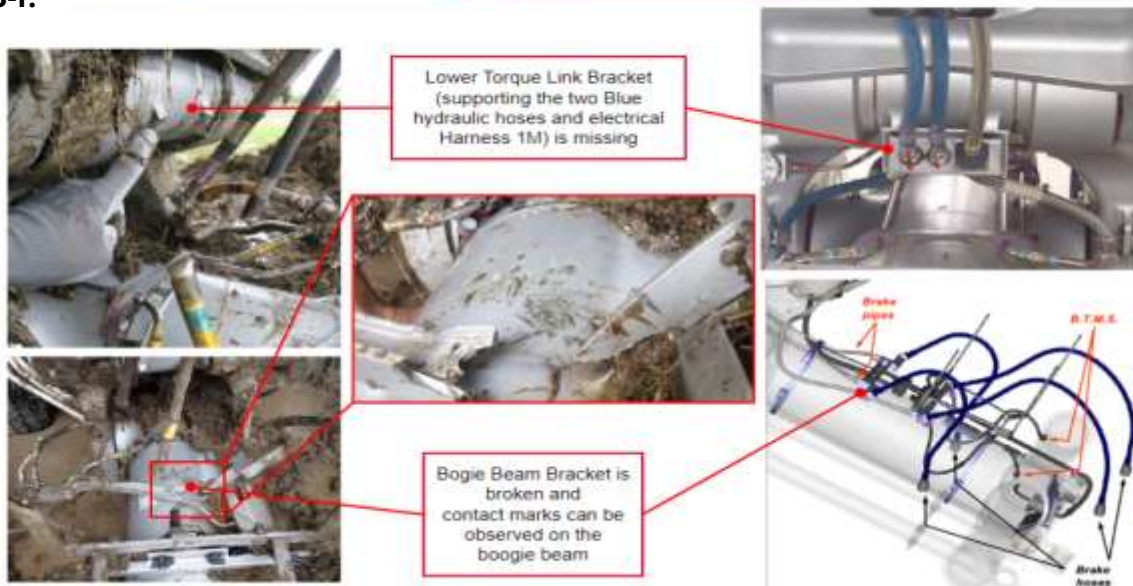
- a. After a high energy longitudinal runway excursion, the aircraft hit the localizer and approach lights installations.
- b. The nose landing gear collapsed during the runway excursion.
- c. Both main landing gears were found in the down locked position.
- d. No trace of an eventual tire burst during touchdown was found on site.
- e. The right main landing gear Lower Articulation Link (LAL) was found broken.
- f. The right main landing gear pitch trimmer was found broken.
- g. Electrical harnesses from the front and aft parts of the right main landing gear were found damaged.
- h. Green and blue braking system hydraulic hoses from the right main landing gear were found broken, leading to leakages.

**Note:** The pictures below illustrate the RH MLG damage, it was at down locked position and all its tires deflated (Figure 13 a, b, c, d, e, f).

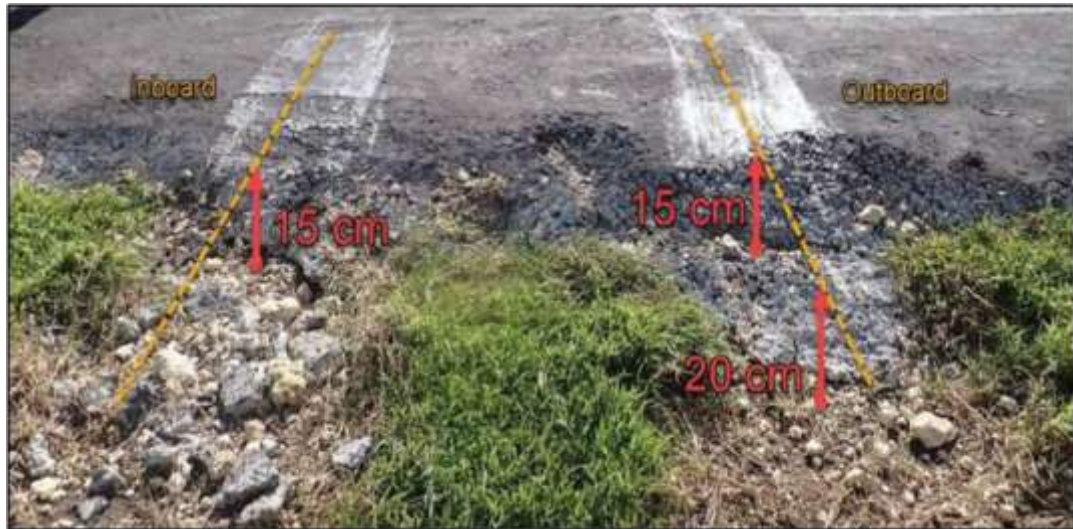
During the on-site examination, tire marks indicated that the aircraft made ground contact before reaching the paved portion of RWY 22. It was also observed that the right-hand main landing gear (RH MLG) struck the uneven concrete edge adjacent to the unpaved area of RWY 22, with a step approximately 15 cm in height (Figure 18). This uneven surface is located in the transition zone between the paved portion of the runway strip and the graded part of the undeclared RESA.

Such existing surface was not in accordance with the published AANSO-CAAP Manual of Standards, 2nd Edition, dated February 2017, chapter 6.4.1.13, ICAO Annex 14 Volume 1, chapter 3.5.8, and ICAO Doc 9157 Aerodrome Design Manual Part 1, which states that “a RESA must be prepared or constructed so as to reduce the risk of damage to an aeroplane undershooting or overrunning the runway. The aerodrome operator has to consider improving the conditions of the threshold end of Runway 04/22 to meet the CAAP and ICAO requirements.

Figure 18 - The 15 centimeters step at of the cemented edge of RWY 22.

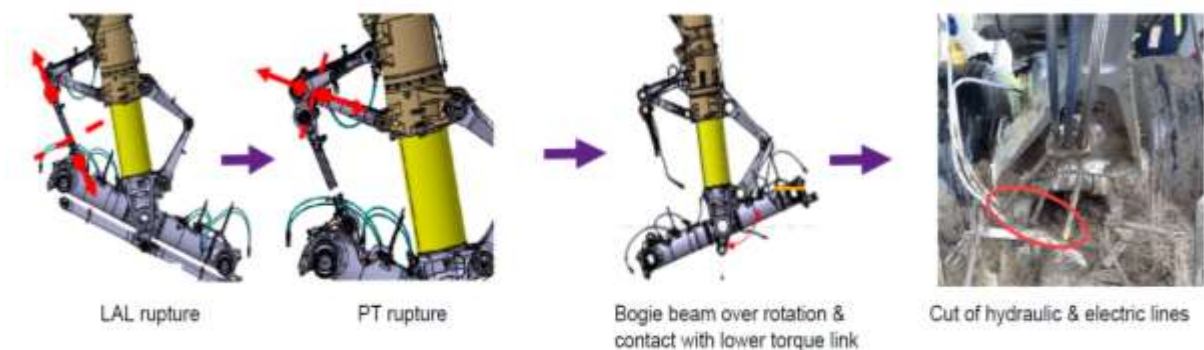
After the rear wheels of the RH MLG hit the step, the bogie beam had a sharp derotation that resulted in the LAL being ruptured. This subsequently allowed the bogie beam to continue its derotation freely and made contact with the lower torque link (front wheels not being stopped by the ground due to the aircraft trajectory). The sequence of events was shown in figure 19.

Figure 19 - The Derotation.

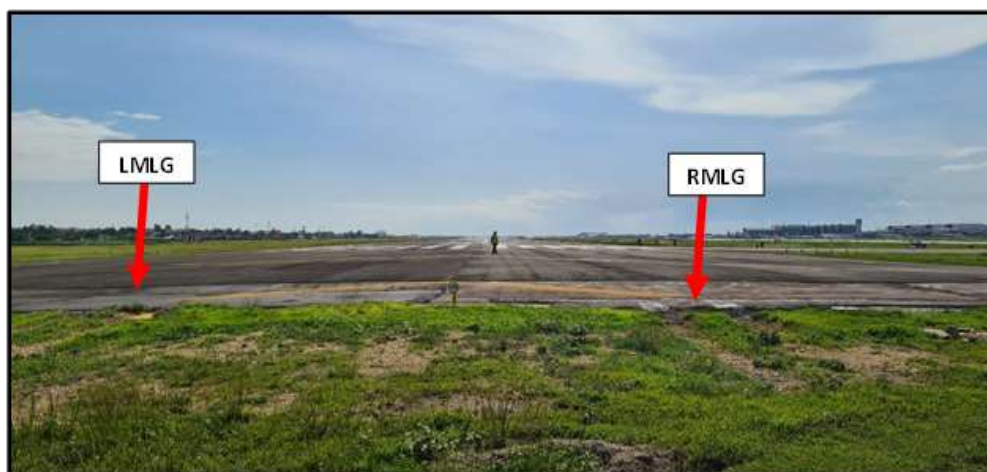
A late go-around may result in ground contact (Figure 24). The flight crew must consider to perform a go-around if adequate visual references are not obtained at minima or lost below minima, there is a loss and/or a doubt about situation awareness.

Figure 24 - The MLG visible tracks were seen before the pavement of RWY 22.

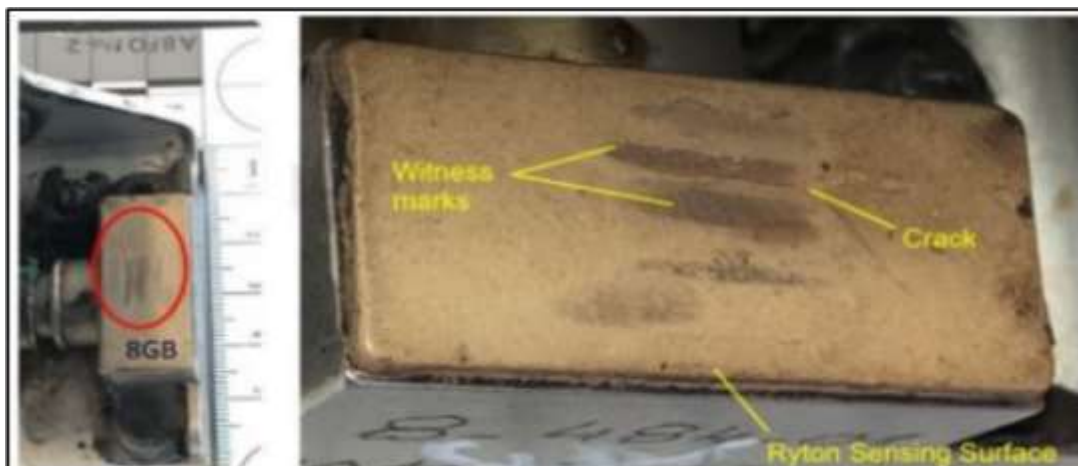
The returned proximity sensor was determined to have physical damage to its sensing face, as a noncontact sensor, this is considered an unusual finding. The physical damage to the Ryton face appears to be new damage; this is in line with it occurring during the event. An energy-dispersive x-ray spectroscopy (EDS) was conducted on the sensing surface, and metallic material surface (i.e., traces of Cr, Fe, Ni, and Zn) was found in the two witness marks (Figure 28)

Figure 28 - The witness marks found in the RH MLG (8GB) sensor.

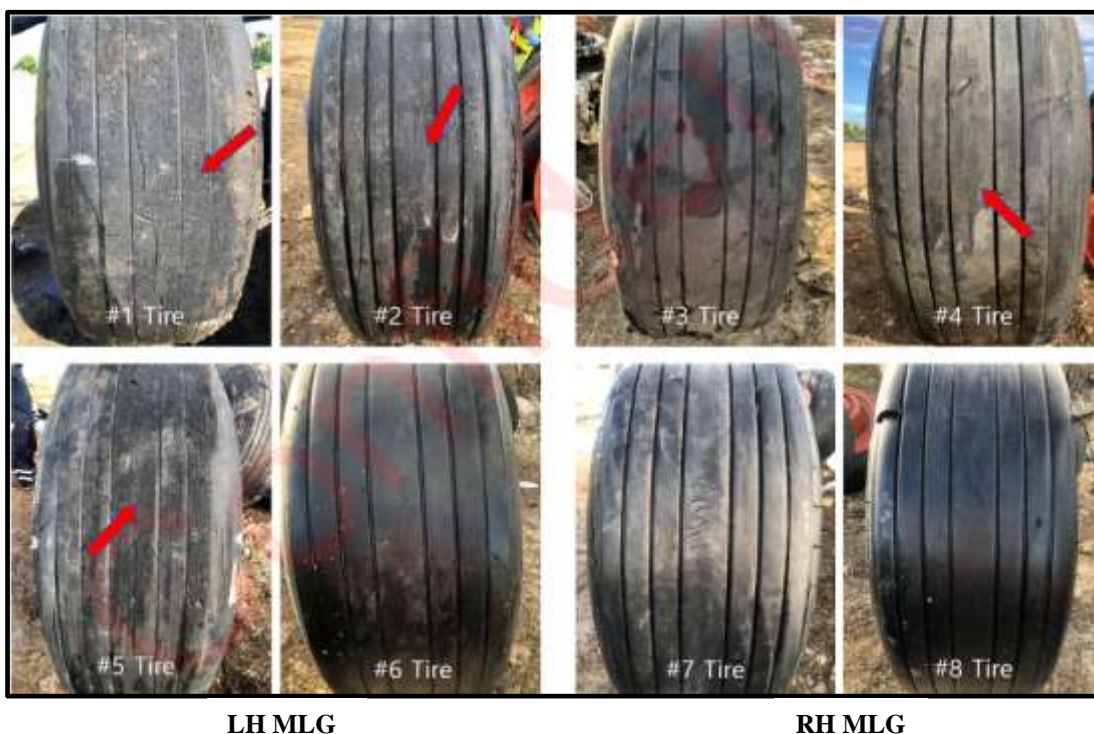
even though the crew used the right brake pedal more than the left (Figure 31). This was explained by the rupture of hydraulic hoses at the RH MLG brake level.

Figure 31 - Tire condition after the accident as per Airbus wheel numbering convention.

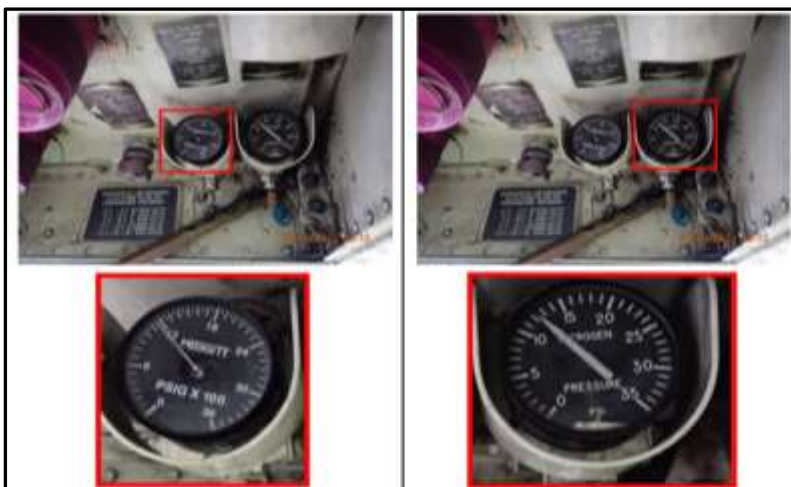
1. Parking Brake Accumulator Pressure-Guage (5432GG) – The pressure was about 1,200 PSI.
2. Yellow Power Accumulator Pressure-Guage (5433GG) – The Pressure was around 1,200 PSI.

Figure 32 - The aircraft brake pressure accumulator gauges during inspection.

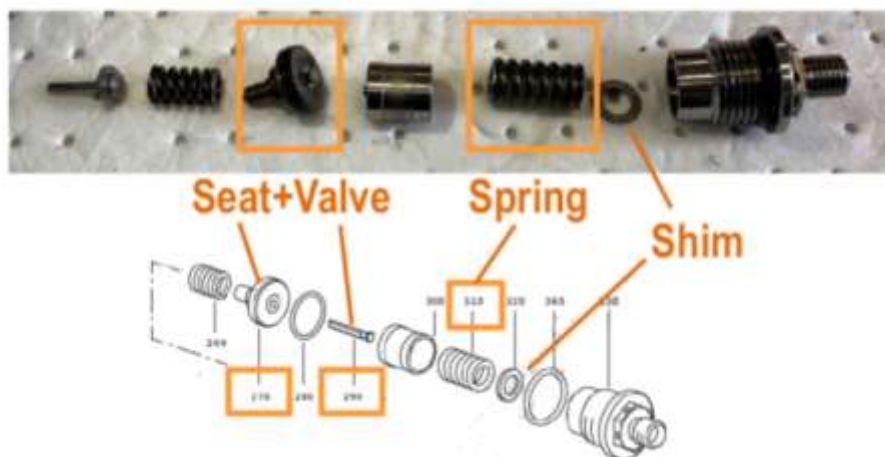
Therefore, the cracking pressure of the PRV was well below the nominal one (defined by the specifications) and was close to the operational supply pressure of the blue hydraulic system (i.e.,  $206 \pm 3/-0$  bars at zero outlet flow). On the other hand, as the hydraulic lines were cut at the brake level, all the return lines (including port D of the Park Hydraulic Manifold) were at atmospheric pressure, i.e., 1 bar, instead of the 5-bar nominal pressure in the return lines. This resulted in increasing the delta pressure between the two ports of the PRV and eased its opening at operating supply pressure.

Figure 35 - The disassembled PRV for examinations.

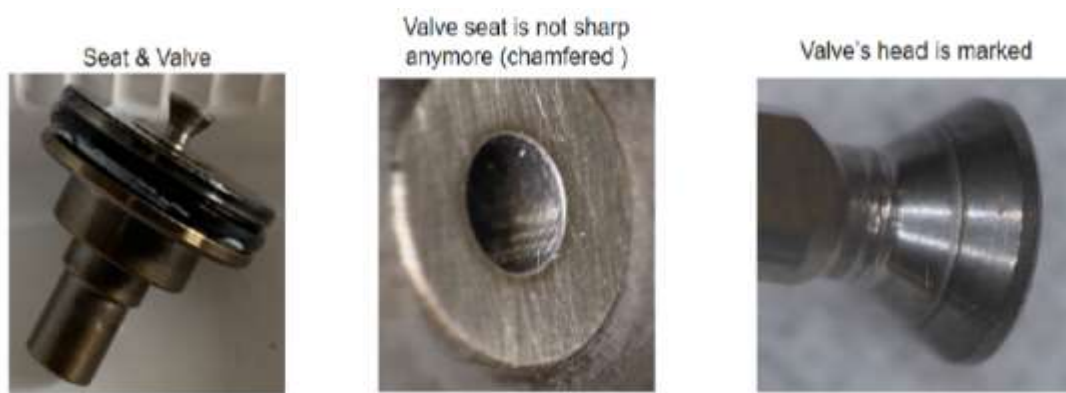
- a. A circular mark on the valve on the interface area with its seat,
- b. A radius edge on the seat instead of an expected sharp edge.

Figure 36 - Damage in the seat and valve

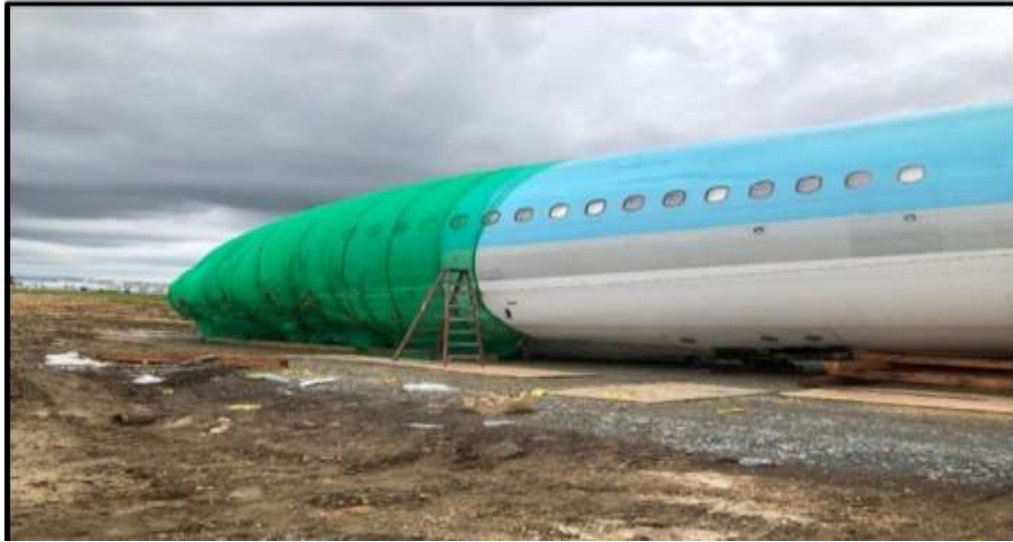
Figure 50 - The aircraft with collapsed NLG at the temporary relocation area.
